BOILER TUBE FAILURE ANALYSIS IN 210MW POWER PLANT STEAM BOILER

Abstract- This study is aimed at analyzing the reasons associated with boiler tube failure. Inspection and data collected from MTPS - I serve as the basis for this analysis. Three samples (damaged LTSH tube, failed Economizer tube and failed RH tube) were collected from MTPS. Metallographic investigations were carried out in the samples collected to understand, interpret and substantiate the probable reasons that led to tube failure which occur when the effective strength falls below a critical level. Apart from visual inspection, optical microscopy, micro-hardness tests, SEM investigations, chemical analysis and EDS tests were carried out on various regions of the failed tubes and the results have been elaborately discussed. Upon visual inspection, formation of oxide layers on the inner side of the tube has been noticed which indicated that the inner side of the tube is subjected to corrosion. Formation of oxide layers has led to inhomogeneous overheating which has thereby affected the homogeneity of the tube. The main reason for rupture (hole formation) in the failed region can be attributed to steam erosion either f

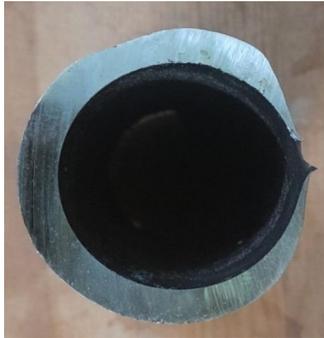
By observing cross section of the economizer and RH tube, it could be noted that half of the cross section of the tube segment was thinner than the other. Figure 3.1 (a) & (b) presents image after making a single cut along transverse plane of failed economizer and RH tube respectively

Figure 3.1 (b): Cross section at the failed region of Economizer tube.

Table 2 - Thickness of the Economizer tube in mm

A1	B1	C1	D1	E1	F1
1.34	6.48	6.40	5.58	6.10	4.19

Upon thinning, the tube could have failed due to following two reasons:

1. The reduced thickness could not withstand the circumferential hoop stress and caused stress rupture.
2. Thinning might have caused over heating which has led the metal temperatures to exceed their creep temperature limit.

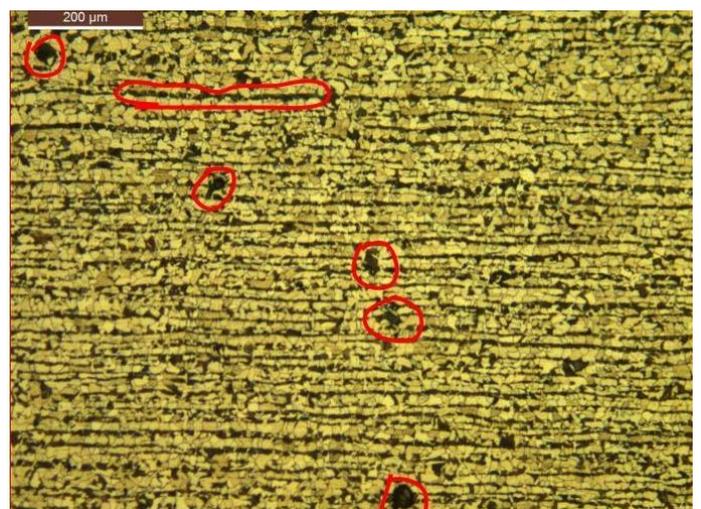
Figure 3.2 (b) More affected region of Economizer tube

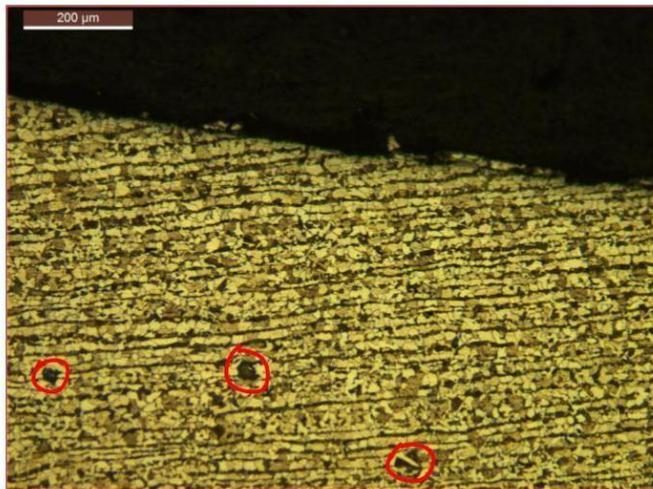
Figure 3.2 (c) More affected region of RH tube with significant graphitization

3. Since, "chromium forms more stable carbides than that of iron and molybdenum", usage of boiler tube materials with high chromium content can withstand graphitization which is one of the most predominant failure mechanisms identified via microscopic examination.

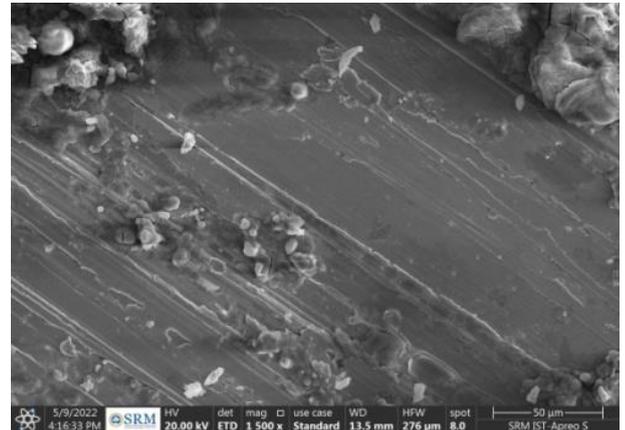
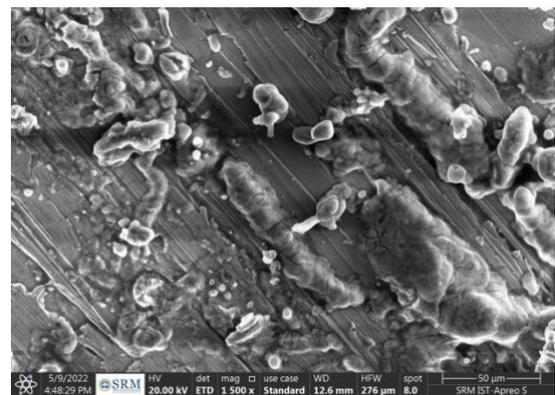
Figure 3.4 (a) SEM micrographs of Economizer tube

Figure 3.4 (b) SEM micrographs of RH tube

By referring the SEM micrographs, we could observe the formation of graphite nodules which confirms the occurrence of elongated as well as spherical graphitization. We could also observe the formation of micro-voids and void coalescence along with micro-cracks and their growth. Since the main purpose of doing SEM in our project is to ascertain the formation of graphite nodules, micro-cracks and void coalescence which occurs due to diffusion of carbon as a result of overheating accompanied by creep, we have done SEM on un-etched specimens. There is a huge scope for researchers to extend our SEM investigation with specimens after applying various etchants so that the formation of new grains with different microstructures can be observed and appreciated.
