# EVALUATION OF PAVEMENT SURFACE DISTRESS USING SMARTPHONE SENSOR DATA AND IMAGE-BASED ANALYSIS TECHNIQUES

Jadeja Krushanrajsinh Ramsinh<sup>1</sup>, Dr.Prachi Pandya<sup>2</sup>, Durgesh Kumar Singh<sup>3</sup>, Dr.C.G.Patel<sup>4</sup>

<sup>1</sup> Final Year Student, Department of Civil Engineering (IoT) Ganpat University, Gujarat, India

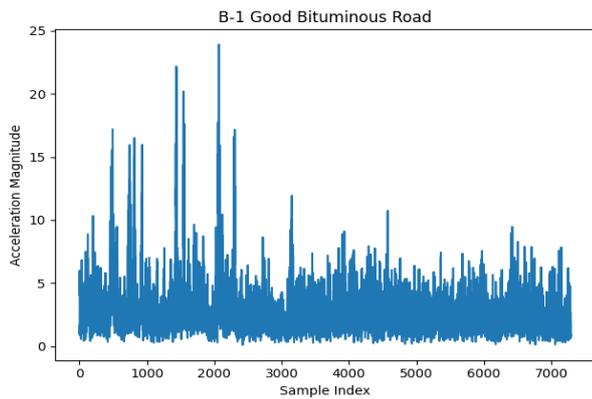
The acceleration response recorded along the good-condition bituminous pavement section (B-1) indicates relatively smooth vehicle motion with minimal vibration fluctuations. The acceleration signal shows small and evenly distributed peaks, suggesting a uniform pavement surface with negligible surface distress. The calculated average acceleration magnitude for this section was 2.81, which is the lowest among all studied pavement sections. This low acceleration response confirms good pavement condition and superior ride quality.

**Fig. 2:** Acceleration variation along good-condition bituminous pavement section (B-1)

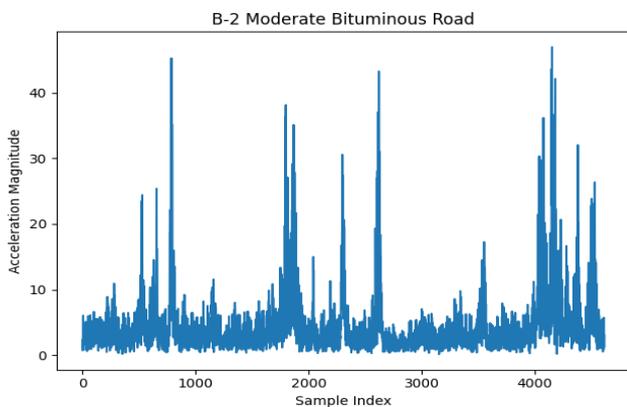
The moderate-condition bituminous pavement section (B-2) exhibited noticeably higher acceleration variability compared to the good-condition pavement. The acceleration signal shows several localized peaks, which can be attributed to minor surface distresses such as shallow potholes, surface wear, patchwork, and uneven riding surface. The average acceleration magnitude recorded for this section was 4.33, indicating a clear increase in pavement-induced vibration response due to surface deterioration.

**Fig. 3:** Acceleration variation along moderate-condition bituminous pavement section (B-2)

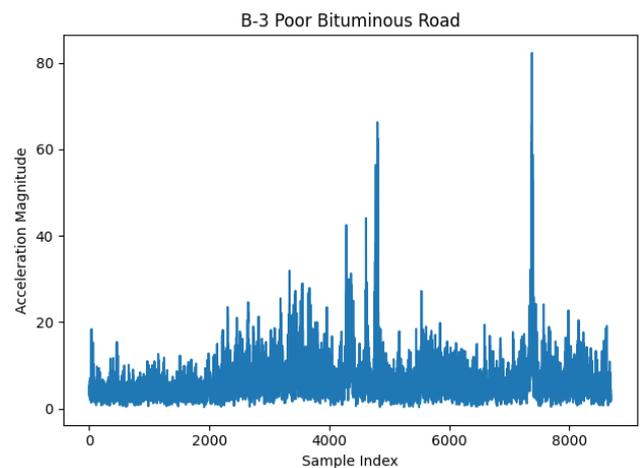
The poor-condition bituminous pavement section (B-3) demonstrated the highest magnitude and frequency of acceleration peaks. The acceleration signal shows sharp, irregular, and continuous fluctuations throughout the road section. These high vibration responses are caused by severe pavement surface distresses such as deep potholes, extensive cracking, surface disintegration, and uneven pavement profile. The calculated average acceleration magnitude for this section was 6.42, which is significantly higher than the other bituminous sections, clearly indicating poor pavement condition and reduced ride comfort.

**Fig. 4:** Acceleration variation along poor-condition bituminous pavement section (B-3)

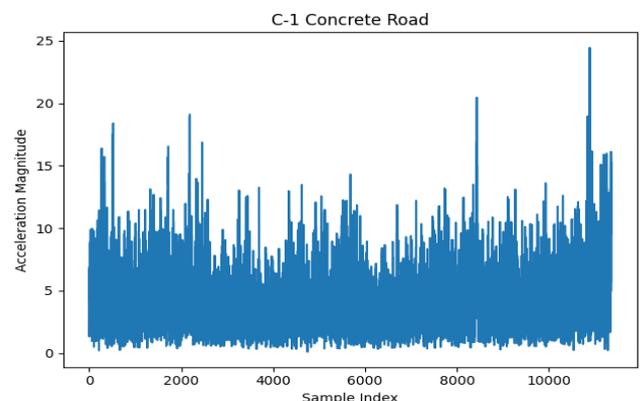
The acceleration response of the cement concrete pavement section (C-1) showed characteristics different from those of bituminous pavements due to the rigid nature of concrete pavements and the presence of transverse joints. The acceleration signal exhibits moderate average values with distinct sharp spikes occurring at regular intervals. These spikes correspond to vehicle movement over pavement joints and surface discontinuities inherent to rigid pavements.

The average acceleration magnitude for the cement concrete pavement section was 4.17, which is higher than that of the good-condition bituminous pavement but lower than that of the severely distressed bituminous pavement. This indicates that even in the absence of major surface damage, concrete pavements can produce noticeable vibration responses due to their structural stiffness and jointed construction.

**Fig. 5:** Acceleration variation along cement concrete pavement section (C-1)

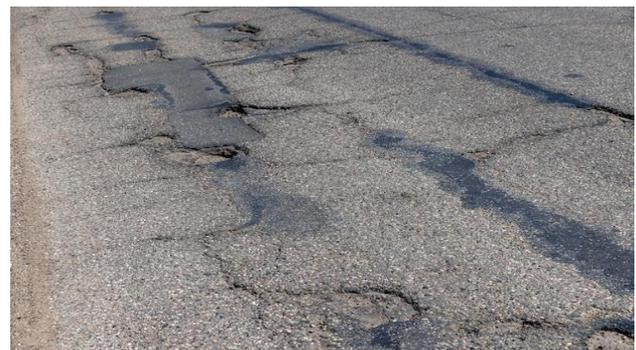
Images from the poor-condition bituminous pavement section (B-3) clearly showed extensive surface distresses such as potholes, cracking, raveling, and surface breakup. These visible defects corresponded closely with the high and irregular acceleration peaks observed in the sensor data, confirming the reliability of vibration-based pavement condition assessment.

**Fig. 7.** Pavement surface distress observed on poor-condition bituminous pavement section

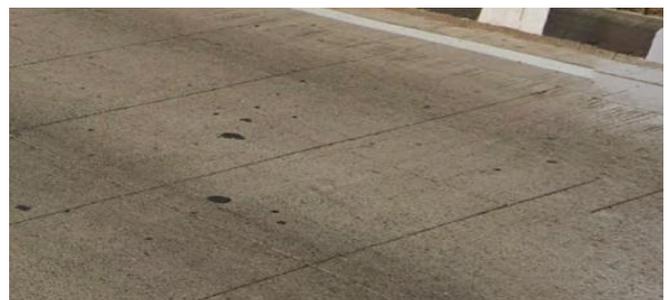
Similarly, images captured from the cement concrete pavement section (C-1) revealed joint-related surface irregularities and minor surface distress. The locations of these joints aligned with the sharp acceleration peaks observed in the acceleration data. This visual confirmation further validates the effectiveness of smartphone-based sensing in identifying pavement surface irregularities.

**Fig. 8** Joint-related surface distress observed on cement concrete pavement section
