Failure investigation of Indigenized Boat under Carriage and Improvement in Frame Design

Anil Kumar¹, Shivkumarappa²

¹ Asst. Manager, R&D Defence, Bangalore Complex, BEML Ltd, Bangalore, India

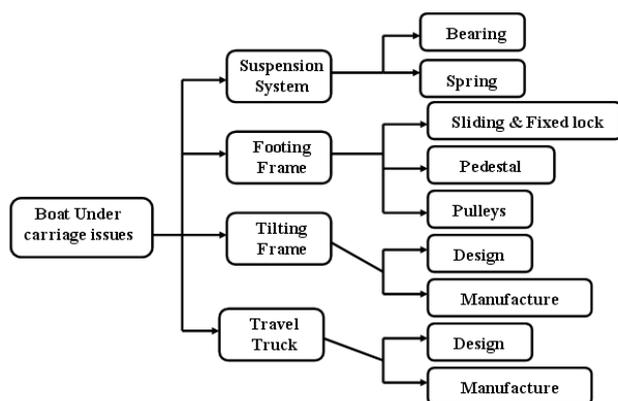
Chart -1: Boat under carriage sub-system issues

Considering the methodology of usage, comparison with the imported equipment and involvement of the sub-system during the actual launching operations, brake system, footing frame, axle assy. and suspension were for the time being removed from consideration.

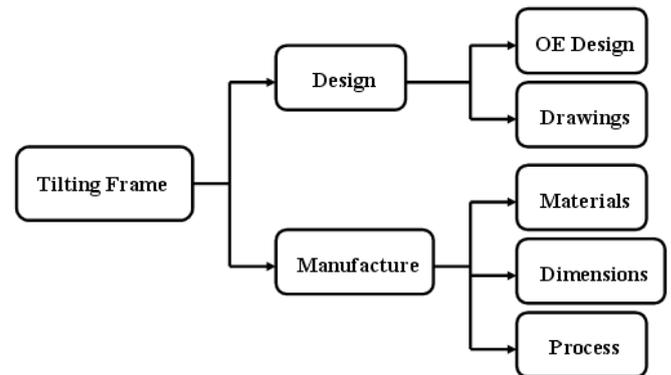
Chart -2: Tilting-frame design & manufacturing issues

1. The Tilting Frame sheets were 5mm thick in OE equipment but the indigenous frame and available OE drawings are with 4mm sheet
2. The gap between the travel truck rollers and the inside surface of the tilting frame is minimum, within 1.5mm, in the imported equipment; while in the indigenous equipment the gap varies up to 15mm
3. The spacing between the guide rails of the tilting frame in the case of imported equipment is $2394 \pm 1\text{mm}$ whereas in the indigenous equipment there is variation of up to $\pm 10\text{mm}$
4. Excessive play of rollers and guide wheels

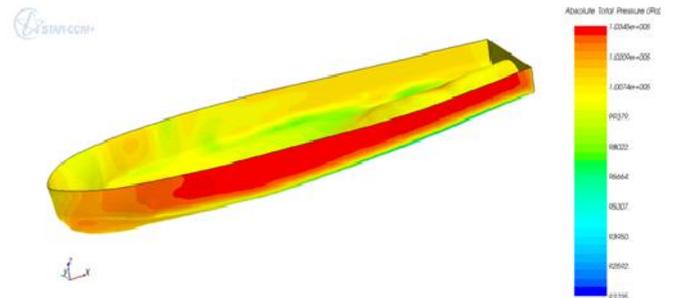
Fig -3: River current force on Boat (0.88t)

From the field report, derailment of Tilting frame recorded at river velocity which is above 1 knot (0.5 m/sec). For the present analysis, river velocity considered as 4 knots (2 m/sec). CFD analysis has been carried out to find out drag force on Boat.

When Tilting-frame released to launch the Boat, it moves along with Travel truck on Roller support for smooth operation. Boat will be lifted up from Roller support when it goes around 60% in to waters (due to bouncy force). Now, boat will be having support only from Travel-truck. The river current force of 0.5 t (around 60% of 0.88 t) will be applied on supporting structure.

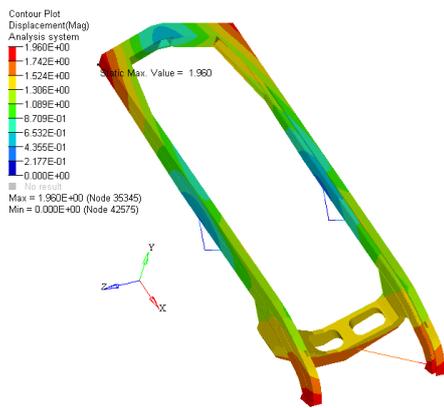
Fig -5: Displacement plot of Boat under carriage Frame

The max stress on Tilting frame is well within the limit of respective material. The twist reported under river current force is around 2 mm which is more enough to cause derailment of Travel truck from indigenized Boat under carriage (refer RCA). Based on FE analysis and Root cause analysis, Existing Tilting frame structure has modified as shown in Fig - 6.

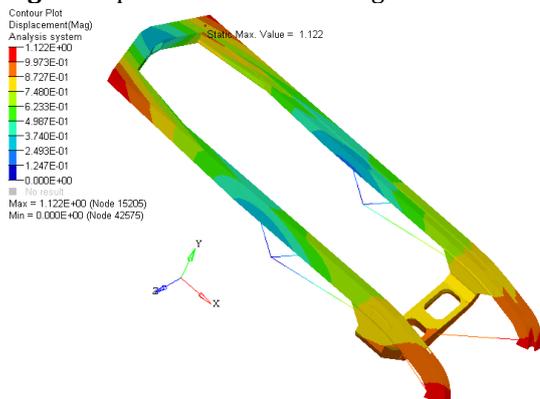
Fig -7: Displacement plot of modified Tilting Frame

Now, the maximum twist reported under river current force is around 1 mm which is self sufficient to operate Boat under carriage without failure (refer RCA).
