Failure Analysis and Prevention of Furnace Water wall Tube Corrosion on Fire side of Boiler

Patel Sunny Sanjay¹, Dileep M², Dr. R K Mandloi³

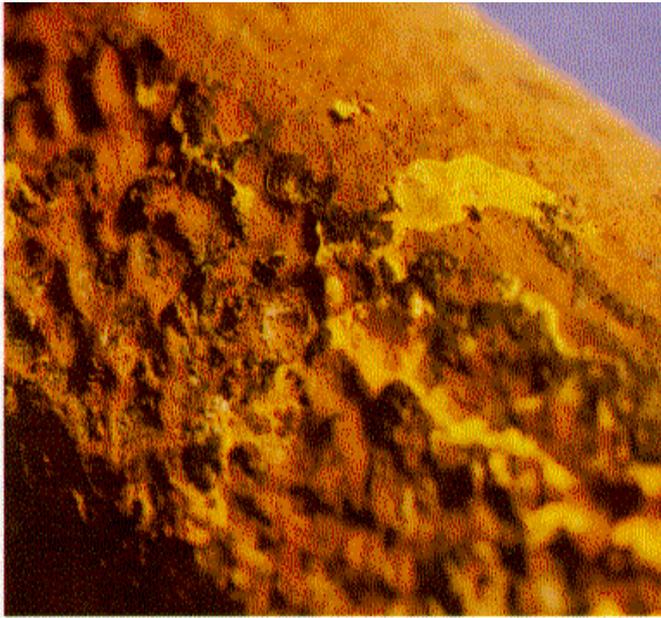
Fig -1: Coal Ash Corrosion

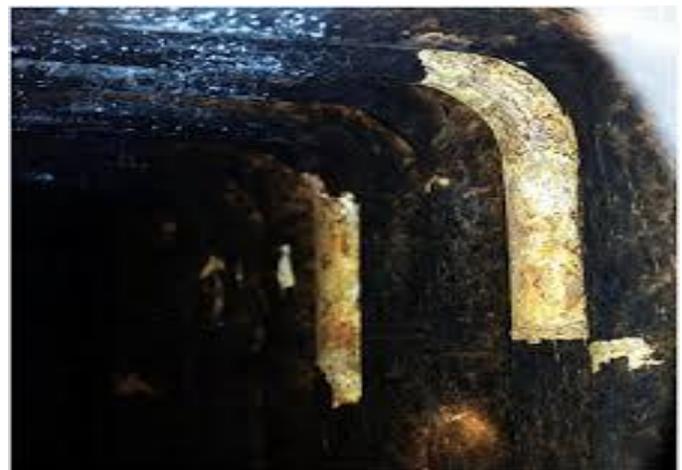
Fig -2: Oil Ash corrosion on water Panel Bends

Circumferential grooving or cracking on furnace water wall tube of 2.25Cr-1Mo Steel in an oil fired super critical unit. Thermal cycling of the water wall caused by load changes and oil as corrosion with possible higher water wall tube temperature caused by flame impingement or by oxidation penetration.
