RCC Fly ash Silo Repair Based on Visual Inspection and PDT/NDTs

Key Words: RCC Silo, PDT/NDT, GPR, UPV, Repair techniques.

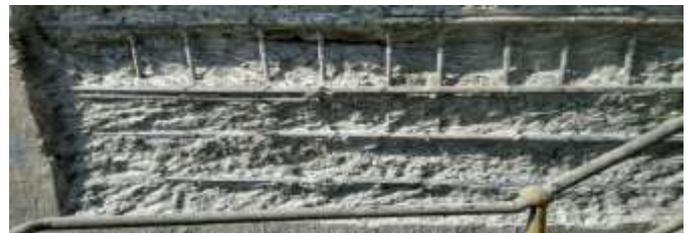
Fig -1: Distressed Concrete Chipping (Initial Repair Stage)

Chipping & Cleaning: Loose material within the grooved area was chipped off using mechanical chippers followed by cleaning the surrounding area for dust and debris using air blowers.

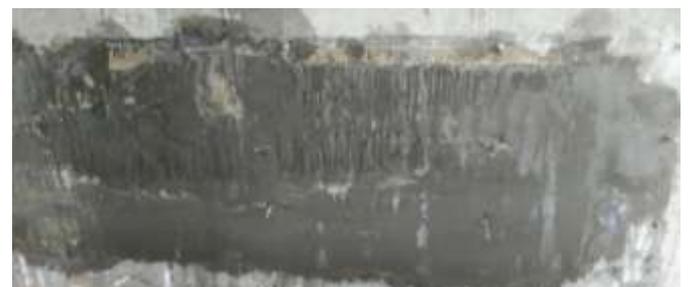
Fig -2: Curing of Repaired Patch (Final Finished Stage)

Curing: Finally, water curing was done to the finished repaired patch.

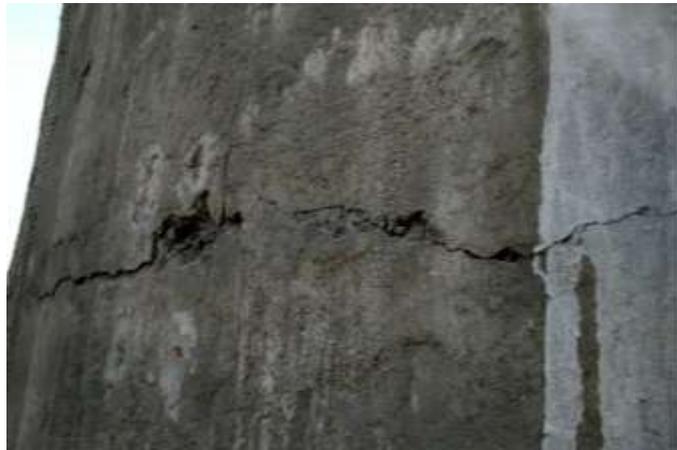
The zero degree wall face of the RCC Fly ash Silo was found to be in a critically damaged condition. The Silo periphery was suffering from some major issues as: **Hand Patching**,

Honeycombing, Pot holes, Spalling, Horizontal as well as Vertical major and minor cracks, etc.

Fig -3: Major Horizontal Cracks

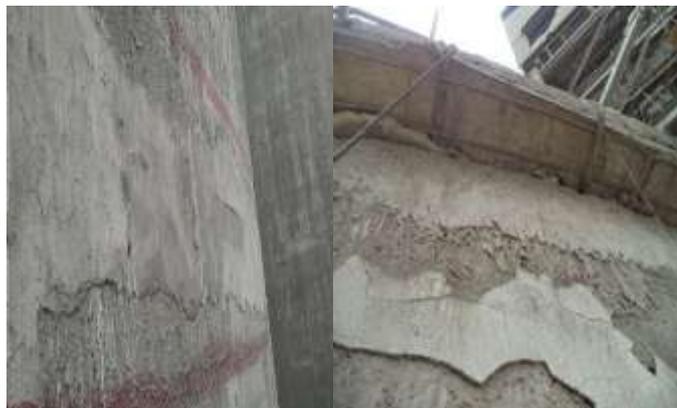
Fig -4: Hand patching and Honey combing of Concrete

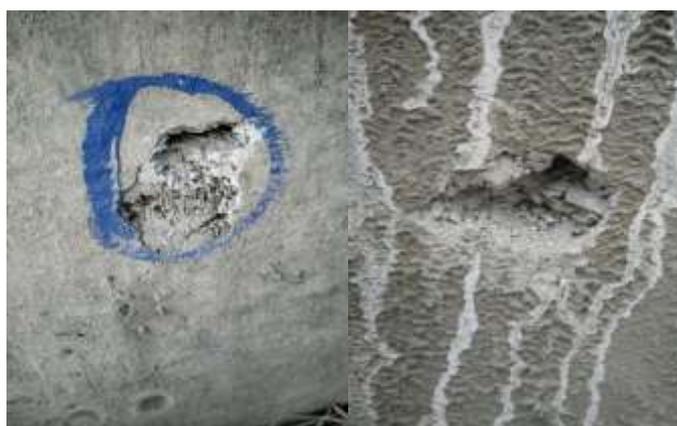
Fig -5: Pot holes Observed

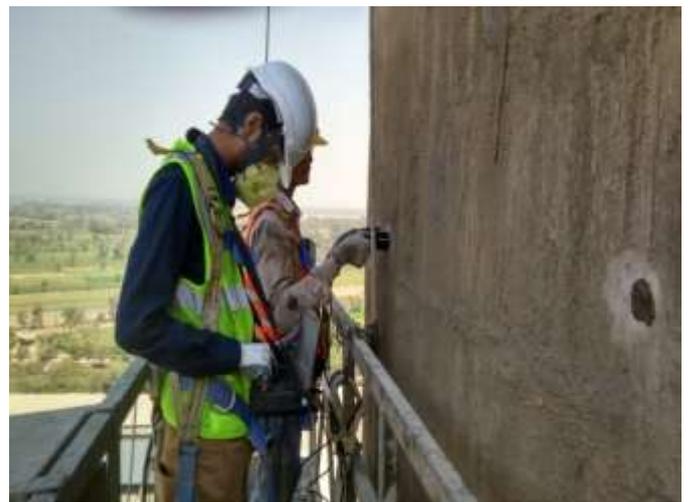
Fig -6: Performing UPV Test at Certain Height

The avg. corrected pulse velocity readings evaluated after considering all the codal guidelines as per **IS 13311- Part 1 (1992)** was found to be minimum for 11 m location as 2.24 km/sec and maximum for 24.5 m location as 3.15 m km/sec. It was clearly seen that majority of the concrete at various locations was Doubtful. However, few of them were having Medium quality concrete. None of the readings were having Good/Excellent quality concrete.
