# Failure Investigation of a Bus Gas Engine Cam Thrust Plate

**Abstract** - A failure investigation has been conducted on a bus diesel engine cam thrust plate wear that is located behind the camshaft pulley in the timing chain area of system that were used in a bus. The cam plate are made from chill-cast gray iron. Adjacent wear appeared on the plate after 1166:29 running hours. In this case Mo is not sufficiently present which can increase the wear rate as Mo increases hardenability, wear resistance and promotes martensitic transformation of the steel and higher percentage of Ni improves the hardenability to a certain extent but too much of soft phase as it will not dissolve completely and remain as Iceland as white colour which can prone to wear of the part.

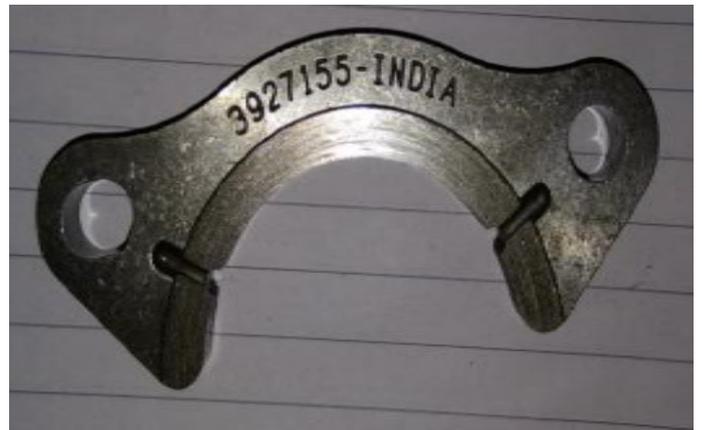
The failed cam thrust plate is shown in Fig. 1, which is located behind the camshaft pulley in the timing chain area of your system as shown in fig. 2. Wear is observed on cam

Fig- 1. Failed cam thrust plate due to wear

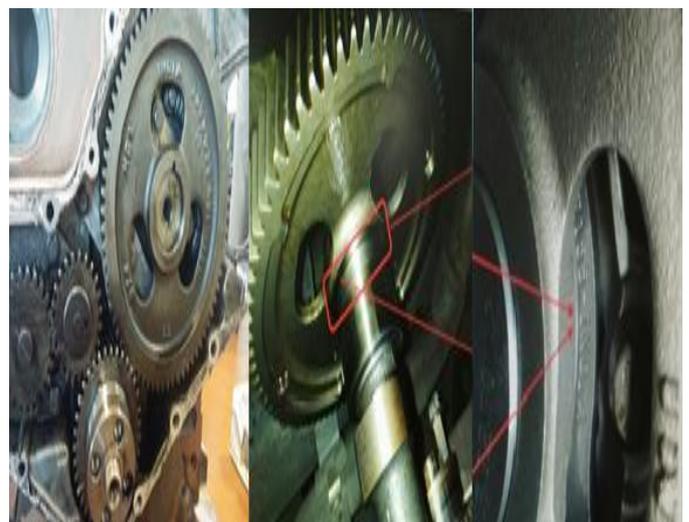
Fig- 2. Position of cam thrust plate in engine

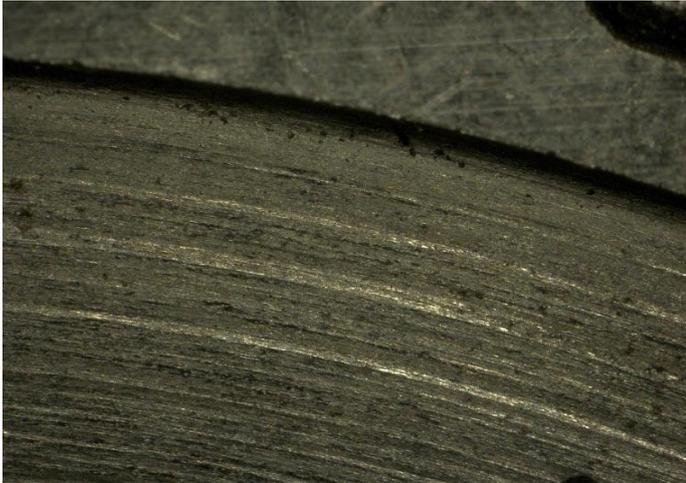
thrust plate on the side facing cam gear hub. Wear marks were observed at 50X as shown in figure 3. Contact extrusion marks and circumferential traces were found on surface. From observation it was deduced that circumferential traces were originated from imprint by the cam gear hub. We neither observed any kind of heat distortion or colorization on failed thrust plate due to lack of lubrication nor we witnessed camshaft bearing journal running dry due to poor supply of oil. So, Oil feed is sufficient.

Fig -3. Wear Marks Observed At 50X

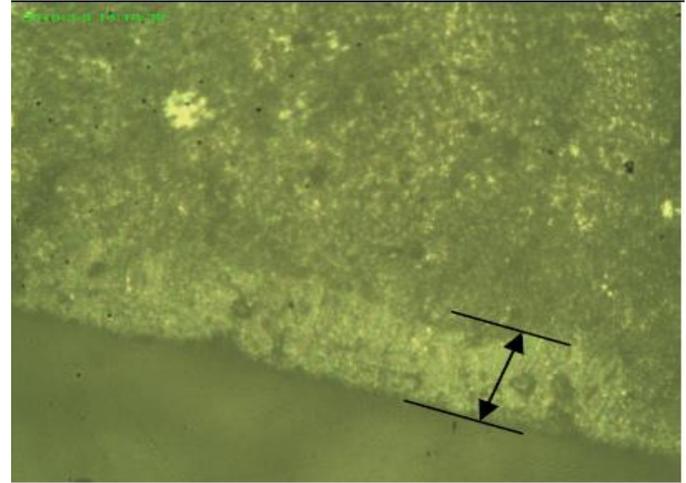
Fig-5. Tempered martensite upto depth of 0.25 mm. Even distribution from surface to core

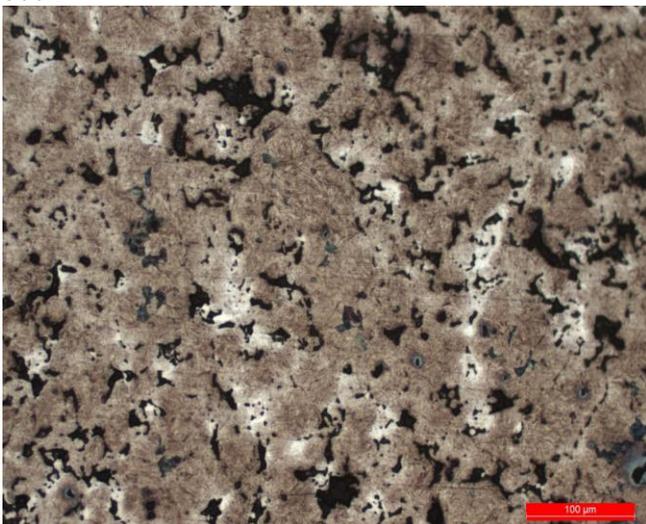
Microstructure on the wear surface was observed by Optical Microscope (Fig. 4). The observation results show that the core microstructure of the cam thrust plate.

Result- Tempered martensitic structure with evidence of porosity (Black coloured) and soft phase (White colour) at 500X

Fig -4. Tempered Martensitic Structure with Evidence of Porosity (Black Coloured) And Soft Phase (White Colour) At 500X

A sufficient content of Mo and Carbon can improve intrinsic wear resistance of the matrix, but in this case Mo is not sufficiently present which can increase the wear rate. Ni improves the hardenability to a certain extent but high percentage of Ni will not dissolve completely and remain as Iceland as white colour which can prone to wear of the part. Under the action of load by the camshaft gear, it is difficult for the soft matrix of the cam thrust plate to perform an effective support which results in wear of the part.

Improper mixing of powders is responsible for the irregular composition in the cam thrust plate. Proper mixing of powders and adding as per suitable alloy contents as per specification will decrease the wear on the cam thrust plate.
