# A Case Study: In-Situ Weld Repair of Steel Casting of Grade C12A ASTM A 217M

<sup>1</sup>Material Research Laboratory, BHEL Haridwar, Uttarakhand, India

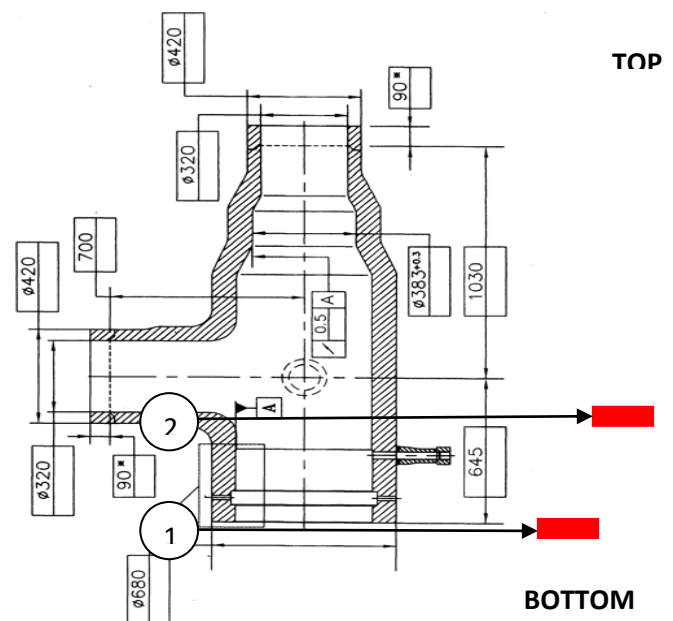
During annual overhauling, main steam and hot reheat strainer were removed and NDT inspection was carried on strainer and its housing. 2 Nos of cracks after excavation (110 mm (Length)) X 42 mm (Width) X 40 mm (depth) and (175 mm (Length)) X 135 mm (Width) X 63 mm (depth) were in Main Steam strainers. The location of these cracks are shown in red color mark in the drawing shown below in Fig. 3.

Fig. 3: Rough Position of crack found in dye penetrant test.

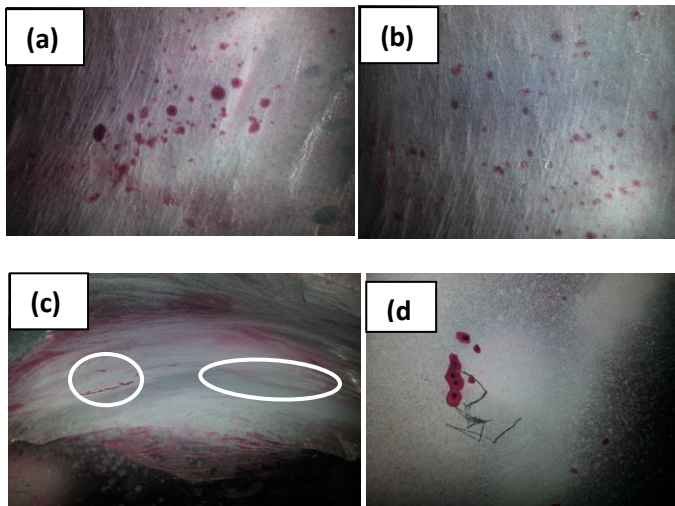
- Cluster and isolated blow holes between 700 mm to 900 mm in the bottom (refer Fig. 4(a), (b))
- **Defect 1** - Six nos. of linear indications in the excavated area (refer Fig. 4(c))
- **Defect 2** - One more linear indication was observed in the right side of the inlet (refer Fig. 4(d)).

Fig. 4: Observations during DPT (a), (b) Porosity on inner surface (800 mm from bottom), (c) 2 nos. of large cracks of 27 mm and 35 mm and 4 nos. of small cracks of length 5mm, 5mm, 17mm and 10 mm, (d) New crack observed (right side from the inlet)

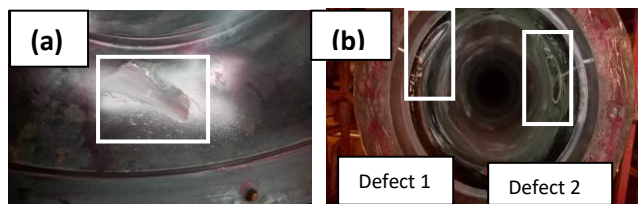
Fig.5: (a) Surface after removal liner indications (b) View of defects from bottom side

- Length :110 mm
- Breadth : 42 mm

- Width :40 mm
- Position: 195 mm from bottom.

Liner indications observed in excavated area of Defect 1 during DPT on inside surface were removed by grinding and complete removal was ensured by repeating the DPT (refer Fig. 5).

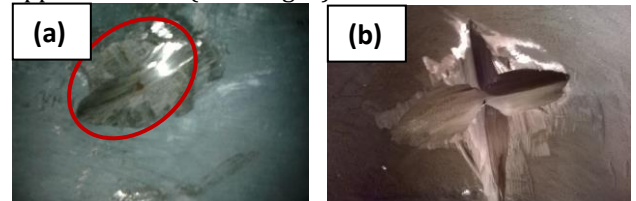
After grinding to a depth of 15 mm, a new crack was observed in the circumferential direction to a length of approx. 15 mm (refer Fig. 6).

Fig 6: (a) After grinding to a depth of 15 mm, (b) Grinding to get the circumferential crack

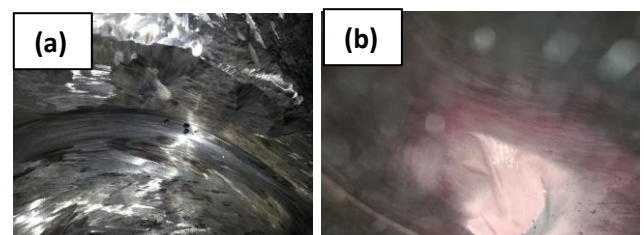
Ultrasonic Testing (UT) [7] was carried out for sizing and location of the defect. Defect with a length of 30 mm and at a depth of 15 mm (refer Fig 7(a)) was confirmed by Ultrasonic testing which motivated to go for further grinding in order to complete removal.

- Length: 175 mm,
- Width: 135 mm,
- Depth: 63 mm,
- Height from bottom face: 340 mm
- Remaining thickness: 27 mm

Fig. 7: Observation after grinding 15 mm (a) and final excavated area (b)

After significant cutting and grinding, a defect free surface was ensured and same was confirmed by conducting DPT. Final dimensions of the excavated area (refer Fig. 7(b)) were as follows:

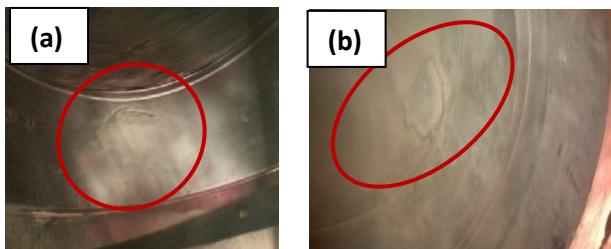
Fig 12. Surface after grinding in defect 1 area (a) and defect area 2(b)

After PWHT, grinding and machining was done to level the surface. The surface looked as shown below
