A case study: Failure analysis of crude oil pipeline rupture

Abstract: A cross-country crude oil pipeline section of 18" diameter API 5 LX 65, LSAW of 996 km was ruptured during its operation. This pipeline is used for carrying the crude oil from an offshore tank farm to a land-locked refinery. The failure occurred along the longitudinal seam. The affected pipeline section length was 206 km. The pipeline section was in operation since a 2002 and failure reported in 2017 i.e. more than 15 years of operation. This pipeline is laid as two parallel strings of 18" diameter pipelines. Prior to failure about two years back the pipeline was inspected using Axial MFL technology based intelligent pigging survey. However, no significant corrosion or other defect was identified in ILI findings in the section which would have eventually failed. Pipeline failed from its longitudinal seam, failure initiated from HAZ when the pipeline was in operation. The failure occurred much below the MAOP of the Pipeline. The MAOP is 91.4 kg/cm² where the pipeline was operational at 77 Kg/cm². Failure appeared to be fish mouth type of failure. Pipeline failure was examined from an operational as well as metal

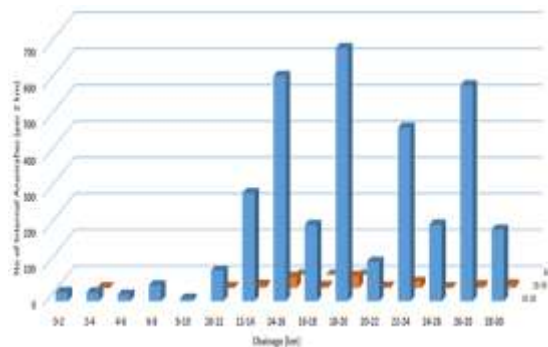
Figure 2: Corrosion anomalies distribution with chainage

As part of integrity assessment program, Inline inspection tool is considered to give the photograph of the pipeline. An axial Magnetic Flux Leakage based inline inspection survey was carried out recently before the failure. Small patches of corrosion were present in the pipeline but not near the vicinity of the pipeline. Moreover, the corrosion patches were evaluated as per ASME B31G. [3] The pipeline corrosion defects are marked as in figure no. 2.

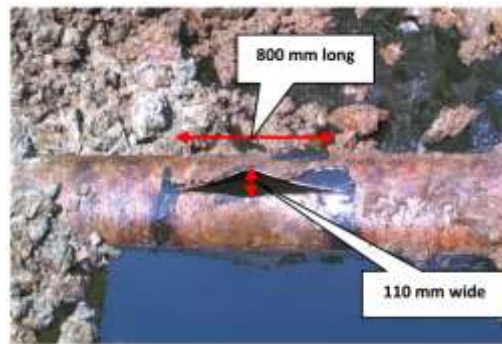
Figure 3a: Preliminary failure photographs at site

After isolation of the affected section, excavation & collection of crude oil from the leaked site, the pipeline was exposed. The seam opening was to the extent of 800 mm in length and the center opening was 110 mm wide, bearing a concave curvature of pipe wall at the center resembling a fish mouth. No scales, dents or laminations were observed in the internal or external surface of the failed section. No internal or external corrosion was noticed near the failure zone. Moreover, no corrosion on seam was observed in the pipeline. Pipeline section had not shown any sign of necking or thinning near the rupture area.

A small amount of swelling was noticed near the surface. Rupture spanned over 800 mm along the pipeline longitudinal seam. The failed pipeline section is represented as figure 3.

The 100 mm long portion of the ruptured surface in the middle of the entire 800mm long failed span from where failure originated can be clearly seen to bear layer or a band-like marks implying advancement of a crack which enlarged over time (Figure:3). The crack propagation might have stopped intermittently when the pipeline was operated at lower pressures.

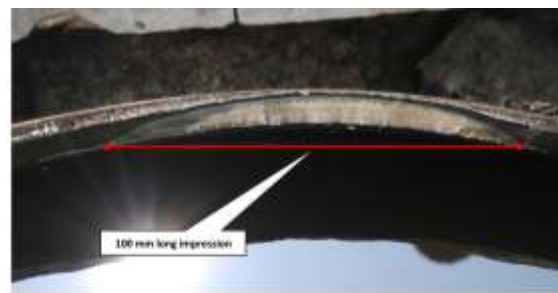
Separation line of the fractured surface in the middle span was 100 mm & the surface was shiny and uniform. On both side of the middle was rough, fibrous and its edges had ridges with a chevron pattern.

On closer examination, it was found that in the entire 800 mm span of the fractured surface, the middle concave profiled 100mm span of opening had shiny and plain surface whereas the rest of the portion bears a fibrous and uneven surface implying that the pipe yield originated in this 100 mm span and the balance portion on either side had ductile failure resulted due to propagation of failed line along the edge of the weld seam, during the release of line pipe pressure

Figure 4a: Rupture at longitudinal pipe seam

A top view of the portion from where failure originated, shows that the line of separation is within the weld seam (Figure-4). This also implies that the failure originated from the weld seam itself.

The shiny surface with the plane contour on the surface is indicative that the pipe seam weld was affected by fatigue and that the failure might have initiated from a crack/cracklike feature developed at the internal surface of the pipe from some kind of weld anomaly. Since the failure was now known to have originated from the weld seam, it can, therefore, be concluded that such an imperfection might have been present in the weld seam since the beginning.

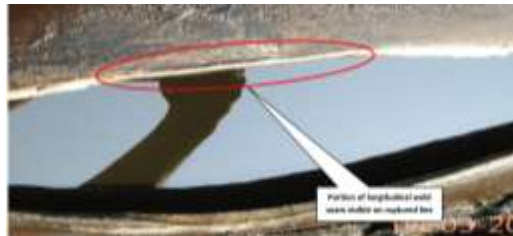
Figure 4b: Visible ruptured line

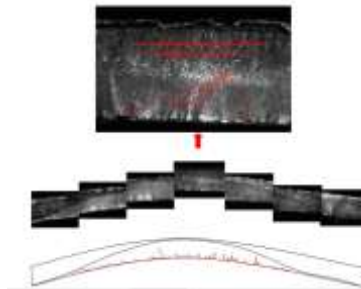
Fractography of the pipe was carried out in the pipeline. Fine weld defects were observed from the inside of the pipeline. Based on the detailed laboratory study, it is concluded that rupture failure of the pipe has occurred by initiation of microcracks at the small weld defects and their propagation through fatigue caused by cyclic operating pressure (figure 5).

The positive interaction of closely spaced microcracks is inferred to have led to a large equivalent crack size eventually causing the rupture of the pipe.^{[10][11]}

Figure 5b: Weld defects visible in HAZ& weld zone

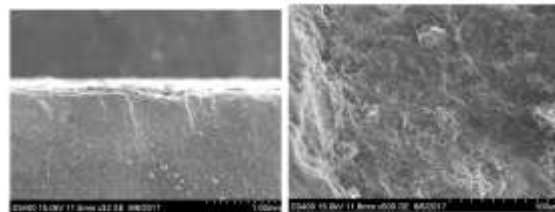
Figure 6: Fractography of fractured surface

Fractography showing the absence of dimple feature typical of brittle fracture. (Figure 6)

- The fracture surface at the point of failure reveals a flat profile throughout the pipe thickness. A Flat fracture surface with the absence of localized deformation, further confirms the crack propagation through fatigue on account of cyclic pressure. Presence of small weld defects enhances the probability of nucleation of microcracks.

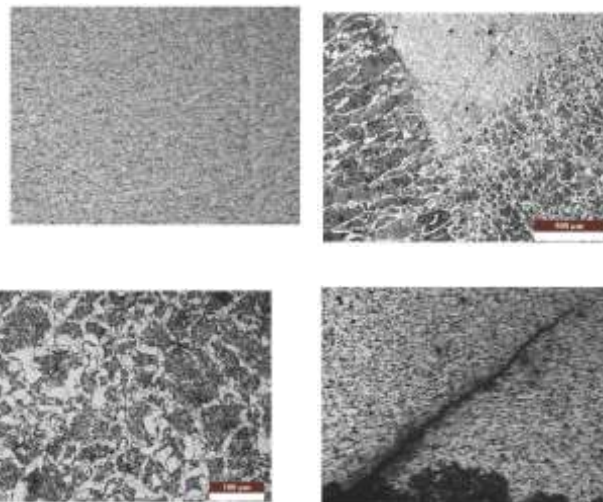
Figure 7: Microstructure of pipe near fracture – a) Parent Metal, b) Weld c) Heat Affected Zone d) Near failed area inclusion of type-B and type-D which is acceptable. ^[9]

- The sectional metallography at the end of the rupture reveals a fine-grained ferrite-pearlite with the presence of a crack from the pipe internal surface at the HAZ. Significant grain flow along the crack path is seen due to higher crack tip stresses.
