# Impact Assessment of Hydro Geo-Technical Variation in Parts of Sector-8, HUDA Division, Ambala and Analysis of Foundation Design W.R.T. Water Logging Area.

**Abstract** - Houses in some parts of the City of Ambala are facing problems related to water seeping in and flooding of the ground floor area. This also leads to damping of walls and settling of foundation. As a result of settlement, structural members like beams and columns attain cracks. Thus this study has been undertaken to investigate the reason for the rise of water table and also its effect on the structural stability of the buildings. As Ambala is expected to see development in the next 10 years which includes multi stories this study thus become important to be carried out. This paper, after days of site study, list out the reasons and their remedies mainly in Sector 8, HUDA Division of Ambala.

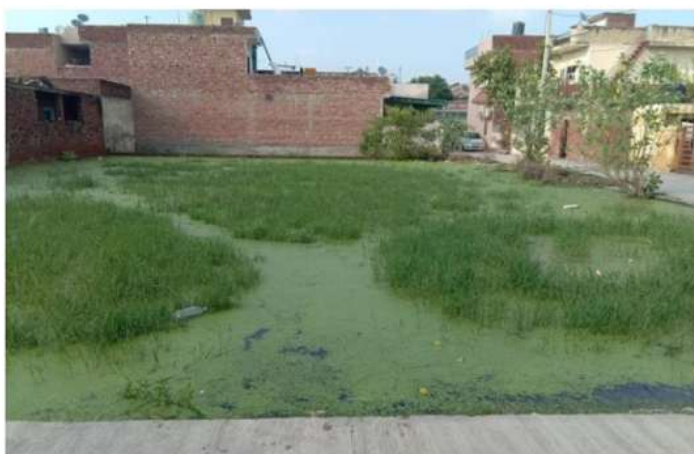
Figure 1 Flooding in vacant plot

1. The major observation was observed from the area near the Nala. It was observed that the water seeps out from the ground causing swelling of plaster and dampening of the structural member. It was also observed that water of considerable height was completely filled up in vacant plots of Sector 8, HUDA Division of Ambala district making the area flooded as shown in Figure 1.

The field TDS meter was used and on spot TDS values were analysed along with pH and electrical conductivity in order to analyse the salinity condition in the area. The soil in that area was found as highly saline with the TDS value of 2800

mg/litre. The high level of salinity in the soil was established as the main reason for low abstraction of ground water.

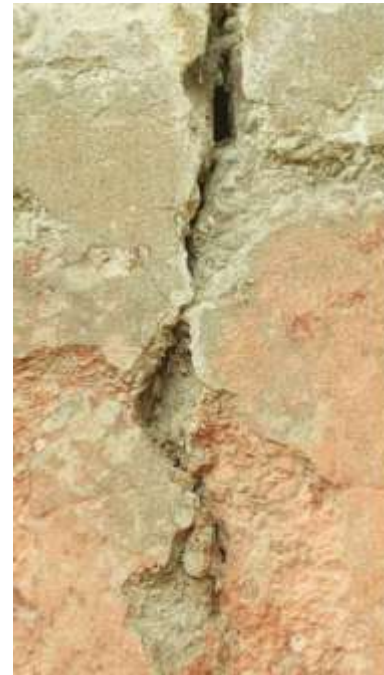
Figure 2 Cracks at Plinth Level

The above calculation clearly shows that the bearing capacity of the soil is reduced to 6 tons per square meters from 12 tons per square meter. As the design bearing capacity was considered as 8 tons per square meters the reduction of bearing capacity to 6 tons per square meters resulted in settlements and cracks in the structural member.

It can be seen in Figure 2 and Figure 3 that the cracks are prominent and the water seeps through it. There are fewer cases in the residential buildings where the foundation seems to have heave inwards by 3 to 4 millimetre leaving the foot of wall exposed as seen in Figure 4.

4. As earlier discussed the bearing capacity of the soil reduced to 6 tonnes per square meters from 12 tonnes per square meters when the water correction was applied to the Terzaghi's equation. This considerable decrease in values were seen as the main reason for the settlement of structure and in turn the cracking of the structural members.

4. Strengthening of sub surface structure can be done either by Underpinning the structure or by anchoring the structure to the adjoining soil strata.

5. Grouting can also be done to fill up any cavity or fissure developed around the foundation or in the surrounding soil that is making the structure unstable.

(FRP) can easily strengthen the structure as well as came it ductile which in turn prevent the structural cracking. Crack stitching can also be a procedure to restore tensile strength across major cracks. The stitching procedure consist of drilling holes on both sides of the crack and grouting in U-shaped metal units with short legs called stitching dogs that span the crack.

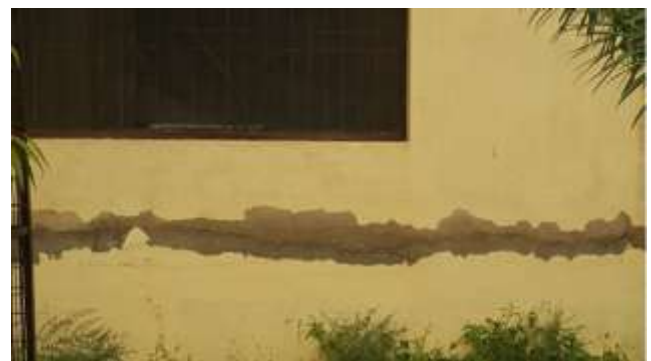
Figure 3 Seeping of water at plinth level due to high water table

3. The hydro geological analysis indicate that the water level has acquired the rising trend and at the time of construction of the building which was recorded 15 meter below the ground level. Due to construction activity the surrounding Nala was filled up with mud as a result the water ways were blocked. Due to restriction on ground water movement and the water started cumulating at the faster rate upto the condition that it has reached 1.2 meters

below the ground level. As the depth of foundation of the structure is 1.5m, the water level has risen and reached the influence zone effecting the bearing capacity of the soil. This in turn effects the stability of the structure.

6. Abstraction wells can be put up in the area to reduce the water table which in turn will increase the bearing capacity of soil.

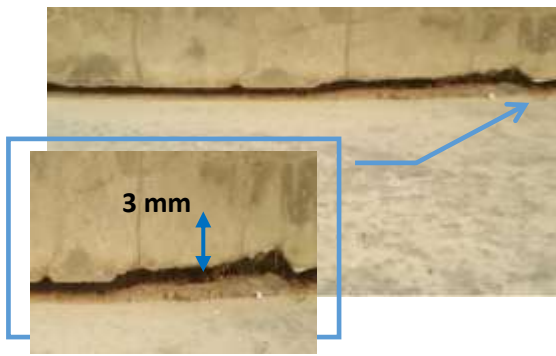
Figure 4 Settling of foundation

Initially when the bearing capacity of the soil was 12 tonnes per meter the settlement was recorded as 50mm. With decrease in bearing capacity of the soil, the settlement was calculated using IS 2950: Part 1

$$\begin{aligned}
 \text{Average settlement} &= \frac{\text{Average contact pressure}}{\text{Average modulus of subgrade reaction}} \\
 \text{of the raft, } \nabla &= \frac{\text{Bearing capacity} \times \text{Area of footing}}{\text{Average modulus of subgrade reaction}} \\
 &= \frac{0.6 \times 1.2 \times 1.2}{10.8} \text{ kN/m} \\
 &= 0.08 \text{ m or } 80\text{mm}
 \end{aligned}$$

As the maximum permissible settlement in a stiff sand is taken as 60-65mm by the IS code, the settlement value to 80 mm is not acceptable. Due to settlement of structure the cracks are developed in the structural member which in turn effects the stability of the structure.

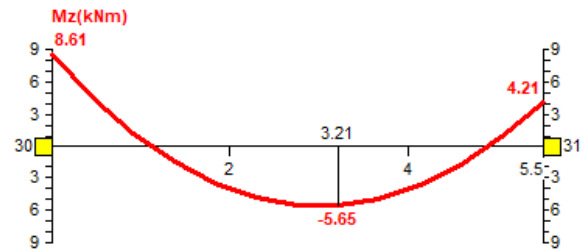
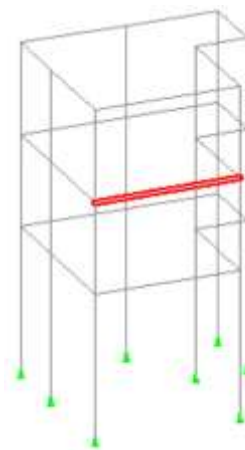
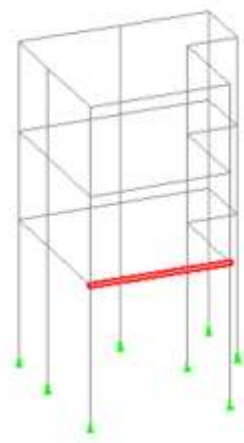
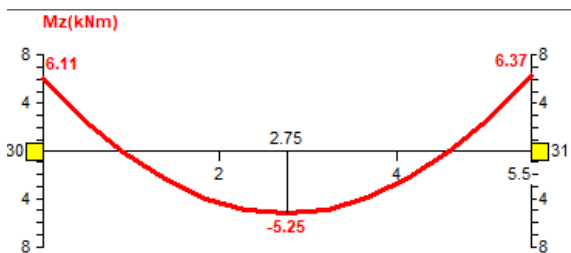
– Bearing capacity 6 T/m<sup>2</sup>

(IS 875-1964 Table II)  
Hogging Moment = 5.65 kNm

Sagging Moment = 8.61 kNm

– Bearing capacity 8 T/m<sup>2</sup>

Hogging Moment = 5.25 kNm

Sagging Moment = 6.37 kNm

9. Also to control the sagging moment caused due to settlement as seen in Section 4.1 intermittent supports can be installed to reduce the span of the structure and in turn reducing the additional moment.

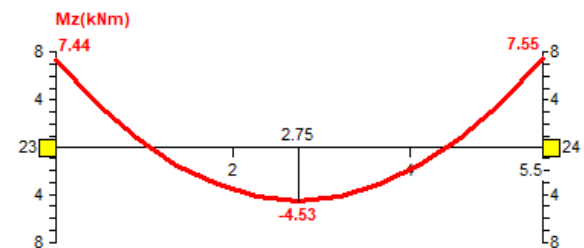
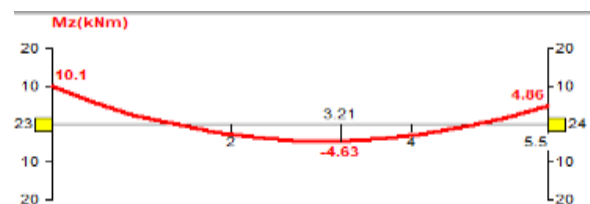
– Bearing capacity 8 T/m<sup>2</sup>

Hogging Moment = 7.55 kNm

Sagging Moment = 4.53 kNm

**Bearing capacity 6 T/m<sup>2</sup>**

Hogging Moment = 10.1 kNm

Sagging Moment = 4.63 kNm

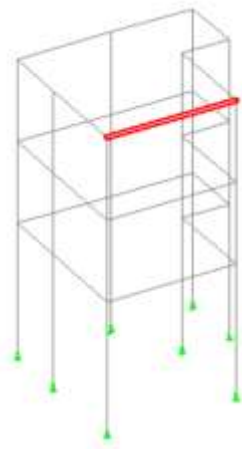
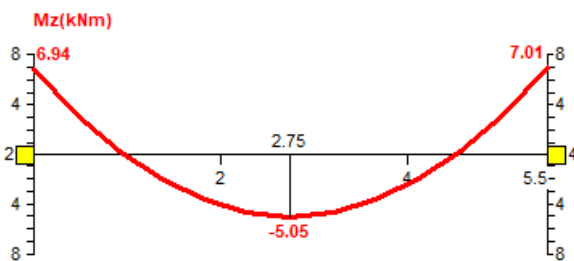
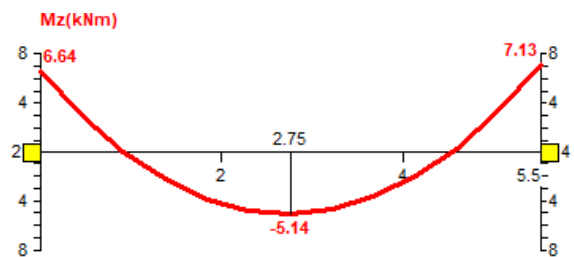
**For Roof Level**

– Bearing capacity 8 T/m<sup>2</sup>

Hogging Moment = 7.01 kNm

Sagging Moment = 5.05 kNm

– Bearing capacity 6 T/m<sup>2</sup>

Hogging Moment = 7.13 kNm

Sagging Moment = 5.14 kNm
