Review About Incidents in Dams and Dike Behaviors Induced by Internal Erosion

Aldulaimi Ali A. Ahmed ¹, AlSaadi Anmar J.²

Key Words: Embankment dam, Failures, Incidents, Internal erosion, Sinkholes.

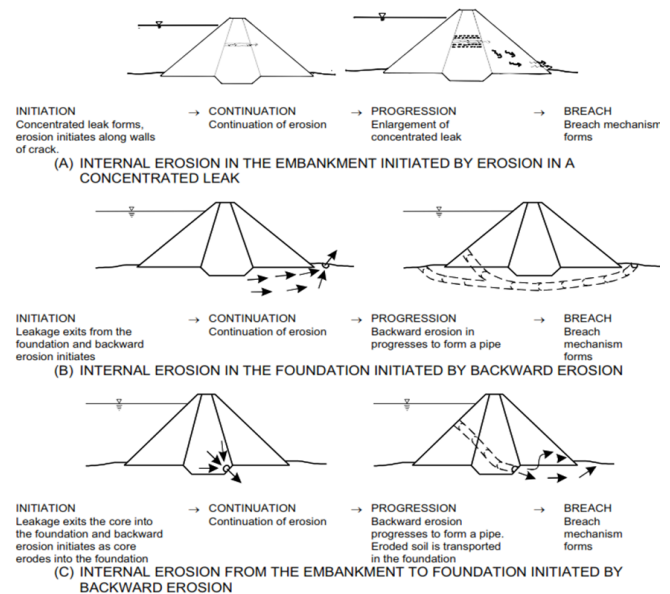
Fig -1: Failure development Models for the internal erosion, [2].

Figure 1(A) illustrates the internal erosion through the embankment initiated by a concentrated leak. While (B and C) in the same figure show the similar processes that apply for piping via the foundation and from the embankment to the foundation.

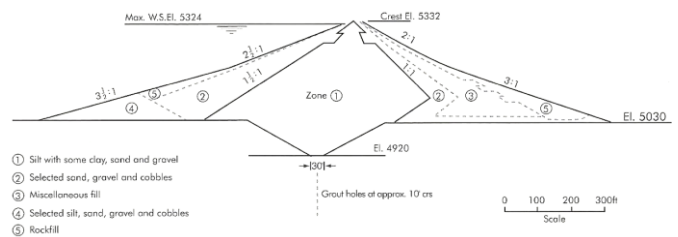
Fig -4: Schematic diagram of the Teton Dam: Section in valley bottom showing fill zones and cut-off through alluvium, [6].

The dam has a 93 m high earth zoned embankment. Sections are shown in Figure 4 on the valley floor and in Figure 6 in the right abutment, around the location where the leakage was first seen, and the failure commenced, [5]. Following practice at the time, no filters were provided to prevent erosion in the windblown non-plastic to slightly plastic Zone 1 core fill. The means provided to stop erosion were grouting of the foundation from a grout cap under the core in a cut-off trench through the alluvium in the valley floor and key trenches in the upper parts of the core contact zone (above El 5,100-ft).

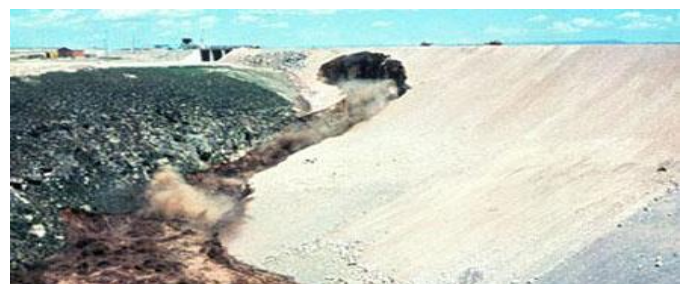
Fig -5: Photograph of Teton Dam: approaching mid-day, the leak has enlarged further and widened under the crest [5].

Teton dam it's a dam constructed in Idaho, USA. The first failed during the first filling on June 5th, 1976. The water level was about one meter below the spillway weir crest. There was no sign of malfunction until the sediment-laden leak was seen flowing from the right abutment, Figure 4. The leakage and erosion accelerated until the dam had failed, see Figures (5 and 7). The dam has not been rebuilt, and its remains can still be seen at the site.

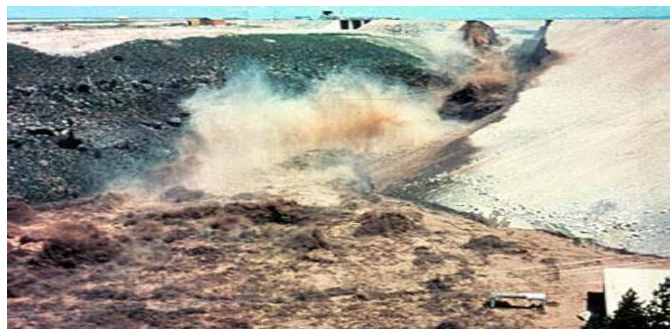
Fig -7: Photograph of Teton Dam: leak has enlarged and widened, crest (bridge) has collapsed, the outflow exceeds 28,300 m³/s eroded all the dam fill, [5].

- **Breach:** the erosion (pipe) broke through into the reservoir soon before the crest (bridge) collapsed. After that, the escaping water-eroded dam fills rapidly,

deepening and widening the initial breach, less or more removing all traces of the dam fills from the side, and exposing the foundations. [5]. There have been many subsequent examinations of the failure, and many papers written about it, which continues to the day. A preliminary trial by Merino [8] of its benchmark approach to analyzing internal erosion examined the Teton case, which USBR reviewed. One result indicated that erosion may have initiated before the eroding opening, and the discharge through it had become large enough to cause and continued undetected for several days the leakage seen in the miter of the dam on June 5th, 1976.

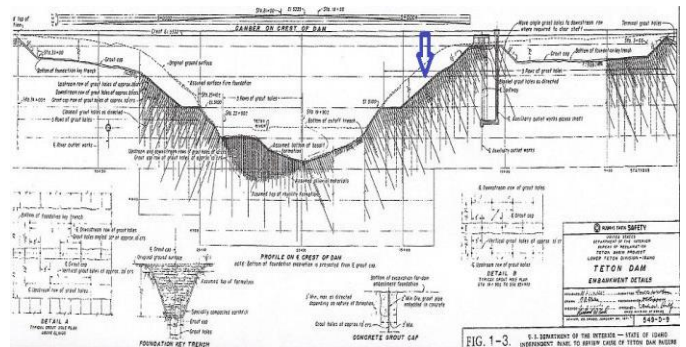
Fig -8: Longitudinal section along cut-off trench showing (arrow) approximate location in the right bank key trench where concentrated leak erosion leading to failure initiated, [7].

Initiation: in this case, by erosion in concentrated leaks through Zone 1, fill in the right abutment key trench at approximately the location is shown in Figure 8.

The cracks and openings probably formed by one or both of the following: from below by water flowing through open joints in the trench foundation not sealed by dental concrete, slush grouting or the grout cap and grout curtain; and through hydraulic fractures resulting from low total stresses caused by 'arching' in the deep steep-sided key trench and possibly from unfavorable foundation profiles in the base of the trench. Water flowing in the open joints in the foundation rock would then enter the openings and readily initiate erosion of the erodible Zone 1 fill.

- **Continuation:** through open joints in the foundation rock at first, not blocked in the cut-off trench by grouting or arrested by filters there.
- **Progression:** progressing upwards through the Zone 1 fill and above the grout cap (which afterward was found to have been washed out at the failure position). The fill was easily eroded, non-plastic, and much was probably not saturated. It could 'hold a roof' of the considerable span, like the photographs, Figure 5 shows. As the erosion 'pipe' enlarged and discharge increased, the hole exposed in miter at the junction between the dam's downstream face and the rock abutment enlarged and rose the slope, gradually approaching the dam crest. A small sinkhole was seen in the crest shortly before the (bridge) across it collapsed, and at this late stage, whirlpools were first seen in the reservoir water above the upstream face, presumably above the upstream end(s) of the erosion pipe.

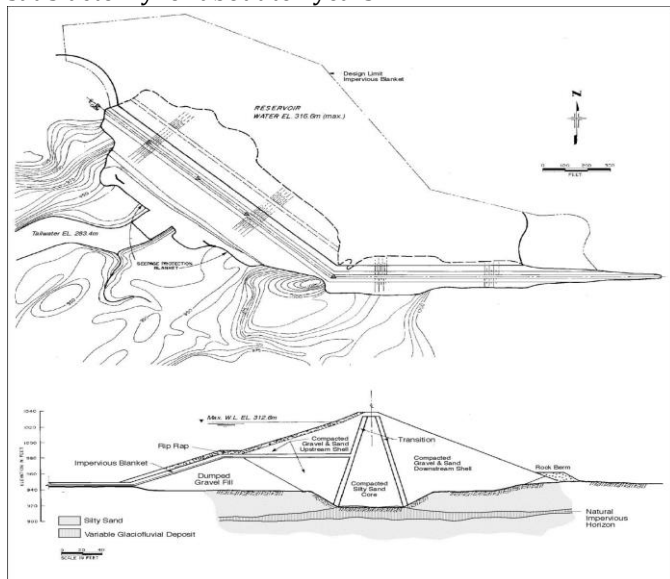
Fig -9: Shikwamkwa Dam: Section and plan showing the extent of the upstream blanket [9].

Shikwamkwa dam was finished in 1958 in Ontario, Canada, [9]. The cross-section is shown in Figure 9. It was a 35 m zoned earthfall dam with a central impervious core constructed using a fine silt material (rock flour). The dam was founded on deep, permeable, and highly variable interbedded glaciofluvial and glaciolacustrine overburden deposits that ranged from cohesionless silts to coarse deposits of nested cobbles and boulders. The primary defense against foundation seepage was a relatively short (about six times the head) and thin (about 3% of the hydraulic head) impervious blanket that connected to the central core and what was thought to be a relatively continuous layer of relatively impervious silty sands in the dam foundation. [5]. During impounding in 1958, numerous

seepage incidents occurred with leakage up to 1.0 m³/s and local instability on the downstream slope. Toe berms and additional blankets were added, and the dam performed satisfactorily for about ten years.

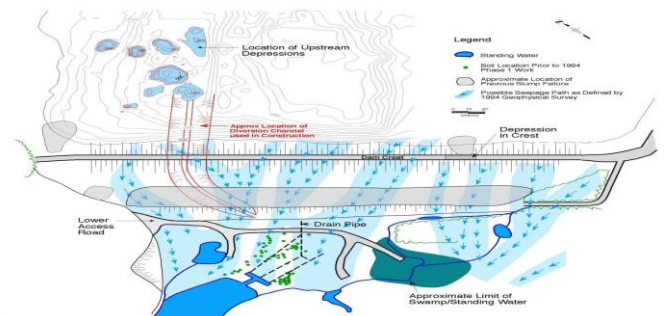
Fig -10: Shikwamkwa Dam: a record of upstream sinkholes, erosion pipe routes, downstream sand boils, and the depression left in the crest after slope failure caused by sinkhole opening at the upstream toe, [9].

Then downstream sand boils, piping incidents, and sinkholes re-commenced, including one sinkhole which in 1971 opened up at the toe of the upstream slope, causing a slope failure, which fortunately did not break through the dam crest. A record of this event (which after repair left a depression in the crest) and the many sinkholes, seepage routes, sand boils, and other damage which occurred see Figures 10 and 11. Repairs were conducted to allow the life of the dam to be extended. The repairs program included a downstream filter blanket and a fully automated monitoring system consisting of piezometers, weirs, and a turbidity meter. Over the years following the installation of the remedial works, the dam was inspected and assessed monthly, identifying vulnerable zones, and carrying out repairs in phases, carefully monitoring each repair before commencing another. Despite the continuous repairing, incidents continued, however, possibly because the foundation was seriously damaged by removing and disturbing large volumes of material by piping over 40 or more years, [5]. The upstream blanket may have been thin and may have cracked as settlement across the old river channel occurred, but the downstream sand boils, the piping, and the upstream depressions confirm that what is now known as backward erosion was occurring. It does not appear to be forward erosion through concentrated leaks, cracks and openings, in the blanket and foundation. The upstream blankets can be ineffective in reducing the overall hydraulic gradient that initiates backward erosion, almost certainly in this case because the blanket materials were fine and vulnerable to backward erosion from below. If upstream blankets are erodible, the outcomes are unpredictable and may be serious. At Shikwamkwa, the emerging upstream end of one of the erosion pipes was at the upstream toe of the dam, causing instability of the slope, but fortunately not

cutting through the crest, thereby narrowly avoiding failure by overtopping. Upstream blanket materials should be plastic or sands and gravels too coarse to be vulnerable to backward erosion from below.

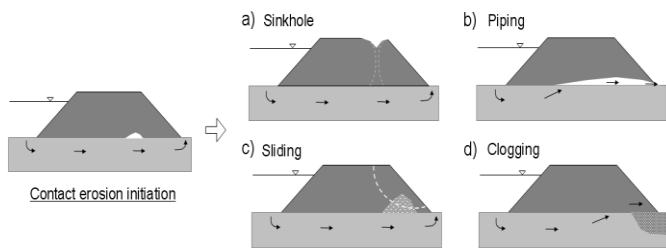
Fig -12: The contact erosion in most cases in sinkholes, [10].

Some twenty cases of leakage associated with the development of a sinkhole or subsidence have been reported in the dikes on the River Rhone. The dikes are embankments constructed with fine alluvium (clayey silt to silty sand often covered by shoulders of coarse alluvium (sandy gravel) on the upstream and downstream slopes. The dikes are often on alluvium foundations (a thin layer of fine alluvium on a thick layer of gravelly alluvium), [5]. Contact erosion occurs when high river levels cause high velocities in the gravel foundation, sufficient to cause erosion at the contact with the silty fill of the dikes. The erosion of the fine fill seems to result in slow settlement of the dikes in such a manner that failure by overtopping is not expected. As in Figure 12, which illustrates the consequences of contact erosion, where the black arrows indicate groundwater flow through a more permeable (light grey) layer under a less permeable dam (dark grey). a) sinkhole daylights b) beginning of backward erosion piping c) creation of a weaker zone initiating instability d) clogging of the permeable layer and increase of pore water pressure, [10].

- 1) Cause piping in extreme cases (but never observed on site)
- 2) Leads to instability

- c. The fine particles accumulate and clog the gravel foundation at the toe,
- d. Possibly causing a hydraulic fracture and heave.

No incidents in collapse and failure of the dike were recorded. This may be explained cause the Darcy velocities were less than the critical limits (0.02 m/s), and the erosion was not continuous. Interrupted erosion may occur after paving when fine silt particles are eroded, leaving coarse particles that filter and retain the oncoming newly eroded fine particles under constant water level and constant Darcy velocity no longer high enough to carry continuous erosion, or the Darcy velocity does not remain high enough for periods long enough to carry continuous erosion. The sinkholes form as fine soils is drawn in to replenish material lost through intermittent erosion above the foundation areas where the critical flow velocity is reached in the grave following the incidents. Diaphragm walls were installed through the embankments and into the gravel foundations over the affected lengths to limit groundwater flow velocities in the gravel to be below critical at the interface with the fine soil in the fill.

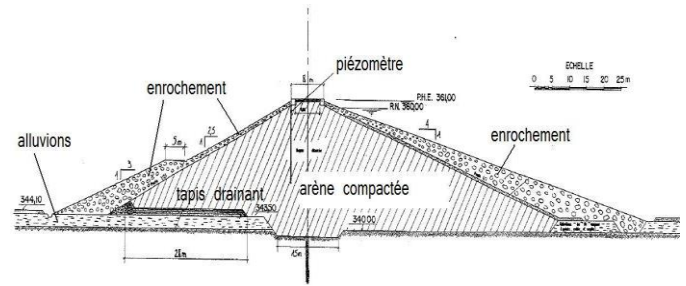
Fig -13: Saint Pardoux dam: decomposed granite fill with a coarser material on the upstream and downstream slopes and a horizontal downstream drain.

Saint Pardoux dam (Figure 13) is a 19 m high homogeneous (unzoned) dam constructed using residual soil of decomposed granite as filled with a layer of coarser material on the downstream slope and a horizontal foundation toe blanket for drainage, [5]. The dam was finished, and the reservoir was filled in 1976. An expert assessment in 1991 found high and increasing pore pressures in the downstream slope, wet areas on the slope, and leakage emerging onto the slope and at the abutments. There was also an increase in the seepage collected from below the upstream slope. The piping progression could mean gradual loss of fines and increase of seepage, indicating that suffusion was occurring in the fill and that there was preferential drainage through some sandy layers included in the fill. To correct the situation, a diaphragm wall was installed from the crest, the foundation grout curtain was made deeper and wider, and drainage was added, and other works were completed in the abutments, [5].
