Impact On Housing During 2018 Floods in Puthenvelikkara Panchayat

Lakshmy Kakkanatt U¹, Akhil Thilakan², Drisya Dinesh³, D A Akhil Raj⁴, Parvathy M H⁵

^{2,3,4,5}Under Graduate Students, Dept. of Civil Engineering, SNMIMT, Kerala, India

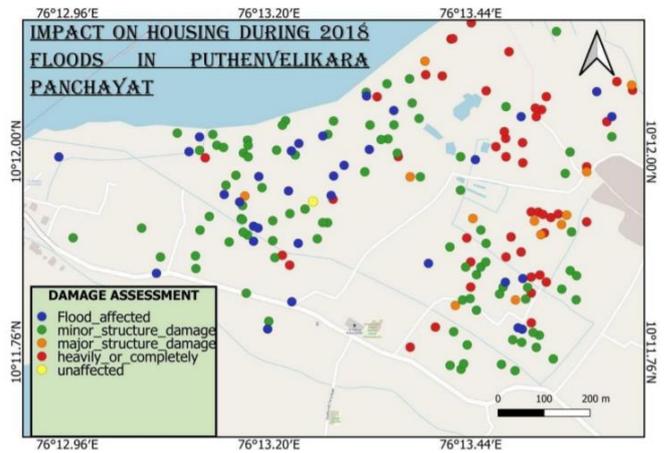
Fig 1: Damage mapping of wards 15 & 16

The impact on housing during 2018 flood in ward 15 and 16 of Puthenvelikkara Panchayat are distinguished into five categories and are plotted in a map in QGIS software as shown in figure.
