2 Literature Review

3 Study Area

4 Methodology and Data Collection

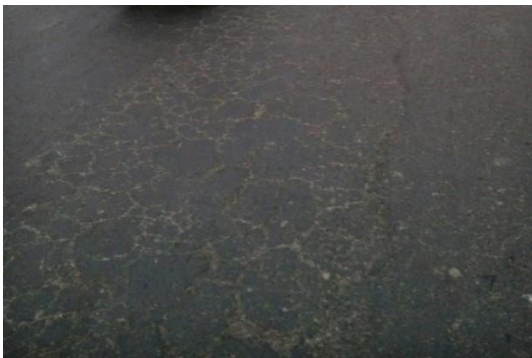
A Crocodile breaking is an extremely normal disappointment. It happened in Chaprashhi Pura. It demonstrates the underlying disappointment that might additionally break down to a pothole. The reasons for this breaking are insufficient design, unfortunate seepage, and so on. Support taken, for example, covering is utilized for ordinary croc breaking, yet fixing is completed for powerful gator breaking (Figure 3).

Figure 3 Alligator cracking at Chaprashhi Pura

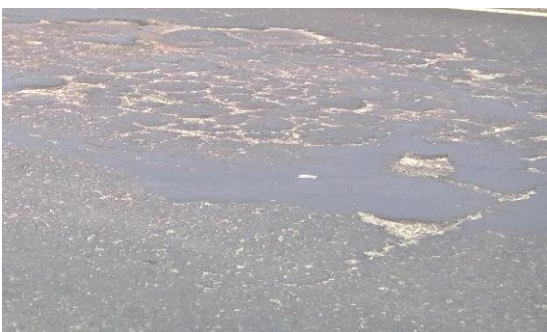
Block breaking is found close to Laali Lawn Bypass region, and so forth. It permits dampness invasion and harshness. It is brought about by unfortunate development and unsteady base. In the wake of covering, seal coat is given to fix the broke surface (Figure 4).

Figure 4 Block cracking at Laali Lawn

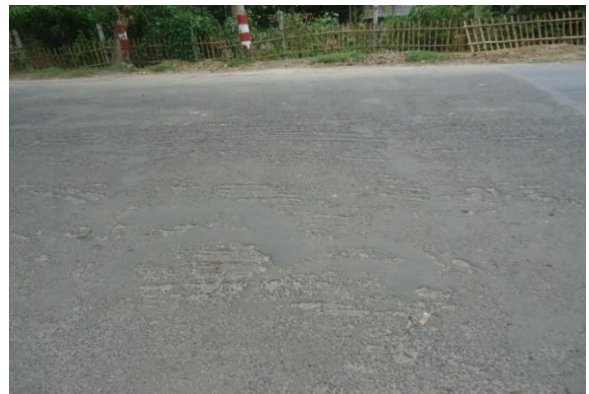
Slippage breaking is found at Chaprashhi Pura. It makes unpleasantness out and about. It is brought about by temperamental wearing surface and terrible seepage. Surface treatment as covering and fixing are finished for the maintenance (Figure 5).

Figure 5 Slippage cracking at Chaprashhi Pura

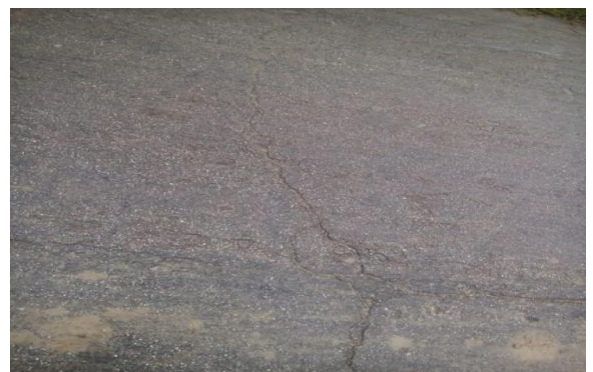
Cross over breaking happens close to Dastur Nagar. It permits dampness invasion and harshness. It is brought about by weighty traffic and unfortunate blend plan. Surface dressing as covering is utilized to fix this break (Figure 6).

Figure 6 Transverse cracking at Dastur Nagar

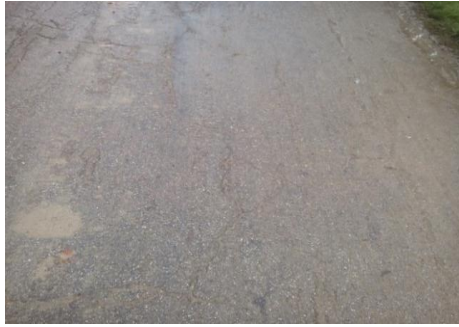
Longitudinal breaking is situated close to Yashoda Square. It permits dampness invasion, underlying disappointment. It is caused because of temperamental base, unfortunate development. Surface dressing is utilized to fix this break (Figure 7).

Figure 7 Longitudinal cracking at Yashoda Square

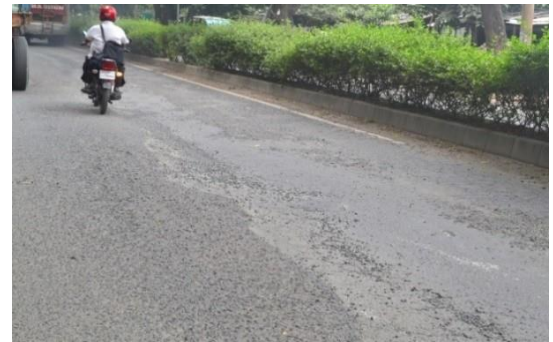
Figure 9 Raveling at Yashoda Square

Raveling is situated close to Laali Lawn, Yashoda Square. It makes free flotsam and jetsam in the asphalt, unpleasantness, and loss of slide opposition. It happens because of the powerlessness of black-top cover to hold total set up, deficient compaction and matured black-top fastener. Surface treatment is utilized to address this disappointment (Figure 9).

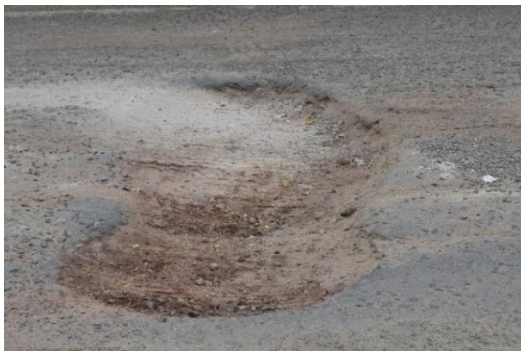
Pothole is the most well-known disappointment that happens in many spots as Juni Vasti, Laali Lawn and so on. It makes underlying disappointment and harshness. It is brought about by the development of weighty stacked vehicle and gathering of downpour water. At the point when the profundity of the pothole is extensive then cutting, filling, moving activity is considered for low profundity pot opening and number of potholes are all the more just filling of the premix materials are done (Figure 8).

Figure 8 Potholes at Juni Vasti

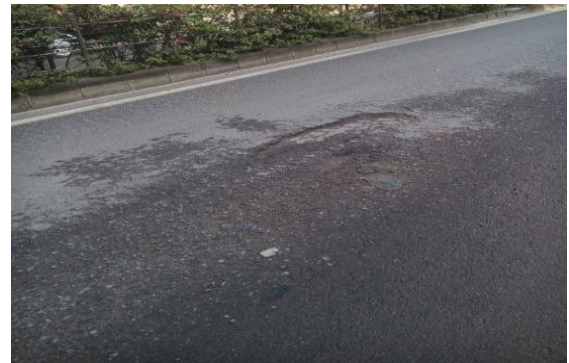
Water draining is found at Rayba Hotel, Chaparashi Pura. It lessens slip obstruction and underlying scaffolding. It is brought about by unfortunate blend plan in with more and unsatisfactory fastener. Sanding is applied to fix by spreading coarse sand over the surface. Sanding and surface dressing are done to fix this water dying (Figure 10).

Figure 10 Water bleeding at Rayba Hotel
