SLOPE STABILITY ANALYSIS USING GeoStudio AND PLAXIS 2D SOFTWARE: A COMPARATIVE STUDY

Abstract - All the civil engineering structures are supported on or below the surface of the earth. The project aims to conduct a comparative study of stability analysis of slopes of roads using 2 software - GeoStudio and PLAXIS. Slope stability is a critical factor in the design and construction of any civil engineering structure. Although individual slope failures generally are not so spectacular or as costly as certain other natural catastrophes like earthquakes, major floods, and tornadoes; they are more widespread and the total financial loss due to slope failures probably is greater than that for any other single geologic hazard to mankind. The objective of this project is to evaluate and compare the stability of slopes using different analytical and numerical methods. The landslide during the monsoon season in Kerala widely affects the livelihood of people. Natural or landscaped slopes may lose their stability by detachment and sliding of a soil volume along a failure surface, because of exceeding its shear strength. This collapse may be developed due to excavation activities and rainfall i

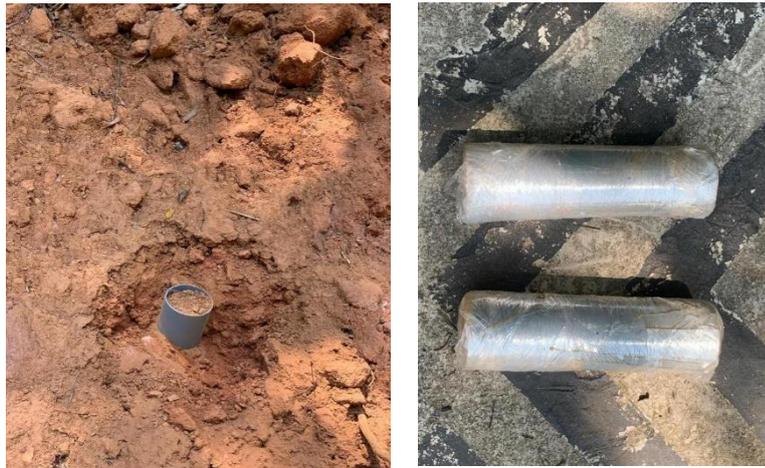
Fig2, 3: Sample Collection

Samples were collected for the laboratory investigations. PVC pipes were driven into the levelled surface of the soil with the help of a rammer and carefully took out the pipes containing soil. Excess soil present on the ends of the pipes was trimmed off. The ends were sealed with molten wax and were again wrapped using polythene covers. This is to ensure that the sample is air-tight and moisture content is intact. The sample was tested for moisture content test, sieve analysis, direct shear test, unconfined compression test etc.

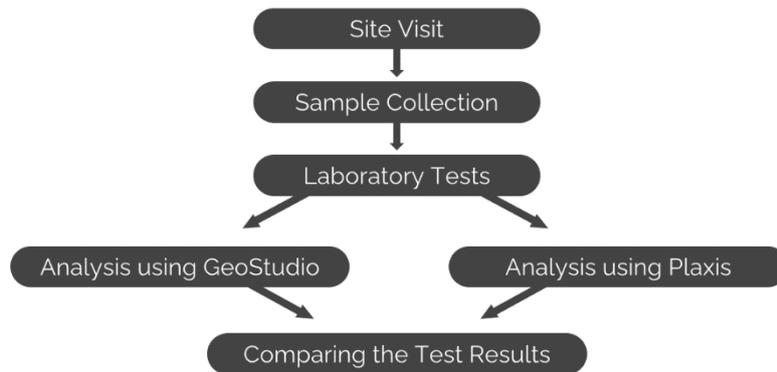
Fig 4: Flowchart of Methodology

The methodology adopted to evaluate the stability of the slope is depicted as shown in Fig 4

1. Detailed geotechnical investigations are carried out.
2. The disturbed soil samples are taken to identify the failure zones and determine their shear strength parameters.
3. Laboratory tests are conducted on disturbed soil samples, such as grain size distribution, direct shear test, and determination of moisture content.
4. Experimental results are used to obtain input soil parameters for numerical modelling.
5. Numerical modelling of the slopes using Plaxis 2D software is carried out.
