'Assessment of structural integrity of G+2 storied old building for vertical expansion through Non Destructive and Semi Destructive testing and Design Analysis'

Abstract - This paper explores the critical process of assessing the structural stability of 46 years old G+2 educational building and performing design analysis to facilitate vertical expansion while preserving historical and architectural heritage. The study employs non-destructive and semi-destructive testing methods and utilizes STAAD.Pro software for structural analysis. The findings contribute to the knowledge of adopting old structures to meet contemporary space demands.

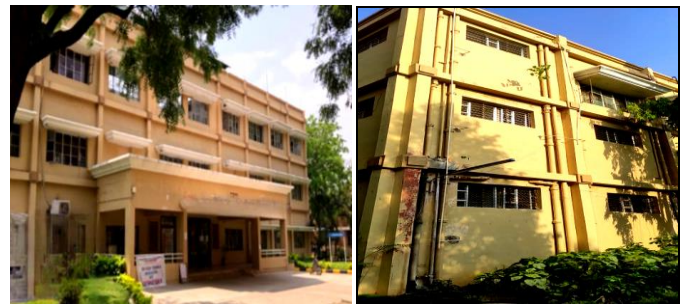
Fig. 1 General View of the Building

During the initial assessment of the building, several physical observations were made. These included the presence of dampness on walls at various locations, the growth of vegetation on exterior walls, masonry cracks in some areas, dampness on slab panels, and the presence of hairline cracks in beams. These observations provided valuable insights into the building's condition.

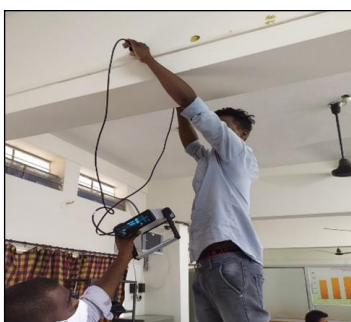
Fig.2 UPV test on RC beam

The ultrasonic pulse velocity test is widely used to measure the quality of concrete. It assesses concrete composition, checks for cracks, voids, and evaluates concrete wear. In this project, the test was conducted on R.C. Columns, beams, and slab panels using PUNDIT LAB, a portable Ultrasonic Non-Destructive Digital Indicator Tester. The results were categorized based on the reference quality grade chart in IS: 516 (Part 5/Sec 1) 2018 (Amended 2019).

Ultrasonic Pulse Velocity Test: The quality of in-situ concrete in the tested R.C. Columns, Beams & Slab Panels of the structure was found to be **"Good at many locations & Doubtful at few locations"** as per IS: 516 (Part 5/Sec 1) 2018 (Amendment in 2019).

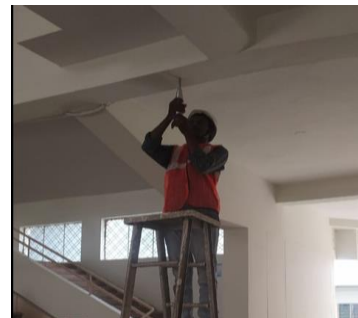
Fig.3 Rebound hammer test on RC beam

The Rebound Hammer Test assesses concrete quality based on surface hardness indicated by the rebound number. Higher rebound numbers correspond to higher concrete strength. The identified R.C. columns, beams, and slab panels were subjected to this test using a Schmidt Rebound Hammer. The results were compared to a reference strength chart to evaluate the surface hardness/quality of the concrete.

Rebound Hammer Test: The strength of the cover concrete in the tested R.C. Columns, Beams & Slab Panels was estimated to be more than **30 N/mm²**.

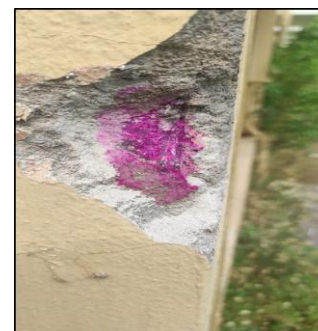
Fig.4 Carbonation test on RC beam

Carbonation of concrete occurs when atmospheric carbon dioxide reacts with calcium in the cement, reducing concrete alkalinity. This project conducted a carbonation test to estimate the depth of the carbonation front in building columns, beams, and slab panels. A phenolphthalein indicator in diluted alcohol was used to detect carbonation. The depth of color change indicated the carbonation level of the concrete.

Carbonation Test: Carbonation of cover concrete in the tested locations of R.C. members was observed to be **moderate** condition.

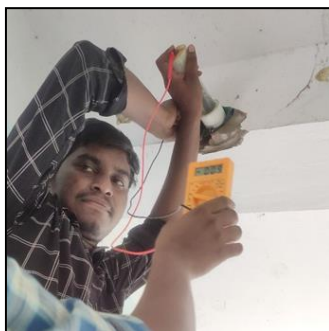
Fig.5 Half-Cell Potential difference test on RC beam

The Half-Cell Potential Difference Measurement Test is used to assess the likelihood of corrosion in steel reinforcement. It measures the potential of steel embedded in concrete using a copper sulfate half-cell. More negative potential values indicate increased corrosion activity. This test was performed on identified R.C. Columns, Beams, and Slab Panels to assess the probability of corrosion.

Half-Cell Potential Difference Measurement Test: The probability of corrosion in tested locations of R.C. members was **uncertain** (moderate) at many locations.

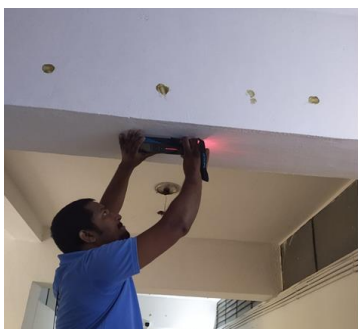
Fig.6 Profometer studies on RC beam

Profometer studies were conducted to measure the thickness of concrete cover and diameter, spacing of the reinforcing bars in accessible R.C. Columns, Beams, and Slab Panels. These studies helped to identify variations in the thickness of the concrete cover and existing reinforcement in RC members.

Profometer Studies: Cover concrete thickness in the tested locations of R.C. members varying from **25mm to 50mm** and **8mm, 10mm, 16mm, 20mm, 25mm** dia. Reinforcement bars were provided in existing rc members.

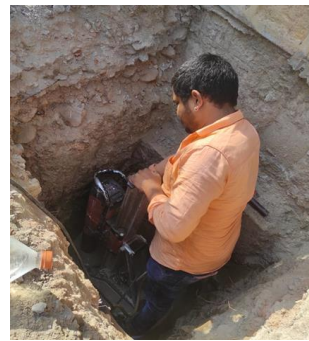
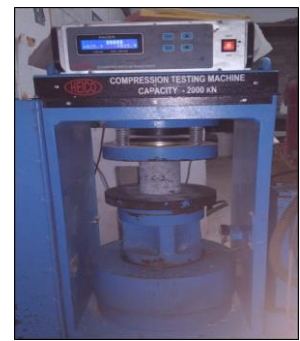
Fig.7 Concrete core compression test

Semi-destructive test in the form of core sampling was used to evaluate the strength of in-situ concrete in RC sections. Core samples were randomly extracted from R.C. members for laboratory experiments. These core samples were then subjected to compressive strength testing according to IS: 516 - Part 4 (2018) guidelines. This test provided insights into the compressive strength of the concrete.

Semi-Destructive Test (Compressive Strength): Compressive strength of concrete core samples in tested locations was observed to be **35.0 N/mm²** and **30.5 N/mm²**.

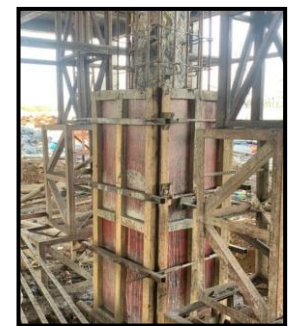
Fig. 11 Column jacketing

From the results of STADD Pro design analysis of existing building for proposed one additional floor load, it is inferred that few columns are under reinforced, RC beams and footings are safe.

1. Strengthen columns through jacketing from footing level to 2nd floor level to ensure the structural integrity and capacity for vertical expansion.

Columns(C5,C6,C16,C18,C19,C20,C29,C31,C33,C40,C42,C43, C46,C48,C54,C58).
