DATA ANALYSIS OF ACCIDENT RATE AT BLACK SPOTS IN AMRAVATI (MAHARASHTRA)

Key Words: Black Spot Analysis on NH-6, Accident Rate & Frequency, FIR index

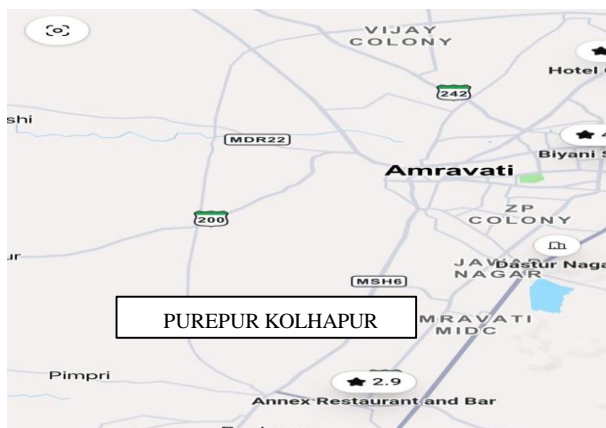
Fig 1 : Study area source : Google Map

For this study, a two-lane stretch of approximately 20 km on NH-6, running from Hotel Gauri Inn to Hotel Landmark in Badnera, was selected. The route was further divided into four equal segments of 5 km each to facilitate systematic data collection and analysis. The identified sections are:

- Stretch 1 – Hotel Gauri Inn to Biyani Square,
- Stretch 2 – Biyani Square to Dastur Nagar
- Stretch 3 – Dastur Nagar to Purepur kolhapur Restaurant
- Stretch 4 – Annex Restaurant to Hotel Landmark

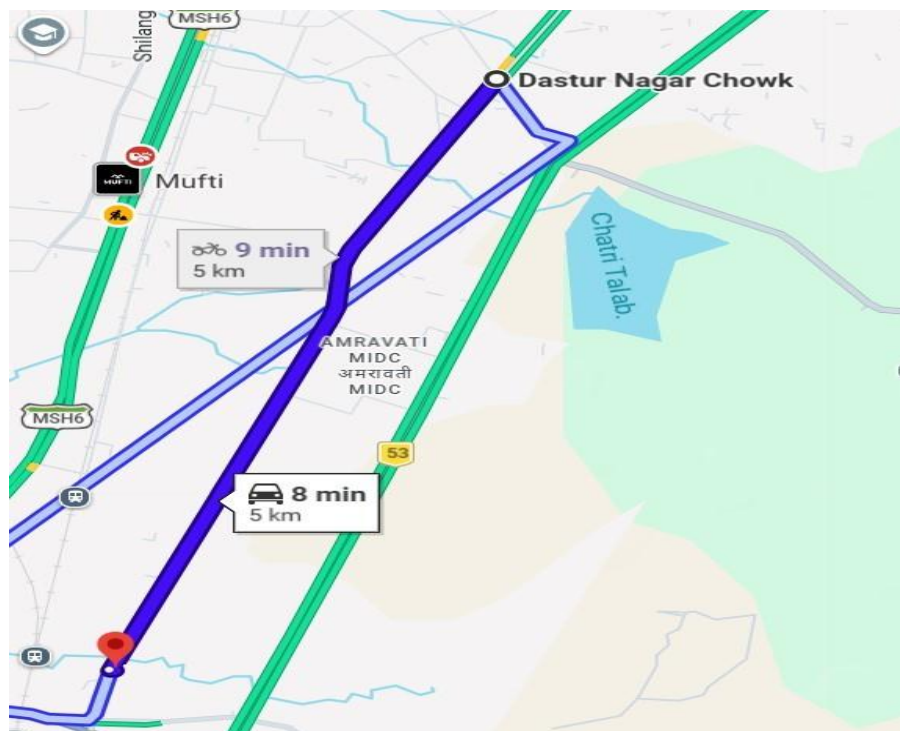
FIG 4: Black Spot Points on Stretch 3

Table 5: Black Spot Analysis of Stretch 3

Accident Point	Nos.	Problem	Safety Enhancement
Dastur nagar	15	Unsignalised, Auto stand Vehicle parking on shoulder , Vendors on Shoulders	Junction improvement, Separate auto stand Clearance of obstruction from shoulder
Gondbaba Temple	19	Cross section , Auto stand , Blind curve, Unpainted Median	Speed limit restriction Junction improvement Medians to be painted
Gunwant lawn	6	Cross junction, Blind Curve, Trees and poles on shoulder	Clearance of obstruction from shoulder Curve sight distance
Lords Hotel	4	T junction	Clearance obstruction from shoulder
Anand Marble	3	T junction , Bad condition of road	Junction improvement Separate auto stand
			Shoulder maintenances, Road marking
Anand Marble	3	T junction , Bad condition of road	Junction improvement Separate auto stand
			Shoulder maintenances, Road marking

A road section where a high concentration of accidents occurs is referred to as a black spot. Analyzing such locations is essential for enhancing the overall traffic environment and safety. A detailed assessment of the four selected stretches is presented in Figures 2, 3, 4, and 5, along with Tables 3, 4, 5, and 6.
