Evaluation of Electrical Properties of 11kv Pin and Suspension Insulator

Smt. N. Sumathi ^{M.Tech., (Ph.d)} ¹, Vasavi Jeeri ²

¹Assistant Professor, EEE Department, JNTU Kakinada, Andhra Pradesh, India

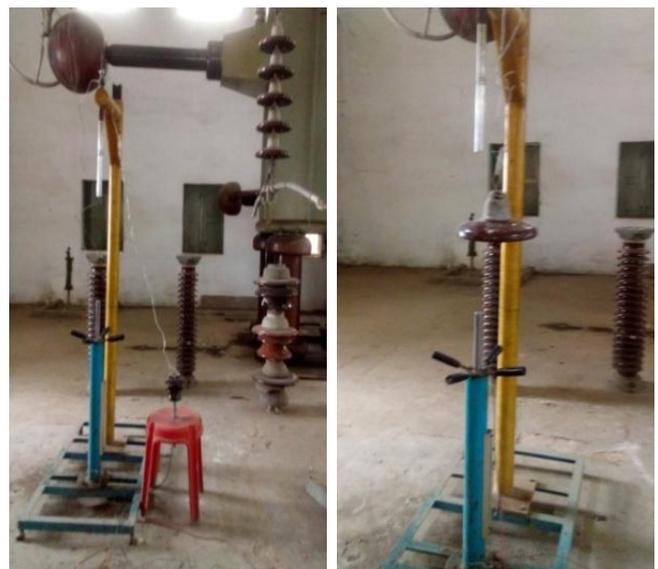
Fig.-2: Experimental setup for (a)Pin Insulator (b)Suspension Insulator

After washing the insulator samples with tap water, kept dry for 24 hours. Then they are placed in the experimental setup with a ground clearance of approximately one metre. One end of the insulator was connected to high voltage side and the other to ground as shown in fig 2. The occurrence of flashover of 11 kV pin and suspension insulator is as shown in fig 3. They are energised to measure the leakage current and breakdown voltage.

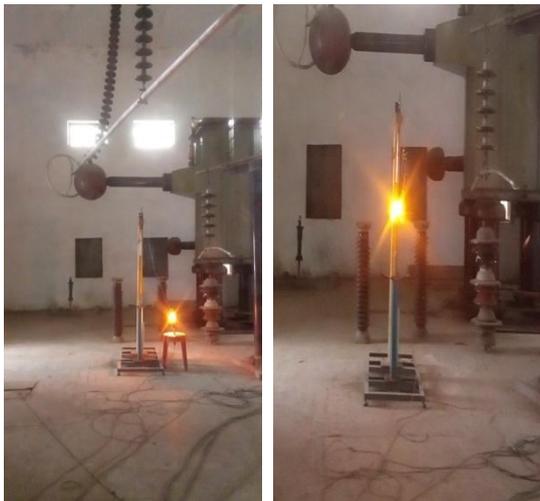
Fig-3: Flashover of (a) Pin insulator (b) Suspension Insulator
