## A CASE STUDY ON A LANDSLIDE: A GEOTECHNICAL INVESTIGATION

The devastating landslide which took place at Muvattupuzha, Ernakulum, Kerala on 27 June 2015 caused severe damages to the public. The catastrophic incident resulted in the complete collapse of a three storied commercial building and the debris got spread to a distance of 200m which affected the traffic flow. Now the main threat was a water tank having capacity 10.5 lac liters (1050 m<sup>3</sup>) which is situated at the top of the collapsed hill. The present slope of the hill cannot withstand the surcharge weight of the water tank. Also cracks were developed along the sides of the road to the water tank. The photograph of the three storied building before and after the collapse is shown in figure 1 and 2.

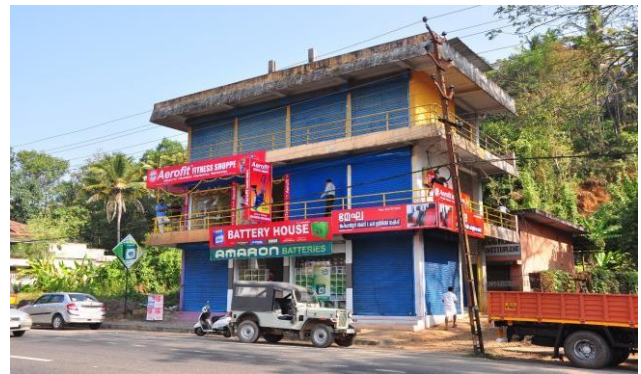
Fig- 1: Three storied building before collapse

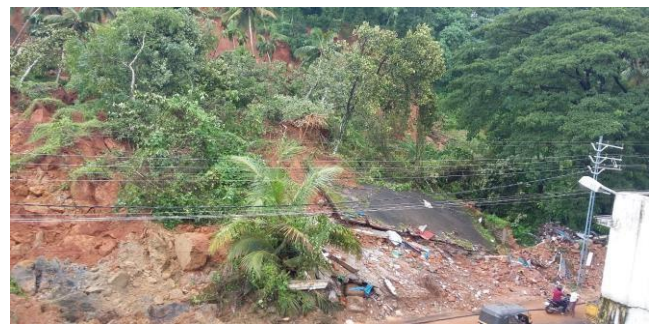
Fig- 2: Three storied building after collapse

As per the case study, it can be concluded that the root cause of the landslide was due to the unscientific cutting of the hill and thus this incident can be regarded as a manmade disaster. Every hill is having its own natural slope, if any alterations are made which is worthy enough to disturb its natural condition without providing any assistance to

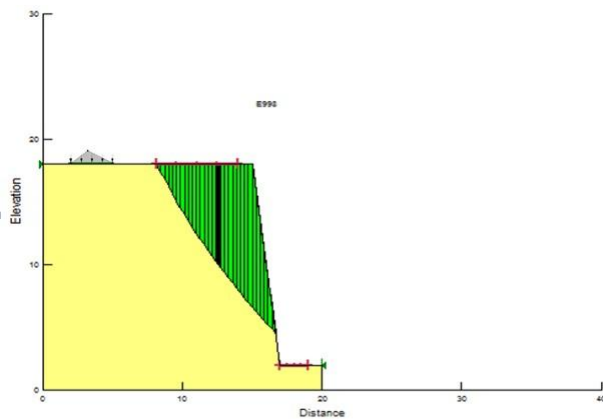
Free body diagram and force polygon

Slice 12	
Factor of Safety	0.998
Phi Angle	17.74 °
C (Strength)	45.1 kPa
Surcharge Load	100 KN/m <sup>2</sup>
Slice Width	0.29835 m
Mid-Height	12.764 m
Base Length	0.4964 m
Base Angle	-53.056 °
Weight (vertical)	62.072 kN
Top Left Coordinate	14.104948, 18 m
Top Right Coordinate	14.403298, 18 m
Bottom Left Coordinate	14.104948, 5.4345813 m
Bottom Right Coordinate	14.403298, 5.0378503 m

Fig-4: Determination of FS using Geostudio

The factor of safety obtained for the sample 1 and 2 were 0.998 and 0.994 and are given in table 1.
