An experimental study on flexural strength and corrosion properties of RCC with sisal fibre

Key Words: Accelerated corrosion technique, Rebar, Durability, Crack width, Sisal fibre.

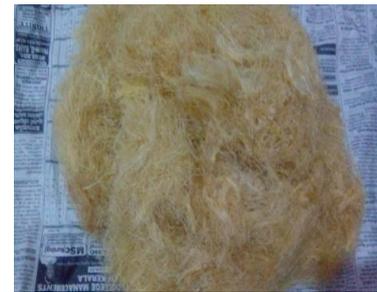
Sisal fibre is one of the most widely used natural fibre and is obtained from sisal plant, known formally as Agave sisalana. These fibres are straight, smooth and yellow in color. Strength, durability and ability to stretch are some important properties of sisal fibres. To remove the wax and dirt in the fibre, it was subjected to alkali treatment (5% of NaOH solution).

Fig -1: Sisal fibre

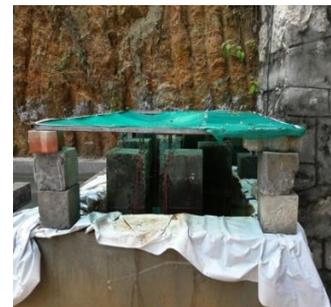
electrochemical accelerated corrosion technique that involves applying a current of specified intensities through the specimens for a specified period to accelerate the oxidation process in a 5% sodium chloride (NaCl) solution. This was achieved through a small DC power supply to which the concrete specimens were partially immersed in 5% NaCl solution in a tank such that the base of the specimen was just in contact with water. The direction of the current was adjusted so that the reinforcing steel became an anode and a steel rod placed on the concrete specimen served as a cathode. The specimens were subjected to corrosion for 20 days and 50 days. The results of both the periods were studied.

Fig – 3: Accelerated corrosion technique set up

After the curing of 28 days, the specimens were subjected to accelerated corrosion process to increase the corrosion rate in the rebars. The specimens were corroded using an
