Effect of Annealing Process on the Corrosion Resistance of Aluminium 7075-T6 Alloy

Palkar Aman Manohar¹, Ghanshyam Das², Nitesh Kumar Sinha³, Rohit Kumar Mishra⁴

^{1,3,4}M.Tech, Department of Materials & Metallurgical Engineering, NIFFT, Ranchi

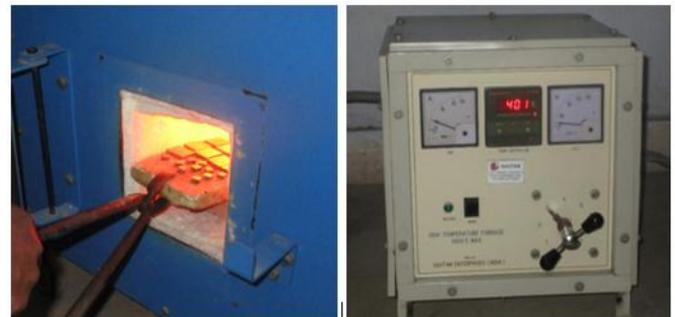
Fig.1: Carbolite furnace at 400°C for annealing heat treatment at NIFFT Ranchi.

The samples of size 10x10 mm, 25x25 mm and 25x30mm were machined using electric discharge machining (EDM). These samples were then annealed by using an electrical type Carbolite furnace at temperatures of 400°C for 4, 8 and 12 h. The samples were named as S₁, S₂, S₃, and S₄. The S₁ sample is the base metal (BM). Fig.1 shows Carbolite furnace performing annealing heat treatment of aluminium 7075-T6 alloy at 400°C.

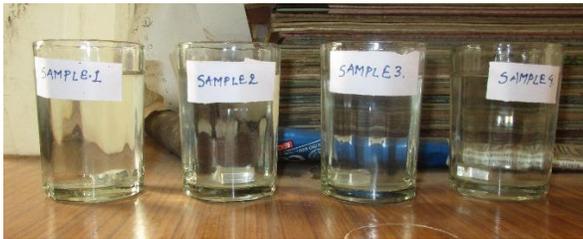
Fig.2: Specimens exposed to 3.5% NaCl solution for a period of 28 days.

To expose sample in aqueous solution of the above pH value, the solution was prepared in a 1000 cc beaker by adding 35 g NaCl to 1000 ltr. of distilled H₂O. Samples of 10x10 mm were polished to 800 grit and cleaned with ethanol prior to weighting. The samples for immersion test were prepared in accordance to the procedure recommended by ASTM G31-72. The specimens were then weighted and then immersed in the test solution for the testing period of 28 days on interval of 7 days. After exposure period, the samples were taken out and brush-cleaned with water to remove the corrosion product and rinsed with ethanol and dried before reweighing. Fig.2 shows specimens exposed to 3.5% NaCl solution for a period of 28 days. The corrosion rates were determined using the relation (1).

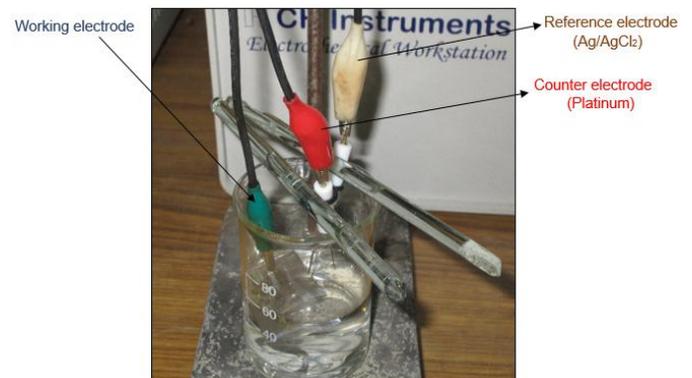
Fig.3: Setup of three electrode flat corrosion cell.

and S₄ samples, potentiodynamic polarization test were done. The test specimens were metallographically polished from 120 grit to 1000 grit SiC emery paper and with alumina powder; specimens were cleaned with ethanol before starting the test. Potentiodynamic Polarization test was carried out in alkaline media namely 3.5wt% NaCl solutions. The test was carried out in the standard three electrode flat corrosion cell using platinum as the counter electrode and silver-silver chloride electrode as the reference shown in Figure 3. The polished Aluminium 7075-T6 BM and annealed specimens were mounted in the corrosion testing cell to expose a surface area of 1 cm² to the test solution. The corrosion cell was electrically connected to Versa STAT Multichannel Potentiostat.

The sample was cathodically cleaned by applying a potential of -30 mV vs. OCP. The experiment was carried out at the scan rate of 50 mV/s. The potentiodynamic polarization plot was generated between voltage and the log of current density for the sample. The plot thus generated was used for comparing corrosion behavior of the aluminium alloys. E_{corr} and I_{corr} were evaluated by drawing anodic and cathodic Tafel slope. All measurements were made at room temperature. Corrosion rate is determined from the following equation (2):-

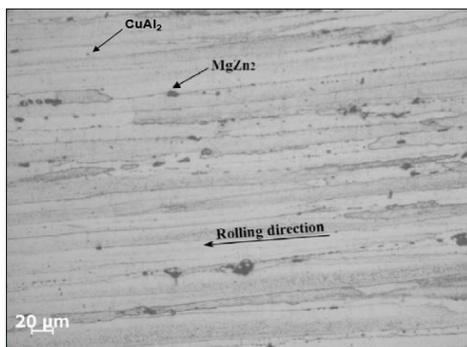
Optical micrographs of the surfaces of as-received 7075-T6 aluminum alloy specimens is shown in Fig. Coarse and dense intermetallic particles are evident on the surface of the as-received specimen (Fig.4). It is seen that the grains are elongated and flattened and the matrix contains precipitates stretched along the rolling direction.

Fig.4: Optical micrographs of as received 7075-T6 aluminum alloy.

Generally, in Al-Zn-Mg-Cu alloys (7xxx Al alloys) two different strengthening precipitates will form and they are: (i) MgZn₂ and (ii) CuAl₂. The black particles seen in BM are strengthening precipitates but there is an appreciable difference in size of the precipitates. Fine precipitates generally belong to CuAl₂ and coarse precipitates belong to MgZn₂, because the maximum available copper for the precipitation reaction is 1.7% only in this alloy but the available magnesium and zinc for the precipitation is plenty.

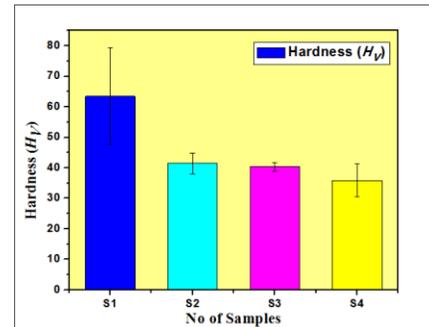
Fig.5: Vickers hardness of the 7075-T6 aluminum alloy as a function of annealed and base metal samples.

The hardness of 7075-T6 aluminum alloy as a function of annealed and base metal samples is shown in Fig.5. As shown in this figure, the annealing treatment applied to coarsen the grain size showed a significant decrease in hardness for the base metal and annealed samples. The average value of base metal hardness is 63.4 H_V. The average hardness values of annealed samples S₂, S₃ and S₄ are 41.4, 38.1 and 40.1 H_V, respectively. The dissolution of strengthening precipitates (MgZn₂ and CuAl₂) in HAZ may be attributed to the reduction in hardness. It was reported that grain refinement strengthening was not the main contributor that enhanced the strength and hardness of the Al-Zn-Mg-Cu alloy because the dislocation networks and tangles within grains and near grain or sub-grain boundaries make dislocation glide more difficult.

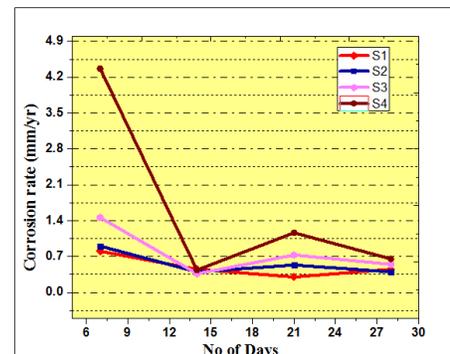
Fig.6: Corrosion rate variations with time for base metal and annealed samples of Aluminium 7075-T6 alloys in 3.5% NaCl solution.

Fig. 6 illustrates the relationships between corrosion rate (mpy) and immersion time by weight loss measurements. In comparison to base metal and annealed alloys showed high difference in weight loss up to initially 7 days of exposure. Thereafter, their steep decrease of weight loss was measured, as there is elimination of the possibility of hydrogen bubbles clinging on to the surface of the specimen and forming a permanent layer affecting the corrosion process. The phenomenon of gradually decreasing corrosion rate indicates the possible passivation of the aluminium alloy. De Salazar [9] explained that the protective black film consists of hydrogen hydroxy chloride, which retards the forward reaction. Castle et.al [10] pointed out that the black film consists of aluminium hydroxide compound. This layer protects further corrosion in alkaline media.

The corrosion rate (mm/yr) derived as per Eq. (1), is plotted against time (Fig. 6). From the trend one can see that the corrosion rate of S₄ occurs comparatively much high than BM alloy till initial 7 days of immersion. After this, there was a steep fall in their corrosion rate of S₄ (from 4.3681 to 0.4368 mm/yr) was measured, whereas BM alloy showed even less than two mpy corrosion rate after 7 days of immersion. The increase in corrosion rate of S₃ and S₄ alloy was further continued with fast rate (4.4555 and 7.10073) till 21 days of immersion. After this period, a decline in their corrosion rate was measured. A steep increase of corrosion rate after 14 days of immersion of annealed alloy evidences the occurrence of fast corrosion reaction that increases with exposure period possibly due to start of intergranular corrosion. Moreover, intensity of the intergranular corrosion appears to be quite high for S₄ annealed alloy. This phenomenon implies that preferential corrosion of the grain boundary region could have occurred, which is due to the fact that the grain boundary region was made more anodic by the segregation of Zn and Mg atoms in solid solution.

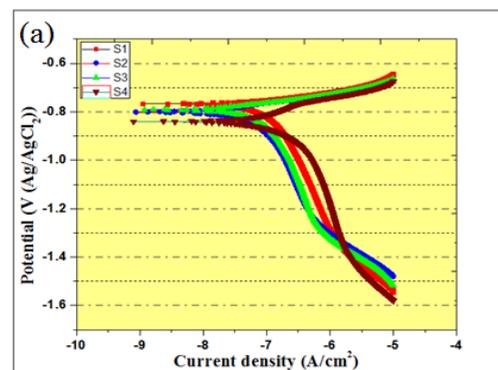
The effect of alkaline medium (3.5% NaCl) on the corrosion rate of base metal and annealed samples of 7075-T6 aluminium alloy was studied using Tafel polarization technique. Fig.7 represent the potentiodynamic polarization curves of 7075-T6 aluminium alloy (BM and annealed) in same concentration of 3.5% NaCl solution. The sample was cathodically cleaned by applying a potential of -30 mV vs. OCP. The experiment was carried out at the scan rate of 50 mV/s.

Fig.7: Tafel polarization curves for 7075-T6 aluminium alloy of (a) base metal and annealed samples.

The results indicate the increase in the corrosion rate with an increase in the annealing time (S₂, S₃, & S₄) immersed in 3.5% NaCl medium. The positive shift in the corrosion potential (E_{corr}) with the increase in annealing time indicates that the anodic process is much more affected than the cathodic process (El-Sayed, 1997). This observation is in accordance with Muralidharan (Muralidharan and Rajagopalan, 1979), who proposed dependence of E_{corr} and i_{corr} on solution parameters. Tafel slopes remained almost unchanged indicating that alkaline medium does not change the mechanism of the corrosion process. It is evident from data of Table 2 that corrosion rate is more in case of 12 hr annealed compared to as received sample.

Moreover, the electrode potentials of the specimens with large annealing time are significantly lower than those of the as-received specimen, which indicates that the specimens with large annealing time are more susceptible to localized corrosion in chloride solution (Table 2). The lowering of the electrode potentials recorded for the specimens with large annealing time can be explained by a decrease in the precipitate content in the aluminum matrix due to the annealing treatment.

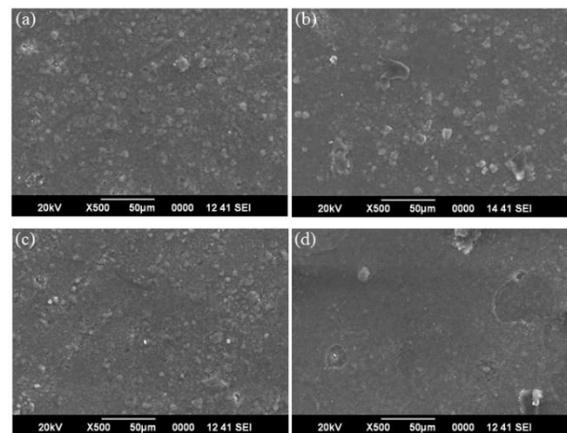
The surface morphology examined by SEM on the surfaces of as-received and annealed 7075-T6 aluminum alloy specimens before corrosion testing are shown in Fig. 8. Coarse and dense intermetallic particles are evident on the surface of the as-received specimen (Fig. 8a). In contrast, the intermetallic particles observed on the surfaces of large annealed specimens are finer and decreased with increasing annealing time. No precipitates are evident on specimen S₄ (fig. 8d), indicates that the precipitates are segregated at the grain boundaries of the alloy, leaving the adjacent region free of precipitates. This process is due to

the slow cooling of the aluminum alloy from the annealing temperature, which results in the diffusion of the alloying elements in a solid solution to concentrate at the grain boundaries.

Fig.8: SEM micrographs of the 7075-T6 aluminum alloy at 500X showing the precipitate phases in the as received specimen (a) and the annealed specimens (b) (c) & (d) for 4, 8 & 12 hr annealing time.

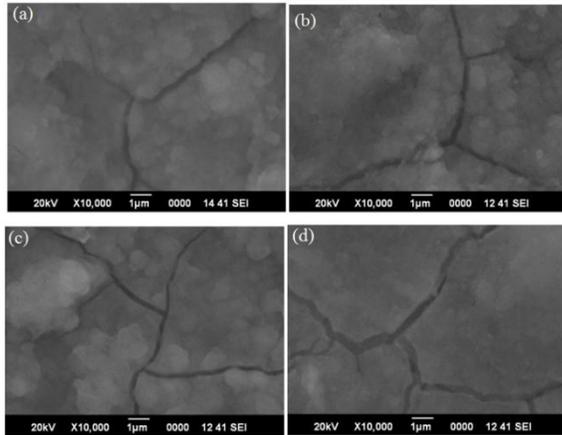
The surface morphology was examined by SEM immediately after corrosion tests in 3.5% NaCl medium. The SEM image of corroded sample given in Fig. 9 shows the degradation of alloy, which revealed the intergranular attack was initiated on the surfaces of the as-received specimens and the specimens with large annealing time. In contrast, the initiated intergranular cracks (IGCs) formed on the surface of the large annealing time specimens were denser and longer (Fig. 9d), which clearly demonstrates that the intergranular corrosion rate increases with annealing time (Fig. 9b–d). The higher current density (Table 2) observed during polarization of the samples with large annealing time indicates a more severe IGC attack because the current or, more precisely, the charge passed is directly proportional to the amount of metal dissolved by intergranular corrosion. The IGC growth can be attributed to the segregation of more grain boundary precipitate phases such as MgZn₂ and CuAl₂, which are

more active than the matrix. Moreover, it is believed that the high-grain boundary angle associated with large grain size provides an easy path for the IGC.

Fig.9: SEM micrographs of the surfaces of 7075-T6 aluminum alloy specimens at 10,000X immersed in 3.5% NaCl solution for 28 days (a) as-received specimen and (b), (c) and (d) are annealed samples for 4hr, 8hr and 12hr respectively.

- e. The SEM micrographs revealed that the most severe intergranular attack was observed on exposed surfaces of the 7075-T6 aluminum alloy specimens with larger annealing time.
