Study of Collapse Behavior of Building Under Fire Condition

Dileep Kumar Suryavanshi¹, Dr. Pankaj Singh²

²A.P. & Head, Department of Civil Engineering, RKDF I-ST Bhopal, M.P., India

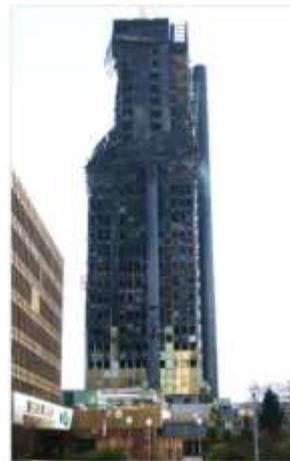
Fig.1.1 Windsor Tower (Madrid)

Concrete is a material when we bring it in contact with fire, it looks like tremendous behavior It does not burn, it means it is non-combustible and has a lot of thermal mass, which makes significantly spread of heat through the medium of concrete elements. In general, when a fire initiate in reinforced concrete structure, the outer layer of concrete section of thickness approximate damaged 3cm to 5 cm depth of the reinforced section. Therefore, a lot of reinforced concrete structures that damaged by fire, be capable of easily repaired & can be reuse. An instance of a good behavior towards the fire of reinforcement concrete structures is the Windsor Tower of Madrid. Due to the fire on February 14, 2005, the building was badly damaged. After this the fire was spread over several floors of the building and the fire continued for 26 hrs, still the building remained standing, Which can be seen in figure 1.1 & 1.2..

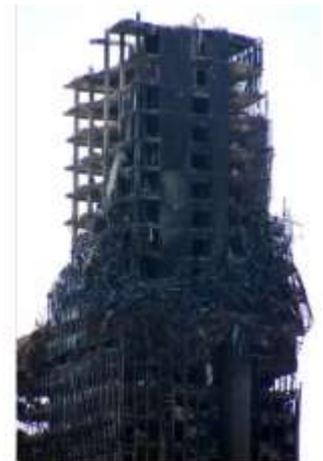
Fig.1.2 Windsor Tower After Fire

The only section that fall down where the steel columns on top of 20th storey, Which was sustaining the floors.

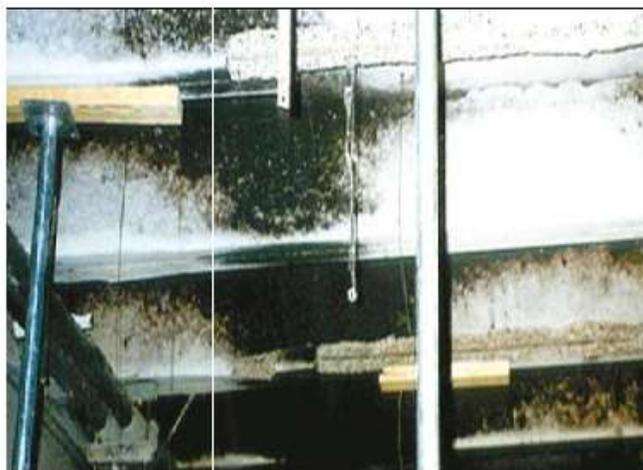
3.1 Separation of Slab & Joist Spalling

Fire happen in reinforcement cement stadium and intensity of fire is high. After the department of fire accepted the area for access, primary investigation was arranged. The fire severely damaged the estimated area of concrete by about 25 meters × 25 meters. The concrete beam was extremely damaged, the beam section was separated from the slab, and severe cracking was present.

In Destructive test notice that the strength of reinforcement concrete & reinforcing steel on the fire was compromises. Repairs of concrete structure were designed to rebound the slab & beam using L-shaped dowels to hook the slab & beam webs jointly. Repair the load bearing capability of the affected beam and slab.

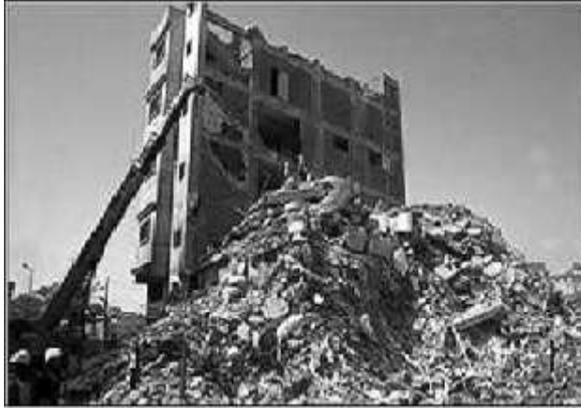
Fig.3.2 Collapse of Clothing

A 6th storey clothing factory (Fig 3.3) in Alexandria, Egypt collapsed after a fire in July 2000. Authorities believed the fire was initiated by an electric short circuit within the RCC building. The fire spread rapidly and took firefighters 7 hrs to extinguish. When the fire appeared to be put out, the building rapidly collapsed, killing at least 15 people and injuring many others. The expected cost of the destruction was \$2.5 million.
