STRUCTURAL CONSERVATION OF HISTORICAL PALACE USING REFOR_TEC AND SOCKFIX TECHNIQUE

Key Words: Structural Conservation, Heritage structure, REFOR-tec, Sock Fix, Structural Strengthening.

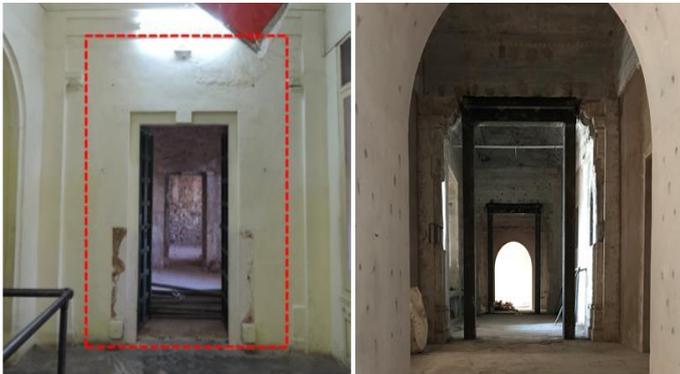
Fig -1: On Site Structural strengthening and circulation provision before and after.

The walls were made up of stone, lime and red mud. The wall was supporting a horizontal stone beam beneath the stone slab. To remove this stone wall, it was necessary to provide a fix support to the stone beam.

The Height of wall was around 3.420 m and the stone beam was resting on to it with the wall length along with the stone being around 2.260 m.

To provide a firm support to the stone beam, two types of steel sections (200mc and 100mc) were used which were then welded with steel plated box. After supporting the wall with the steel frame sections, all the supporting steel sections were filled with the Refor-tec material.

Refor-tec is a high performance reinforced micro concrete material with added fibres into it. It was mixed in one time by mixing component A Powder of 25kg bag, component B Liquid of 3.125 kg in 1 can and component C Fibre Fib-Energy ST/HS of 1.15 kg thoroughly into a container with the help of a mechanical mixing paddle.

The mixed material was then filled into the all supporting steel sections.

After hardening of Refor-tec material, the finishing work was done by welding and grinding the section surfaces to provide smooth finishing.

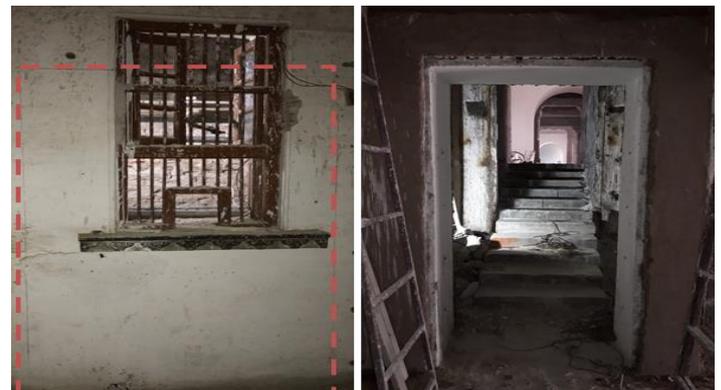
Fig -2: On Site gate opening and circulation provision before and after.

There was a requirement of pathway for the visiting tourists which resulted into the provision of opening of gates by cutting the existing stone walls.

The over loads coming straight from the upper stone masonry imparted heavy load on to these walls. Thus, this wall removal process may result into Buckling of those walls. To overcome this problem of Buckling, a brand new technique was introduced for the first time in our country named as “Sock-fix”.

Gate opening is done right after the application of sock-fix material into the wall. It was around 2133mm height and 1370mm width. Holes of 32mm dia. were drilled at various locations away from the gate opening throughout the wall. After that the sock-fix installation work was done. In ancient masonry works, the Sock Fix technique was used for stabilising purpose. This project commenced with marking of position on exterior face of the masonry wall for making holes followed by the Core drill at correct inclination and direction with a prescribed core diameter and depth. The Set-up was then pre-arranged so as to carry out pressure potting followed by the compressor installation. Later on, pressure

pot was purged and the components were colligated with clean water. Each Sock Fix was moistened and the injection tube was left for priming with the help of clean water anterior to the installation. Sock Fix Grout was then mixed by a power mixer at least for 3 minutes or until a smooth fluid material is obtained followed by its pouring using a sieve into the pressure pot container.

Sock Fix was then inserted into the drilled hole and it was ascertain that the sock has uniformly distributed along its full length. It was to bring into notice to do not force or twist it as tears in the sock if found may lead to premature grout leakage. If the assemblance length gets beyond 1000 mm, then Sock Fix supposed to be wetted again once inserted. Sock Fix valve was then connected with pressure pot and Sock Fix sleeve was amplified with Sock Fix Grout from pressure pot with a maximum pressure of 3 bar. It was to be noted that injection should be done under reduced pressure so as to avoid damage in masonry under low strength masonry.

As soon as Sock Fix sleeve gets amplified, it was gradually rotated into the hole so as to aid the flow of grout and also to ensure that the bar gets centralized on closure. The pressure was kept constant until the sock gets completely amplified in the drilled hole and all the grout gets expelled out. The shut off valve was then shut and separated from the pressure pot. In the end, grout tube end that was below the masonry surface was cut off when it got confirmed that the grout has cured sufficiently to restrict further residual pressure. Later with time, the gate opening was done there right after the hardening of Refor tec material.
