Analysis of FRP in Strengthened RC Columns

Abstract - This research work focusses on the rehabilitation of corrosion-damaged concrete columns using Glass Fibre Reinforced Polymer (GFRP) wraps. An accelerated corrosion process was used to induce different levels of corrosion damage (15% and 30%) in the steel reinforcement. The columns were wrapped with different configurations of GFRP namely Chopped Strand Mat (CSM), Woven Rovings (WR) and Uni-Directional Cloth (UDC) of different thicknesses. The columns were tested under uni-axial compression till failure. The axial and lateral deflections were recorded at all load levels. The load carrying capacity, deformation capacity and ductility of the GFRP wrapped corrosion damaged concrete columns were evaluated. It has been found that the GFRP wraps enhanced the strength, deformation and ductility of the corrosion damaged concrete columns appreciably.

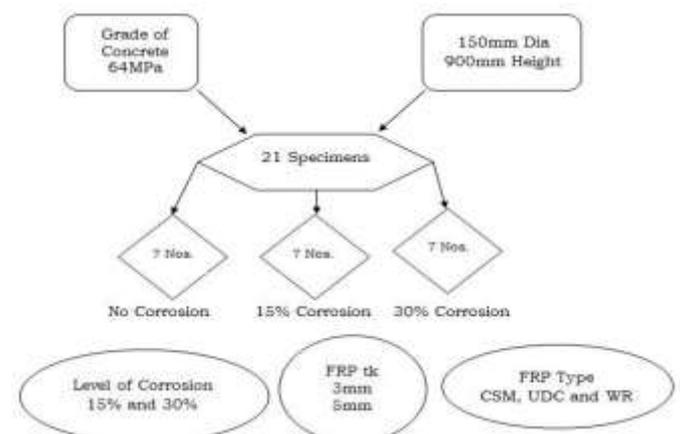
Fig-4: Experimental Investigation Flow Chart.

An experimental work has been carried out to study the performance of GFRP wrapped corrosion-damaged concrete columns. A total of 21 specimens of 150mm diameter and 900mm height with varying levels of corrosion damage, wrap materials and wrap thickness were cast and tested for this investigation. Each of the seven specimens were subjected to 15% and 30% level of corrosion-damage and in that two-column specimen were used as corroded control. Glass fiber reinforced polymer wraps were used with different configurations such as CSM, UDC and WR. The wrapping was done with 3 mm and 5 mm thickness for each material. The columns were tested under monotonic loading in a loading frame of capacity 2000 kN.

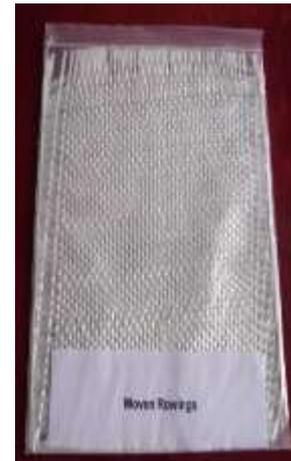
Fig-6 Woven Rovings Fabric

The Chopped Strand Mat (CSM) has randomly oriented E-glass fibres with an aspect ratio of 4800. The Uni-directional Cloth (UDC) has fibres oriented in single direction. The Woven Roving has interwoven fibres oriented at 90° to the longitudinal axis of the fabric. The fibre distributions of all the fibre materials were 450 gram per square metre.

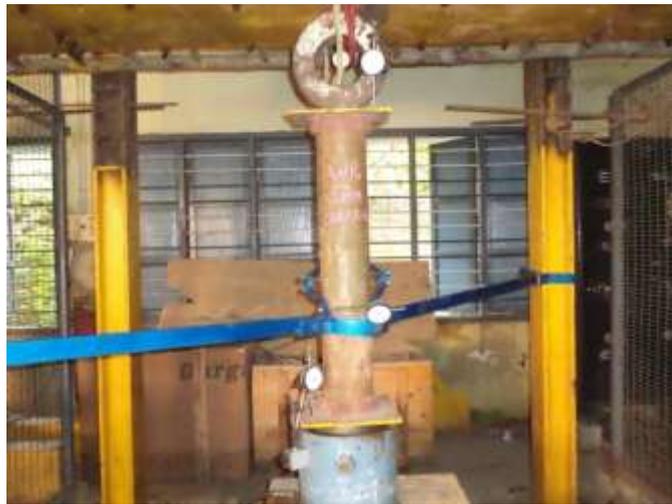
Fig-9 Test Set-up and Instrumentation

All the specimens were tested in a loading frame of capacity 2000 kN. To measure the axial compression of the column specimen, two deflectometers with a least count of 0.01mm were fitted at top and bottom of the specimen. A lateral extensometer was provided at mid-height of the

column to measure the lateral strain. Fig. 9 shows the test set up and instrumentation provided for the test specimens.

1. The column specimen was placed in a loading frame of capacity 2000kN. The specimen was capped at both ends.
2. The verticality of the column was checked with a plumb bob.
3. The load application was achieved through a hydraulic loading jack placed at the bottom of the specimen.
4. The deflectometers and extensometer were mounted at their respective positions and they were then adjusted to zero.
5. An initial load was applied slowly so that the column specimen was set properly to take further loads.
6. Successive uniform load increments were applied to the column. The axial deformation at top and bottom was noted from the deflectometers. The lateral deformation was recorded from the lateral extensometer.
7. The column specimen was tested to failure.
8. The failure mode of the column specimen was observed and recorded.
