Seismic Retrofitting

Abstract - Seismic retrofitting of building can be done by conventional design such as jacketing of beams and columns, strengthening of beams and columns by use of new materials, stiffness strengthening by adding shear walls, shear panels and bracings and secondly by a seismic design by adding devices to reduce the seismic forces such as base isolators, energy absorbers like visco elastic dampers, friction dampers and tuned mass dampers etc.

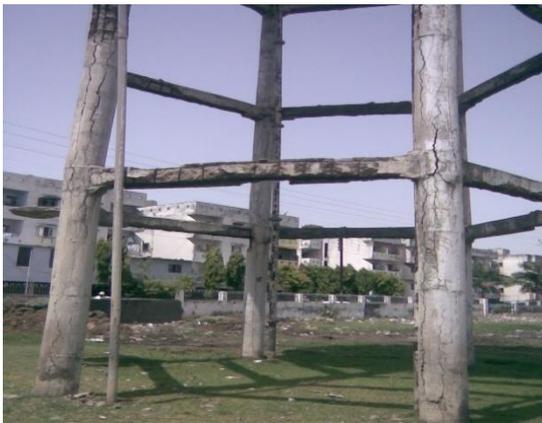
Fig. 1 Water tank at M.G. Road

On M.G. Road, Jabalpur, water tank of the storage capacity 50,000 gallon which is not in working condition was damaged in Jabalpur earthquake (Fig.1).

Water tank has four circular columns without diagonal bracing. On the visual inspection of the structure we observed cracks on column, beam and slab members and spalling of concrete.

Based on the investigation carried out on water tank the retrofitting measures to be carry out are jacketing by fiber reinforced plastics as they are resistant to corrosion caused by acids ,alkalis and salts or plate jacketing³ to column. Steel angle or channels section diagonal bracing is to be added in between the columns by bolting the steel section to the column by steel plates to increase the lateral resistance of the structure, as it is easier to add structural steel rather than concrete bracings because new concrete beam would require formwork and shoring and are difficult to construct. Slab is to be jacketed by fiber reinforced plastics. Beam section can also be strengthening by bolting the steel channel section (Fig.4).

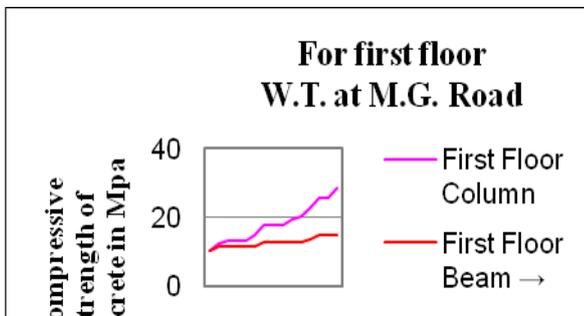
Fig. 2 Rebound hammers results for first floor of water tank

The column and beam members were divided into 30 cm length and in each zone minimum 15 readings were observed by Schmidt hammer and ultra sonic pulse velocity. The observed readings are tabulated (Table 1) shows the average compressive strength of concrete in MPa for each member. (Fig. 2) shows the graphical representation of compressive strength of concrete in MPa for each member for first floor and (Fig.3) for second floor.

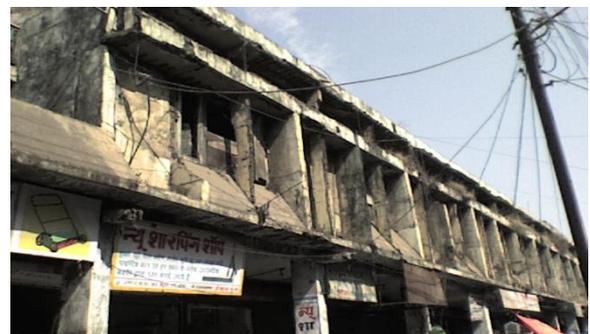
Fig.6 Bal Vihar building

Bal Vihar is a commercial building in Bhopal, R.C.C. two storey building. On inspection, we find cracks in columns,

beams, slabs, and R.C.C. parapet wall and also deflection in the beams (Fig. 6)

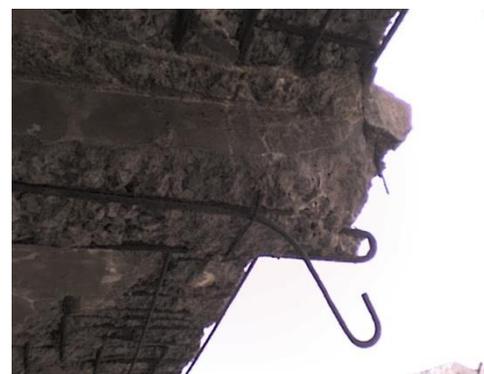
Fig.7 Beam of Bal Vihar building

The reinforcements of beam are exposed to the environment (Fig. 7). The readings were observed by Schmidt hammer (Fig.8) and ultra sonic pulse velocity. The observed readings are tabulated (Table 2) shows the average compressive strength of concrete in MPa for each member.
