Health Monitoring of Mundhwa Bridge

Site location: Mundhwa Bridge (no.15) over Mutha River, Pune.

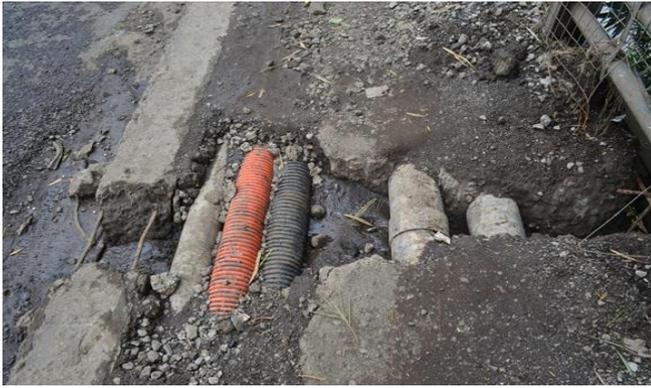
[f] Utilities: There is a pipe line passing from the centre of the bridge. Which also acts as a median. Pipe line has leaked and this has cause several damages, it is therefore advisable to have arrangement at the joints in pipe to collect leaking water & let it be released out. In the pipe line there is one expansion joint, gap for expansion does not appears to be adequate. There is another service line going over the footpath which is not covered. A service line is passing outside the railings, fixed to the bridge by steel brackets.

Image-2: service lines in footpath are not covered

[7] The service line going over the footpath should be covered.

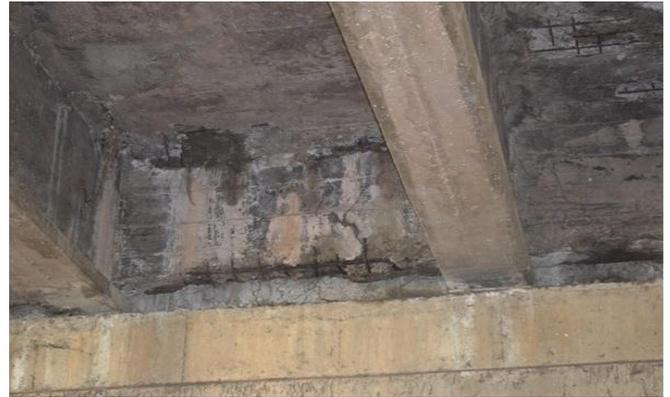
[a] Concrete [RCC and PSC]: No deflection in the deck appears anywhere. There are minor surface defects in concrete. From the surface it appears that earlier there was stone masonry which has been plastered which can be verified by opening a portion of masonry and removing plaster.

Image-6: Damage in deck slab, steel is open in slab

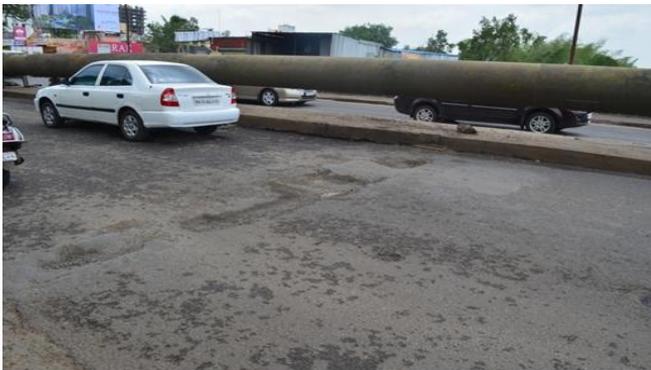
[e] Expansion joints: Concrete at the expansion joint is deteriorated. Whenever the vehicles travel over the bridge, a thudding sound coming from the expansion joints & bearings indicating upward or downward or longitudinal movement, due to movement of joint. It is not merely a sliding phenomenon. The vertical movement is more prominent. Initially the steel railing was continuous over the joint later the pipes were cut to make a joint at expansion gap. In the service pipe line there is one expansion joint, gap for expansion does not appears to be adequate.

Image-3: Expansion joint are to be damaged

[1] The width and the span being equal there is expansion and contraction in central and longitudinal direction, however the bearing and expansion gaps are designed only for longitudinal direction. It is therefore necessary to provide such type bearings and expansion joints which can move in both directions i.e. lateral and longitudinal. POT-PTFE bearings and strip seal expansion joints are ideal for such situations.

[3] All expansion joints are to be replaced by strip seal expansion joints.

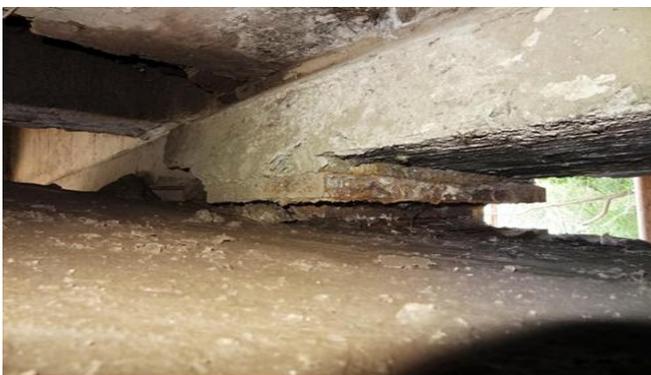
5.5 Bearings: RCC roller rocker bearings are provided. The bearings are in very poor condition.

Image-4: Damaged bearing

[2] Replace the bearings by POT-PTFE bearings as RCC roller rocker bearings are not permitted by MORTH, since many such bearings have cracked.

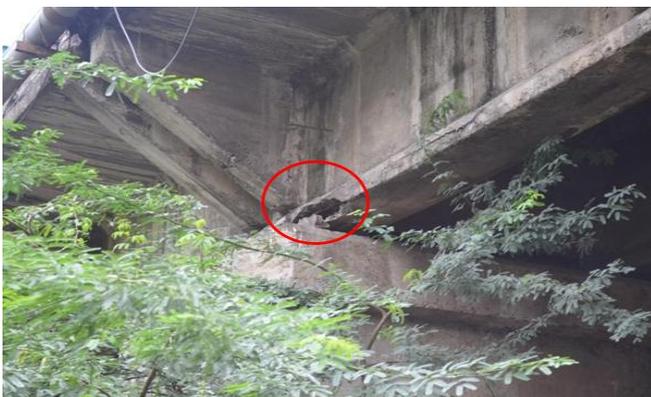
Image-5: damage to the structure at bearing location

Sr no	location	member	Distance mm	Time micro sec	velocity
1	Damage bearing location	RCC girder	245	57.2	4.28
2	Damage bearing location	RCC girder	245	67.2	3.65
3	Damage bearing location	RCC girder	400	104.7	3.82
4	Damage bearing location	RCC girder	500	121.8	4.11
5		RCC girder	400	110.7	3.61
6		RCC girder	220	49.8	4.42
