Effect of Eccentricity on Power Consumption of a Three Bolt Flange Coupling with Variation of Speed and Braking Torque

Shasikanta Sahoo¹, P.K. Soni²

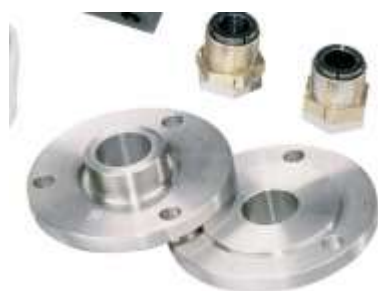
Fig.1

The flange coupling is made up of two halves; one half with inset centring recess and one half with elevated centring collar. The two halves of the flange are held together by three bolts.

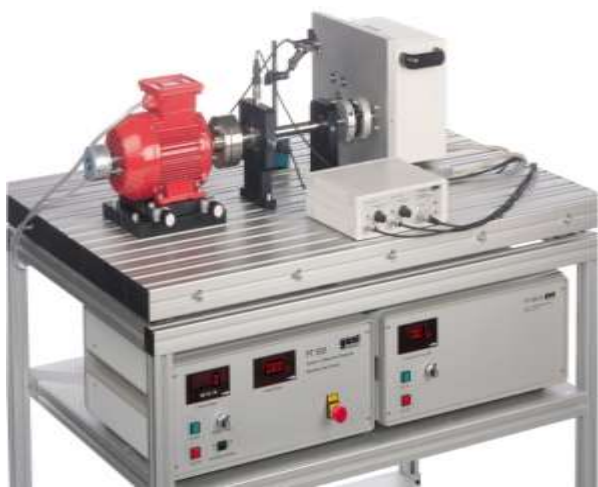
Fig.2

The experimental setup is shown in the fig.1. It consists of brake and load unit, elastic spare ring Coupling, bearing block with rigid bearings, reflective mark, short shaft, bearing block with elastic bearings, acceleration sensor, three bolt flange coupling, drive unit and reference sensor. The drive unit is fitted on the clamping plate and is connected to control unit. The control unit is connected to power supply. Three bolt flange coupling which is to be investigated is secured in between the drive unit and shaft. The bearing block with elastic bearing is loosely fitted onto the clamping plate and is flushed in front of drive unit. The short shaft is slid through the bearing block with elastic bearings. Then the first setting ring is slid onto the short shaft in such a way that the shaft can subsequently be fixed in place on the bearing block with rigid bearings. Setting ring is provided on each side of bearing block. The short shaft with both bearing blocks is slid on to the coupling so that the coupling can be connected to the shaft. The position of short

shaft is secured to the bearing block with rigid bearings. Possible lateral misalignment is minimized to align and secure the drive unit and bearing blocks. The setting rings on the bearing block are aligned with rigid bearings. The brake and load unit is placed onto the clamping plate in such a way that the elastic spacer ring coupling can be used to offset the misalignment of the shafts. The short shaft and the brake and load unit are connected to the elastic spacer ring coupling. The acceleration sensors are attached to the bearing block with elastic bearing. The reflective mark for the reference sensor is attached on the shaft. Reference sensor is fitted with magnetic clamp and is roughly aligned with the reflective mark. Acceleration sensor and reference sensor are connected to the measuring amplifier. The measuring amplifier is connected to the PC via the USB measurement box.
