Experimental Investigation on Utilization of Crumb Rubber Waste in Tile Manufacturing

Abstract - This paper presents the results from an experimental investigation carried out to assess the performance of roofing and flooring tiles with different proportions of crumb rubber as a fine aggregate replacement. The tests conducted include breaking load, water absorption, permeability and thermal conductivity in accordance with the specific standards. Research into the use of waste by-products in construction industry has been increasing over the past years. The present work assesses the suitability of crumb rubber to replace different percentages such as, 2, 4 and 5% of fine aggregates in roofing and flooring tiles.

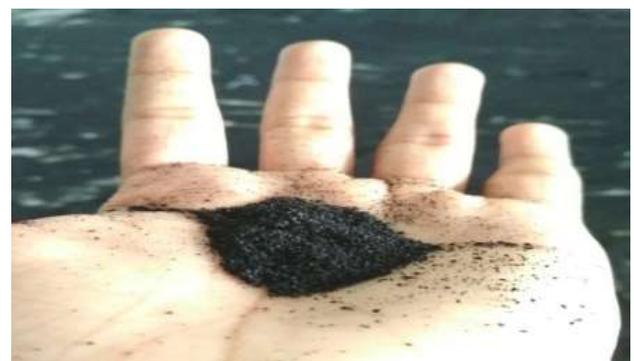
Fig-1: Crumb rubber

Crumb rubber produced from grinding process and having size less than 1mm was used for the study. Fig -1 shows the photo of crumb rubber. The properties of crumb rubber are given in Table-3.

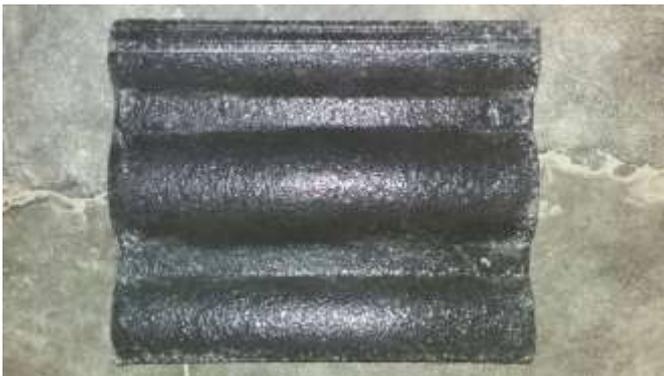
Fig-2: Roofing tile

The roofing tiles were prepared using Italian imported mould of size 420mmx330mm by a machine working under extrusion process. The specimens were prepared with replacements of fine aggregate with 2, 4 and 5% crumb rubber. The prepared mix was delivered into the extrusion head and it is extruded between the pallets and roller. The tiles were placed in heated chambers for curing.

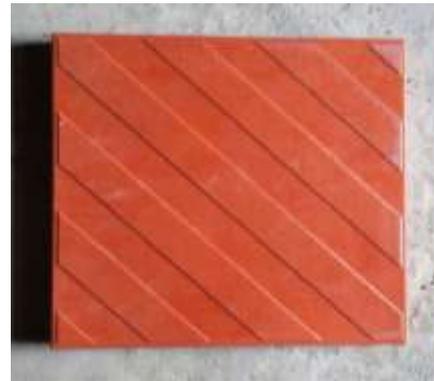
Fig-3: Flooring tile

The flooring tiles were prepared in two layers. Top layer is a mixture of cement, coarse aggregate (6mm), coloured pigment, crumb rubber and water. Bottom layer is a mixture of cement, fine aggregate and coarse aggregate (6mm and 12mm). Size of the mould was 300mmx 300mm. After placing and compacted the top layer, bottom layer were laid

over it and compacted by vibration. The specimens were prepared with replacements of 2, 4 and 5%.
