# Reduction of Stray Losses in Distribution Transformer using different materials of Clamping

This paper presents the case study involving the estimation of stray losses and ways to reduce it using different clamping material in Distribution Transformer 3 phase 100 KVA, 11/0.443 KV.

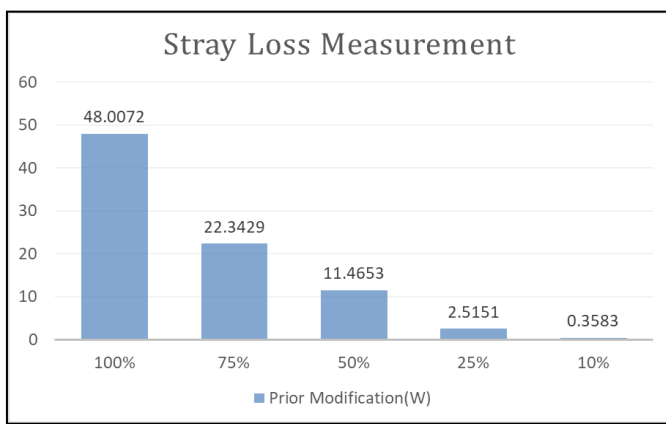
After Routine test individual losses such as Copper loss, Iron loss and Stray loss was found out using practical approach. Using power analyzer, the no load loss which gives iron loss was recorded as 171 Watt. Further for Copper losses transformer was loaded at 0%, 25%, 50%, 75% and 100%. And total load losses at each level was calculated. Then total loss was corrected for the reference temperature of 75°C, then Stray losses at each load level was calculated for ambient temperature and reference temperature of 75°C.

Chart -1: Stray losses at different load levels prior to modification

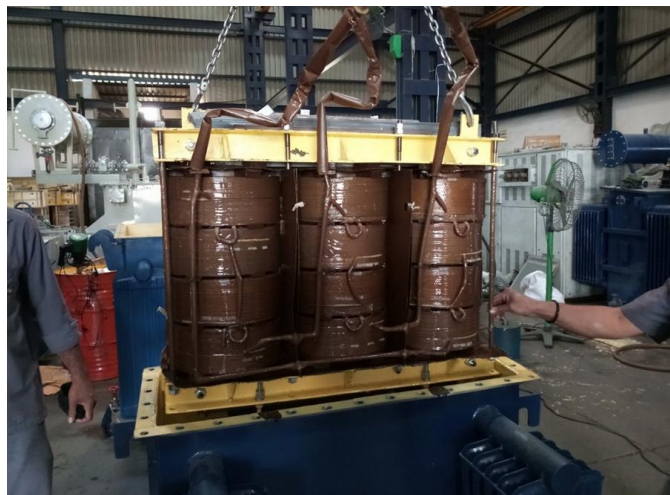
- The main focus is on reducing stray loss due to clamping which hold the laminated core in a transformer tightly.
- The current Clamping are made up of Mild Steel which have ferromagnetic properties which aids to magnetic leakage flux.

Fig -1: Transformer with mild steel clamping

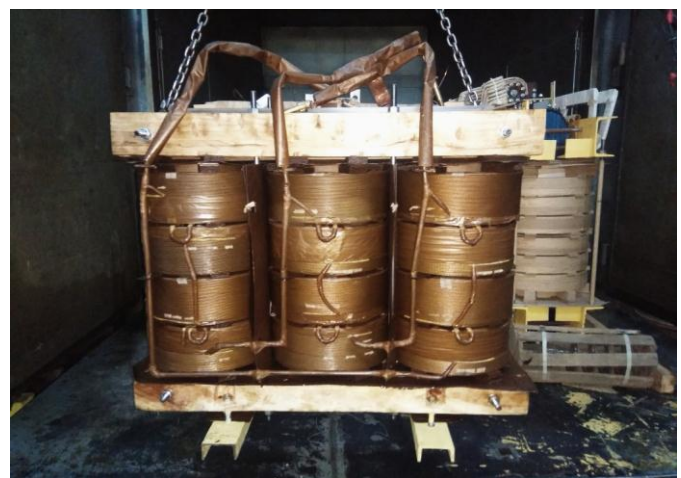
After calculation of stray losses, clamping of transformer was replaced with wooden material. The same transformer after the modification was subjected to same level of load test.

Fig -2: Transformer with wooden clamping

After the calculation of stray losses for both material, it is to be noted that wood has certain advantage in reducing stray losses. Further wood has the strength required to hold up the core laminations tightly. It can be assessed that using a diamagnetic material can reduce stray losses.
