Reduction of Stray Losses in Distribution Transformer using different materials of Clamping

This paper presents the case study involving the estimation of stray losses and ways to reduce it using different clamping material in Distribution Transformer 3 phase 100 KVA, 11/0.443 KV.

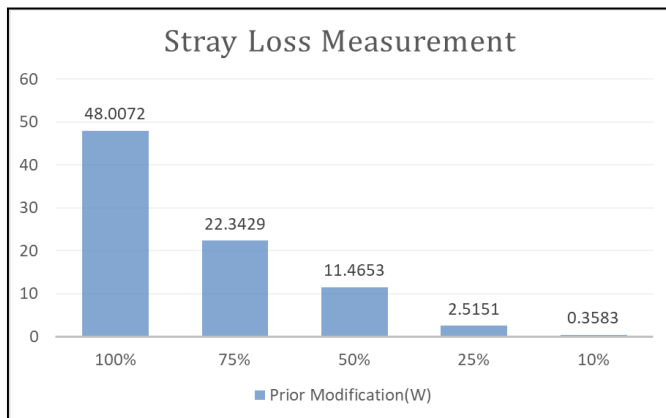
Chart -1: Stray losses at different load levels prior to modification

After Routine test individual losses such as Copper loss, Iron loss and Stray loss was found out using practical approach. Using power analyzer, the no load loss which gives iron loss was recorded as 171 Watt. Further for Copper losses transformer was loaded at 0%, 25%, 50%, 75% and 100%. And total load losses at each level was calculated. Then total loss was corrected for the reference temperature of 75°C, then Stray losses at each load level was calculated for ambient temperature and reference temperature of 75°C.

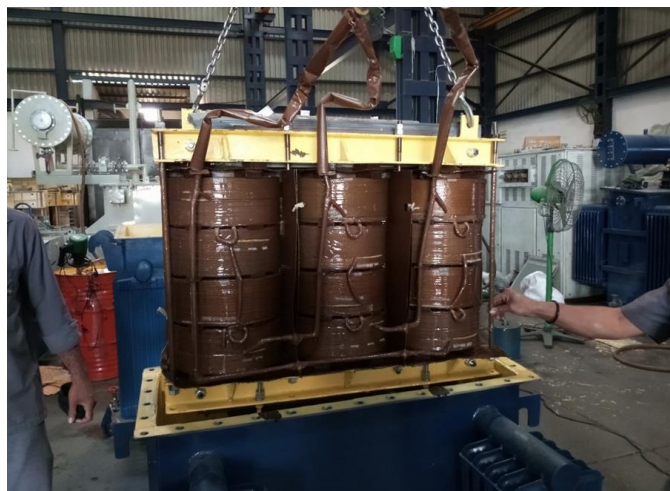
Fig -1: Transformer with mild steel clamping

- The current Clamping are made up of Mild Steel which have ferromagnetic properties which aids to magnetic leakage flux.

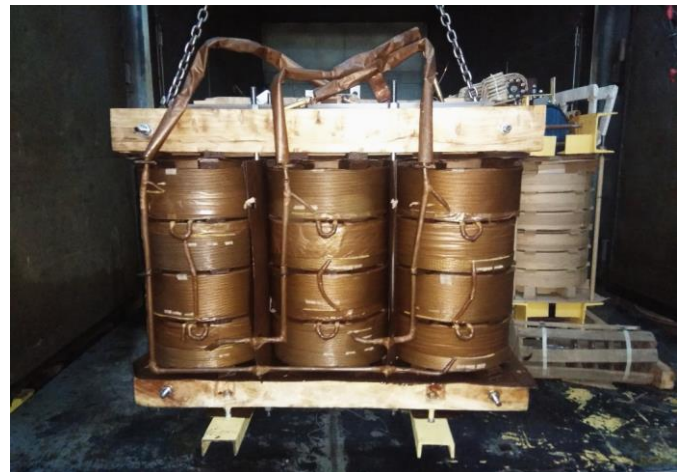
Fig -2: Transformer with wooden clamping

After making the changes in clamping material i.e. replacing the steel clamping with wood. The load loss test as performed
