Review on Study the Investigation of mass Movement along Malshej Ghat

KEY WORDS: Hillside, Latitude, Longitude, GPS

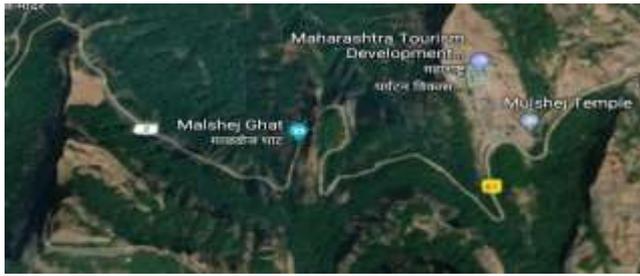
Image- 2: Satellite image of malshej ghat
