Rehabilitation of Reinforced Concrete beams by using Micro-cement and Glass Fiber Reinforced Polymer (GFRP)

Sankalp. R¹, Dr. B. Shivakumara Swamy², Dr. S. Vijaya³

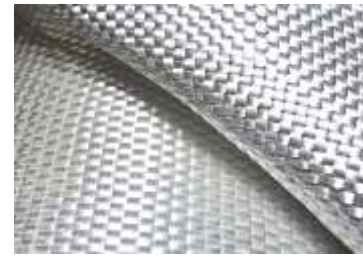
GFRP is a high strength material and has Ultimate strength ranging 480-1600 MPa and elastic modulus of 35-51 GPa. At failure it has got lower strain ranging 2-4.5% (as per the manufacturer). Bi-directional GFRP of 360gsm was used in this current experimental work. Fig -1 shows the bi-directional GFRP fabric.

Fig -1: bi-directional GFRP fabric

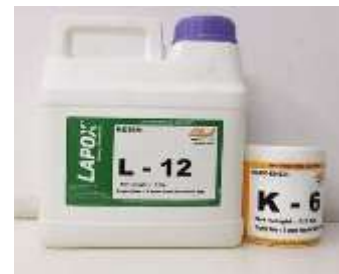
Epoxy resin is a reactive polymer containing epoxide group. Hardeners are the reactants with which the epoxy resins are reacted. Lapox L-12 is the epoxy resin and hardener K-6 were the products used. Fig -2 shows the epoxy resin and hardener.

Fig -2: Epoxy resin and hardener

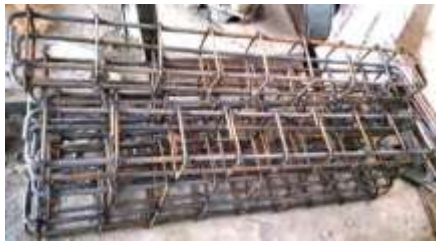
Fig -4: Reinforcement skeleton

The formwork used was of bolted type. The formwork of size 150 x 200 x 1300 mm, which was available in the laboratory was used. After keeping the cover blocks of 25mm, the reinforcement skeleton was placed inside the formwork.

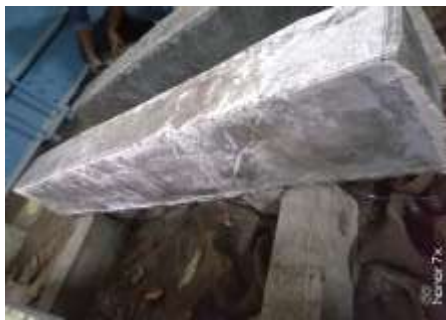
In the second stage, the rehabilitation of beams was done by wrapping the full length of beams by GFRP fabric in U shape, which intern gives strength to the damaged beams. It was taken care to clean the surface before pasting the GFRP fabric. By mixing the epoxy resin and hardener in the proportion 100:10 to 12 (as per the manufacturer) to get a high viscosity uniform paste. Firstly, the epoxy resin was brushed on the beam and the pre-cut GFRP fabric was pasted by pressing gently so the epoxy oozes out from bottom to the top. Then the pasted fabric was allowed to set for 24 hours. Fig -6 shows GFRP sheet wrapped on the beam.

Fig -6: GFRP sheet wrapped on the beam

The Micro-cement was injected to the beams by hand pumped pressure grouting machine and the GFRP fabric was U-wrapped throughout the length of the beam. To paste the GFRP fabric, epoxy resin was used as an adhesive.

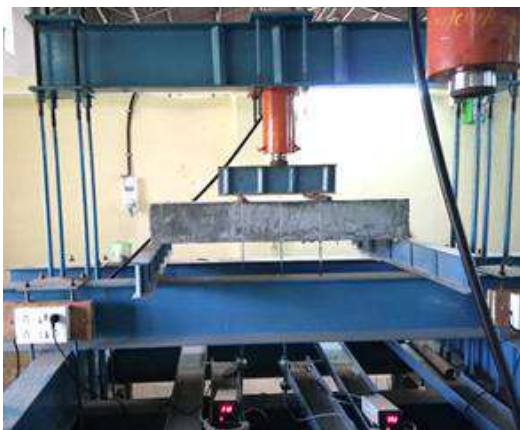
A loading frame of capacity 50 tonnes was used to test the beams. After 28 days of curing, the beams were tested. The beams were tested under two point loading. Using a hydraulic jack, the load was applied on a spreader beam, which in turn transfers the load to the beam on two points. Using three linear variable deformation transducer (LVDT) at the centre and at the point of loading, the deflections were determined. Fig-7 shows experimental setup.

Fig -7: Experimental setup

The beams were placed on the loading frame and the LVDTs and strain gauges were fixed. The hydraulic jack was lowered till a point such that there is contact between jack

and spreader beam. At increments of 10KN, the load was applied and the corresponding deflections and strain gauge readings were noted. The control beam was tested for ultimate load and the remaining beams were damaged by 80% of the ultimate load. Then the damaged beams were rehabilitated by injecting micro-cement and GFRP fabric and tested up to failure. The load vs deflection and stress vs strain curves were plotted and then the results were compared to identify the effectiveness of rehabilitation.

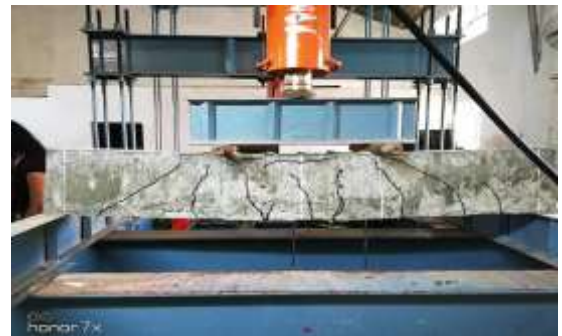
The test results shows that the control beam fails at 150KN load with numerous cracks in the flexure and shear region. The rehabilitated Group A beams i.e. BSL1 and BSL2 fails by complete delamination of GFRP fabric at 170 KN and 166KN respectively. The rehabilitated Group B beams i.e. BTL1 and BTL2, fails at 200KN and 192KN with delamination of GFRP fabric. Fig -8 shows the crack pattern of control beam after failure.

Fig -8 Crack pattern of control beam

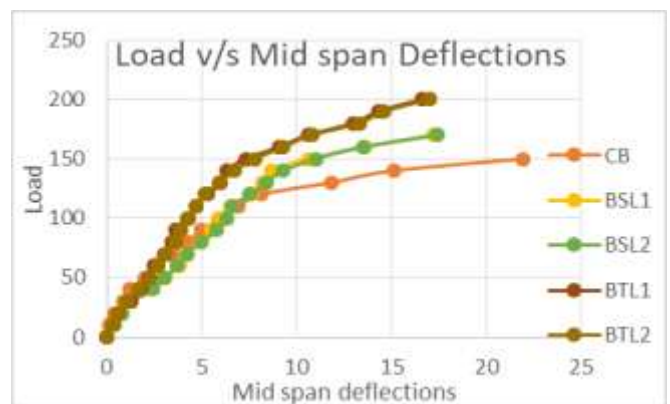
The load v/s Deflection readings were tabulated and the curves were plotted for all the beams. Fig -9 shows the load v/s mid span deflections of all the specimen beams.

Fig -9: the load v/s mid span deflections of the beams

In rehabilitated beams, by injecting micro-cement and GFRP has helped to reduce the deflections at higher ultimate loads i.e. decrease in deflection by 20.5% to 21.5% for group A

beams and 22.3% to 24.2% for group B beams respectively when compared to control beam.

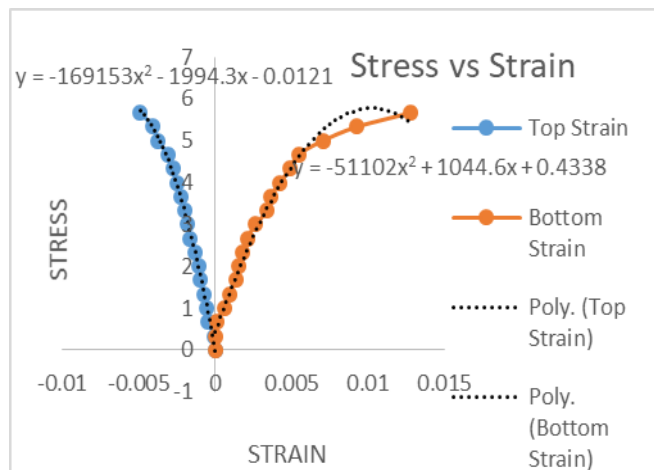
Fig -12: Stress v/s strain curve for BSL1

Using Demec-gauge the strain was measured at top and bottom of the neutral axis. For all beam specimens, at top and bottom of neutral axis, stress-strain graphs was plotted. Table -3 Stress-Strain at top and bottom of neutral axis at the 1st crack load/ initial delamination load and failure load respectively. Fig -11, 12, and 13 shows the stress-strain curve for control beam, BSL1 and BTL1.

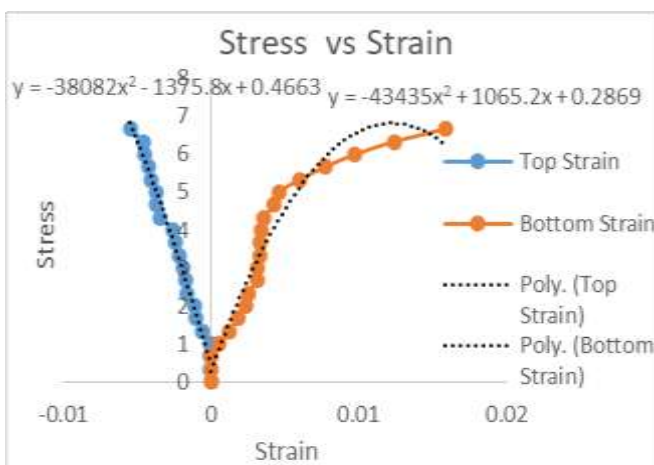
Fig -13: Stress v/s strain curve for BTL1
