Rehabilitation of Reinforced Concrete beams by using Micro-cement and Glass Fiber Reinforced Polymer (GFRP)

Sankalp. R¹, Dr. B. Shivakumara Swamy², Dr. S. Vijaya³

¹M.Tech Student, Department of Civil Engineering, Dr. Ambedkar Institute of Technology, Bengaluru, Karnataka, India

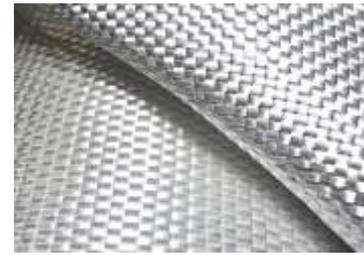
Fig -1: bi-directional GFRP fabric

GFRP is a high strength material and has Ultimate strength ranging 480-1600 MPa and elastic modulus of 35-51 GPa. At failure it has got lower strain ranging 2-4.5% (as per the manufacturer). Bi-directional GFRP of 360gsm was used in this current experimental work. Fig -1 shows the bi-directional GFRP fabric.

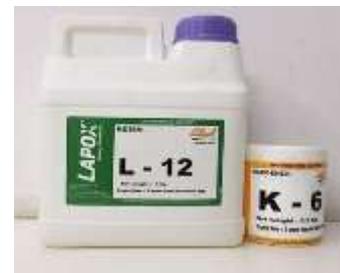
Fig -2: Epoxy resin and hardener

Epoxy resin is a reactive polymer containing epoxide group. Hardeners are the reactants with which the epoxy resins are reacted. Lapox L-12 is the epoxy resin and hardener K-6 were the products used. Fig -2 shows the epoxy resin and hardener.

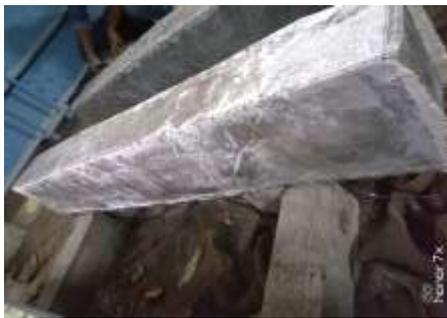
Fig -6: GFRP sheet wrapped on the beam

In the second stage, the rehabilitation of beams was done by wrapping the full length of beams by GFRP fabric in U shape, which intern gives strength to the damaged beams. It was taken care to clean the surface before pasting the GFRP fabric. By mixing the epoxy resin and hardener in the proportion 100:10 to 12 (as per the manufacturer) to get a high viscosity uniform paste. Firstly, the epoxy resin was brushed on the beam and the pre-cut GFRP fabric was pasted by pressing gently so the epoxy oozes out from bottom to the top. Then the pasted fabric was allowed to set for 24 hours. Fig -6 shows GFRP sheet wrapped on the beam.

The Micro-cement was injected to the beams by hand pumped pressure grouting machine and the GFRP fabric was U-wrapped throughout the length of the beam. To paste the GFRP fabric, epoxy resin was used as an adhesive.

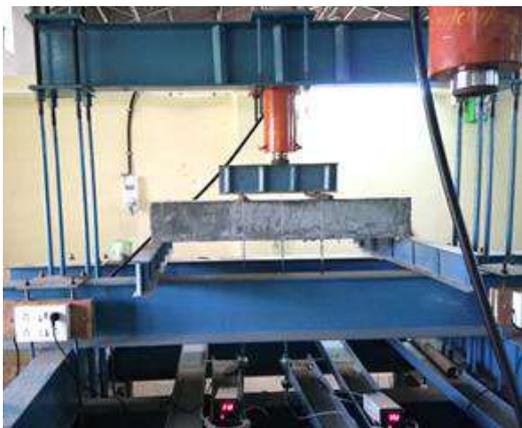
Fig -7: Experimental setup

A loading frame of capacity 50 tonnes was used to test the beams. After 28 days of curing, the beams were tested. The beams were tested under two point loading. Using a hydraulic jack, the load was applied on a spreader beam, which in turn transfers the load to the beam on two points. Using three linear variable deformation transducer (LVDT) at the centre and at the point of loading, the deflections were determined. Fig-7 shows experimental setup.

The beams were placed on the loading frame and the LVDTs and strain gauges were fixed. The hydraulic jack was lowered till a point such that there is contact between jack

and spreader beam. At increments of 10KN, the load was applied and the corresponding deflections and strain gauge readings were noted. The control beam was tested for ultimate load and the remaining beams were damaged by 80% of the ultimate load. Then the damaged beams were rehabilitated by injecting micro-cement and GFRP fabric and tested up to failure. The load vs deflection and stress vs strain curves were plotted and then the results were compared to identify the effectiveness of rehabilitation.

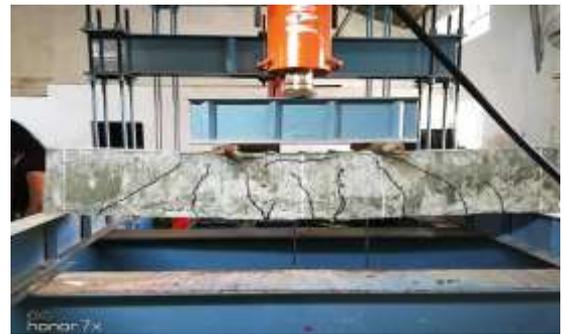
Fig -8 Crack pattern of control beam

The test results shows that the control beam fails at 150KN load with numerous cracks in the flexure and shear region. The rehabilitated Group A beams i.e. BSL1 and BSL2 fails by complete delamination of GFRP fabric at 170 KN and 166KN respectively. The rehabilitated Group B beams i.e. BTL1 and BTL2, fails at 200KN and 192KN with delamination of GFRP fabric. Fig -8 shows the crack pattern of control beam after failure.

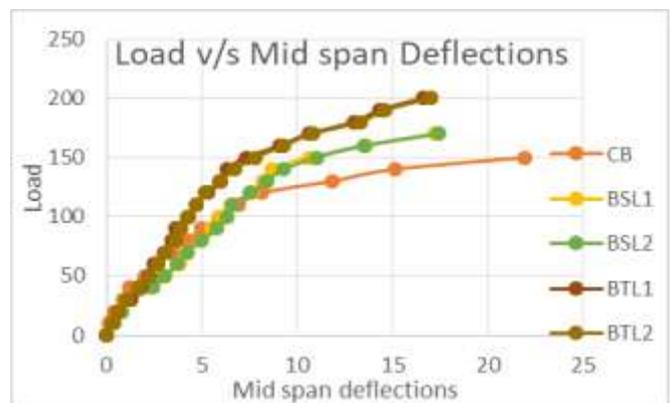
Fig -9: the load v/s mid span deflections of the beams

The load v/s Deflection readings were tabulated and the curves were plotted for all the beams. Fig -9 shows the load v/s mid span deflections of all the specimen beams.

In rehabilitated beams, by injecting micro-cement and GFRP has helped to reduce the deflections at higher ultimate loads i.e. decrease in deflection by 20.5% to 21.5% for group A

beams and 22.3% to 24.2% for group B beams respectively when compared to control beam.

4. In rehabilitated beams, by injecting micro-cement and GFRP has helped to reduce the deflections at higher ultimate loads i.e. decrease in deflection by 20.5% to 21.5% for group A beams and 22.3% to 24.2% for group B beams respectively when compared to control beam.
