Preventive Maintenance and Root Cause Analysis of Sealed Quench Furnace in Axle Heat Treatment Line

Keywords-Sealed Quench Furnace, RCA, Availability, MTTR, MTBF.

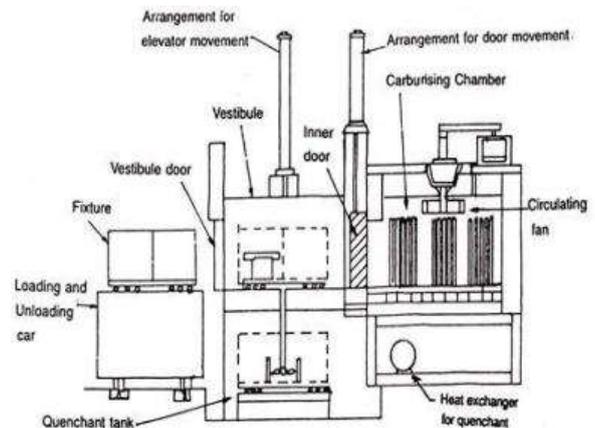
Fig-1: Schematic View of Sealed Quench Furnace

The critical machine was selected to conduct a present work is Sealed quench furnace in the axle heat treatment line of automotive axles limited. Sealed quench furnace is a batch furnace where in the heating and quenching chambers are combined in a single unit. The two chambers are parted by a refractory-lined door which can be opened to permit the hot charge to be conveyed from the heating chamber to the cooling chamber. The quench rack has two sets of rollers, one above the other so, furnace can still be loaded at the same time as the load just treated is still in the quench oil on the lower set of rollers, the load just treated is being atmosphere cooled on the upper rollers. Sealed quench furnaces usually operate over the temperature range 750°C to 1000°C but can operate from 570°C to 1100°C with appropriate modifications. hot zone consists of a steel

outer shell, which is lined inside with refractory bricks. The load stands on a hearth which consists of a thick ceramic plate with holes in it, supported by refractory brick pillars which permit open circulation of the controlled atmosphere. The charge is surrounded by the controlled atmosphere which protects the components from oxidation and provides the ideal environment for carrying out treatments such as hardening, carburizing and carbonitriding.

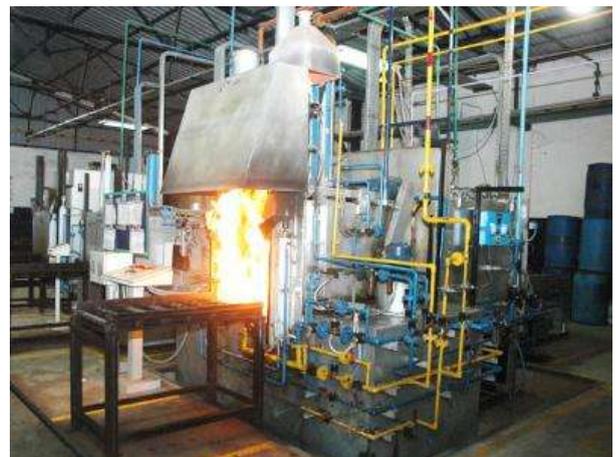
Fig- 2: Sealed Quench Furnace

Here there is a frequent and repetitive breakdown related to both heating and quenching unit. Problem is loading track getting damage, Quench oil circulation

pump coupling failure, Quench elevator air cylinder seal failure, Delay in attaining required temperature. Due to this problem the machine availability is decreased and this is a frequent breakdown. There was a decrease in production capacity and MTBF. Hence in this present work an attempt has been made to overcome the above problems by incorporating new preventive maintenance schedules with safety interlock. To obtain the new preventive maintenance schedule, repeated breakdowns were identified, inspected and analysed using Root cause analysis technique like why- why analysis and fishbone diagram. These techniques helped in increasing availability and MTBF to certain extent and reduce the downtime and finally to prevent the failure of equipment before it actually occurs.

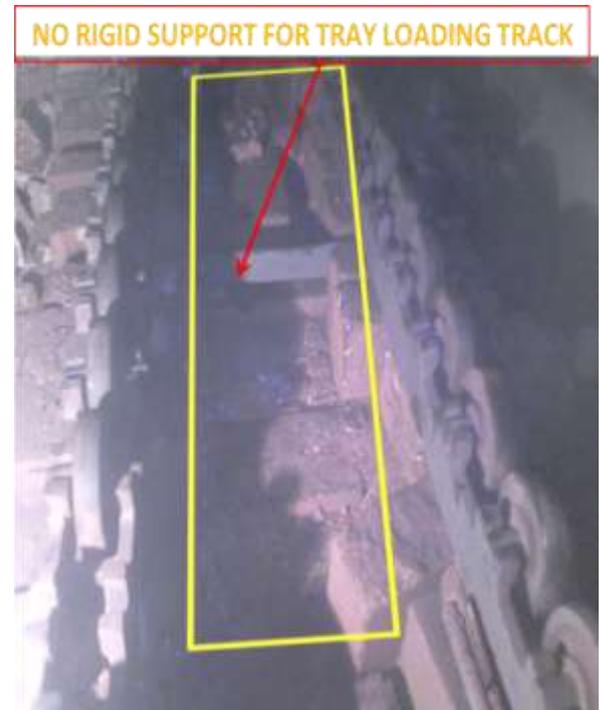
Fig - 3: Before Counter Measure

2.1.1 Break down description - Loading track getting damage

Root cause - No proper rigid support for furnace track

Physical phenomenon - High temperature inside furnace

Problem	Loading track getting damage
Why?	Track getting bend due to high temperature inside the furnace
Why?	Temperature inside furnace is around 900°C
Why?	No proper rigid support for furnace track
Why?	Original design was not proper

Counter measures - Extra strength provided by introducing sillimanite Carbide bricks & SS 310 bracket and cementing it from all side for rigid track.

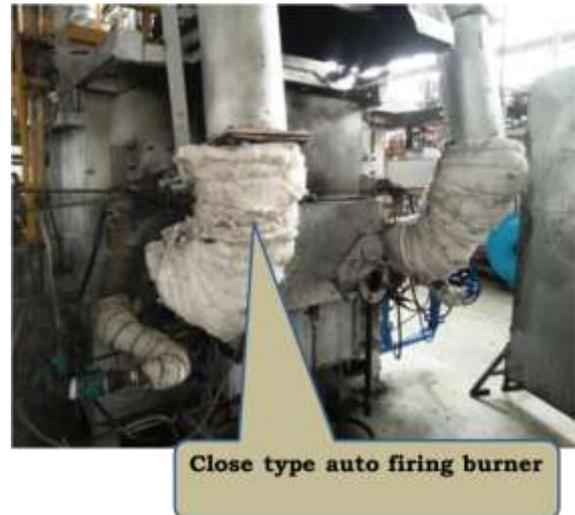
Fig - 6: After Counter Measure

2.1.2 Break down description - Delay in attaining required temperature

Root cause - Original design was not proper

Physical phenomenon - Heat loss near burner area

Problem	Delay in attaining required temperature
Why?	Required temperature was not maintained throughout a cycle
Why?	Heat loss near burner area
Why?	Manual firing was not systematic
Why?	Original design was not proper

Counter measures - Burner design modified close firing provided with auto ignition

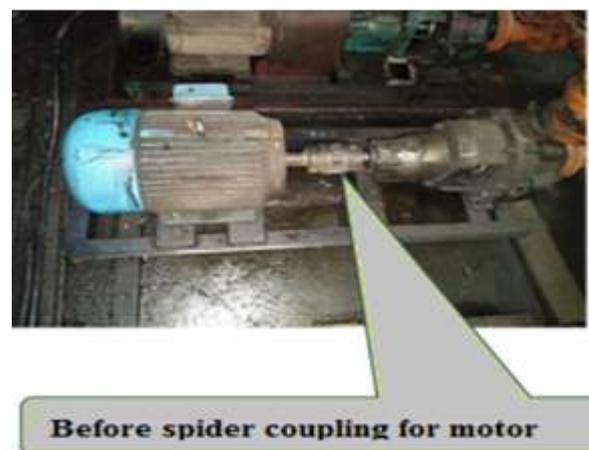
Fig - 7: Before Counter Measure

2.1.3 Break down description -Quench oil circulation pump coupling failure

Root cause - Pump motor coupling Misalignment

Physical phenomenon - coupling spider failure

Problem	Quench oil circulation pump coupling failure
Why?	Quench oil pump coupling spider failure
Why?	Pump motor coupling Misalignment
Why?	Fail in safe guard coupling
Why?	Maintenance was not proper

Counter Measure - Coupling modified by using in house flexible flat belt and flange.

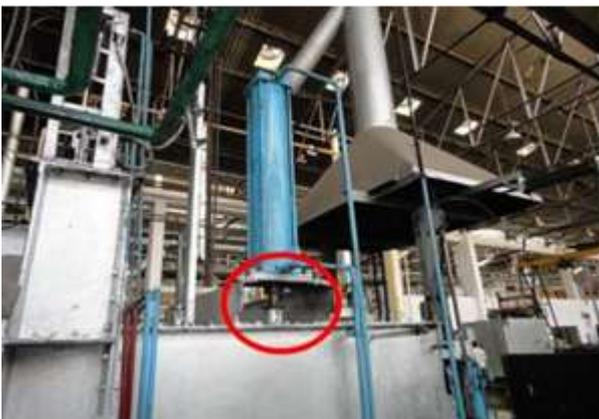
Fig - 9: Before Counter Measure

2.1.4 Break down description - Quench elevator air cylinder seal failure

Root cause - Cylinder is only 100 mm away from the furnace body

Physical phenomenon - High temperature

Problem	Quench elevator air cylinder seal failure
Why?	Piston seal leakage
Why?	Temperature is high
Why?	Cylinder is only 100 mm away from the furnace body
Why?	Original design was not proper

Counter measures - The cylinder height increased from the furnace body to 1.4m.

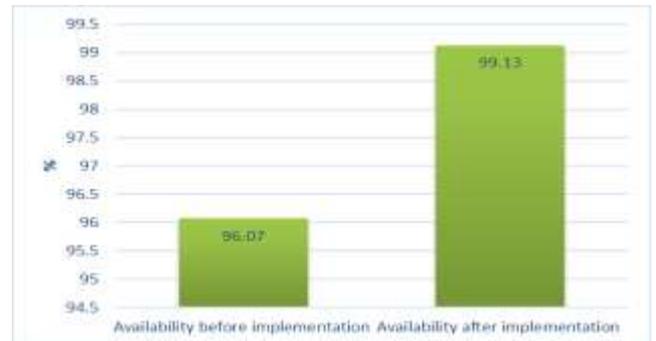
Fig - 11: Graph showing comparison of availability before and after implementation of counter measures

Availability before implementation (%)	Availability after implementation (%)	MTBF before implementation (hours)	MTBF after implementation (hours)	MTTR before implementation (hours)	MTTR after implementation (hours)
96.07	99.13	78.66	230	3.21	2

- The Availability of sealed quench furnace is increased from 96.07 to 99.13%.
- The MTBF of sealed quench furnace is increased from 78.66 to 230 hours.
- The MTTR of sealed quench furnace is decreased from 3.21 to 2 hours.
- The Effectiveness of preventive maintenance of sealed quench furnace is improved.
