ASSESSMENT OF LONG TERM DURABILITY CONSIDERATION OF CONCRETE ON COLUMNS AND BEAMS OF HEXAGONAL SHAPED CONCRETE STRUCTURE AT DELHI EARTH STATION (ISRO), DELHI, INDIA BY USING NON DESTRUCTIVE TEST METHODS

S.N. Singh¹, S.K. Dwivedi², N. Sivakumar³, U.S. Vidyarthi⁴

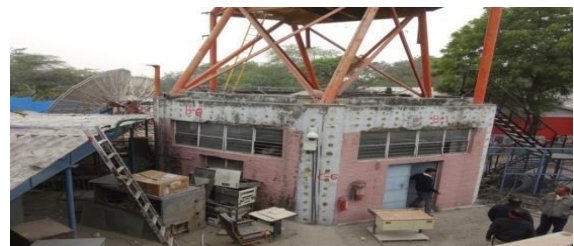
The hexagonal concrete structure is approximately 40 years old and supporting a 10.7 m diameter parabolic antenna weighing approximately 28000 kg. The concrete structure was 4.5 m above ground level. The structure was made of six concrete columns and six concrete beams connecting all the columns with a roof slab on top. No visible distresses were observed in columns. In order to assess the quality of in-situ concrete, non-destructive testing of concrete of various columns and beams of

Fig: 1 View of Concrete Structure (ISRO, Delhi)

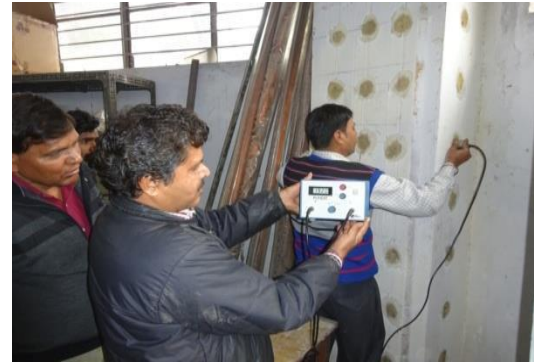
All six columns are in square section having cross section of 70cm x70cm. The non-destructive tests on the concrete columns were carried out using PUNDIT equipment. The UPV tests were conducted by direct method of pulse transmission as this is more reliable method. The test points were marked at 42 cm from ground level and thereafter 28 cm intervals vertically avoiding direct contact of stirrups on each column. Locations of stirrups were ascertained by using Micro Cover meter. UPV tests were conducted on 6 columns by the same method.

The Ultrasonic pulse velocity tests were conducted by direct method on column of size 70 cm x 70 cm at 38 test points with 70 cm path length. It was observed that out of 38 locations that were tested, 23 (60.53%) test locations indicate that concrete quality fell under good category, 7 (18.42%) test locations fell under medium category and the remaining 8 (21.05%) test locations fell under doubtful category. Overall quality of concrete was good.

Fig: 2 UPV Test by Direct Method on Column

6 columns were investigated using UPV Direct method which was most reliable had been adopted in taking the pulse readings. In all 218 points were scanned for the entire 6 columns. Based on the results, 155 (71.10%) points had indicated that in-situ quality of concrete for the entire 6 columns had been found to be good category. The quality of remaining points 63 (28.89%) varied between medium and doubtful category. Since the UPV tests indicate exclusively the quality of in-situ concrete, it was suggested to extract cores from columns having quality good, medium and doubtful to assess the In-situ compressive strength and also the depth of carbonation.

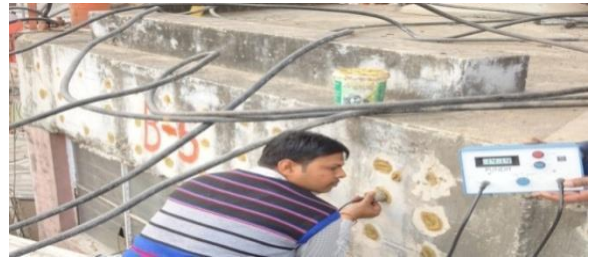
All six beams are having cross section of 50cm x 50cm with roof slab. The non-destructive tests on the concrete beams were carried out using PUNDIT equipment. The test points were marked at 50 cm from each column and then at 30 cm intervals horizontally along the length avoiding the stirrups on each beam. Locations of stirrups were

ascertained by using Micro Cover meter. UPV tests were conducted for all the 6 beams from outer and inner faces directly opposite to it in two rows by direct method.

Fig: 3 UPV Test by Direct Method on RCC Beam

6 beams were investigated using UPV by Direct method which was most reliable one. In all 127 points were scanned for the entire 6 beams. Based on the test results, 120 (94.48%) points had indicated that in-situ quality of concrete for the entire 6 beams had been found to be good category. The quality of remaining points 7 (5.51%) had been found to be medium category. Since the UPV tests indicate exclusively the quality of in-situ concrete, it was suggested to extract cores from beams having quality good and medium to assess the In-situ compressive strength and also the depth of carbonation.
