Study on Fibre Reinforced Polymer Beams with BFRP Wrapping

Abstract - In this study, research was conducted in order to determine the effectiveness of rehabilitating corroded steel beams using BFRP fabric. The fundamental objectives of this research study are the following: The change in load-carrying capacity of corroded steel beams after rehabilitation using BFRP can be determined. Any changes in ductility due to the rehabilitation can be determined. To model the behaviour of rehabilitated beams using finite element analysis. To determine the optimum thickness of BFRP needed for different percentages of corrosion using finite element models. The various characteristics of the beams with BFRP wrapping along with the failure mode and crack pattern were also studied.

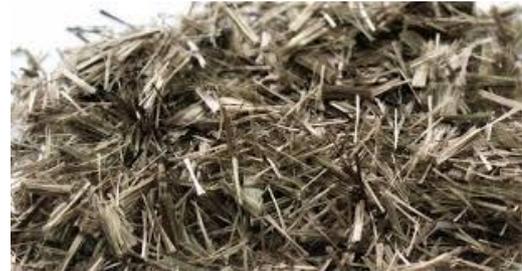
Fig -1: Basalt Fibre

The Basalt fiber reinforced polymer (BFRP)was created in 2-directional-twin type. It is naturally available and it is derived from Basalt rock that is formed by solidification of lava that comes out during volcanic eruption. Table 1 which shows the various properties of BFRP.

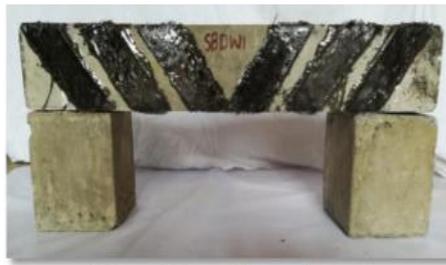
Fig -2

(a) Diagonal wrapping

For beams wrapped in diagonal manner, there have been no cracks at the initial loading stages, because the load increased little cracks began to form within the flexural zone. At the initial loading stage there started a little vertical crack within the flexural zone. Because of the loading increased, further cracks were formed and started to propagate vertically. Diagonal wraps arrested the cracks from widening. At later loading stages, these cracks tend to propagate in inclined direction. The failure mode was

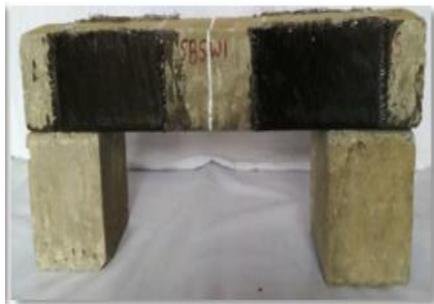
Fig -3

(b) shear zone wrapping

Failure mode and crack pattern of control beam and retrofitted beams were noted and explained on an individual basis. For control beams, since the beam specimens were weak in shear, the shear crack tends to propagate at the initial stages of loading itself. very little flexural cracks were determined within the flexural zone at later loading stages. because the load will increase, shear crack widens and propagates quickly. The specimens clearly failed in a very brittle manner with sudden destruction. both the control beams failed in same manner. Fig. 6 shows the failure patter of all beams. For beams wrapped within the shear zone, at the initial loading stage a little vertical crack regenerated within the flexural zone. because the loading will increase, these crack began to propagate slowly in vertical direction. At later loading stages, this crack began to propagate in inclined direction. The failure mode was flexural shear failure. that's BFRP wraps on the shear zone modified the mode of failure from brittle to ductile which supplies enough warning before failure. In each the beams only single crack was seen, that widened as load increased and each the beams failed in similar manner. There was no rupture or debonding of the BFRP. There was no concrete crushing Fig.3 shows the enlarged view of the crack pattern.

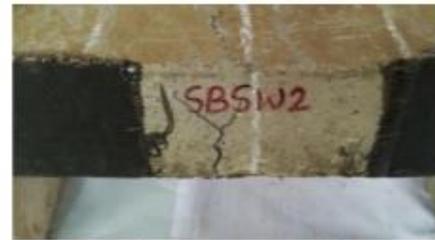
Fig-4

(a) Shear zone wrapped beam

flexural shear failure. both the beam showed similar failure behaviour. The crack width of each beams was terribly less compared to other beams. There was concrete crushing at the loading points and debonding of BFRP strips from the concrete surface. Fig.4 shows the enlarged view of failing beam.
