# COMPARATIVE ANALYSIS OF HIGH STRENGTH CONCRETE AND NORMAL STRENGTH CONCRETE COLUMNS EXPOSED TO FIRE

**Abstract** - The increased usage of high strength concrete in buildings has resulted in concern regarding the behavior of such concrete under fire. In particular, spalling at certain temperatures, as identified by performing a fire test on concrete columns in laboratories, is of particular concern. This paper provides comparative analysis of structural behavior and the principal influences of high temperature in concrete at loss of compressive strength and spalling, the unintended discharge of material from a member of high strength concrete (HSC) column and normal strength concrete (NSC) columns. Though a lot of information has been gathered on both phenomena, there remains a need for a broader understanding of the response of concrete structures to different heating rates and the performance of complete concrete structures subjected to realistic fire exposures. There is a lack of information derived from large-scale tests on concrete buildings in natural fires. So we are experimenting fire test on Four Reinforced (normal strength and higher strength) concrete columns in labora

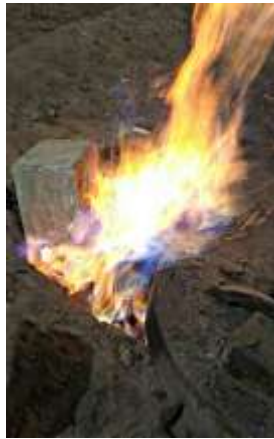
**Fig-2:** RCC columns Under Fire

The columns were installed in the furnace. Each column, exposed to fire was from all the sides. At high temperature, the stiffness of the unheated column ends, which is high in comparison to that of the heated portion of the column, contributes to a reduction in the column effective length. In previous studies, it was found that, for columns tested fixed at the ends; an effective length of 2000 mm represents experimental behaviour.

The load was applied approximately 45 min before the start of the fire test and was maintained until a condition was reached at which no further increase of the axial deformation could be measured and while columns were in fire the colour changes, formation of cracks, spalling type and time-temperature is observed. After the fire test compression test were taken after 24 hours.

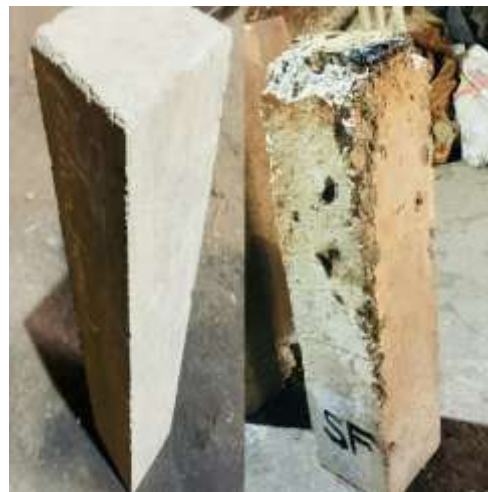
Fig-4: Spalling of column before and after

All three columns failed in compression mode or in tension mode were observed. In the NSC and HSC column, significant spalling occurred until the failure of the column is find out which is shown in table-4.

Column	Spalling type	Time (min)	Temperature (OC)
NSC 1	Minor	79	481
HSC 1	Major	88	503
HSC 2	Minor	108	576
HSC 3	Severe	98	587
