CASE STUDY ON DIAGNOSIS AND REPAIR OF FAILURES IN RCC BUILDING

The RCC structure selected for study is Residential G+ 3 apartment in Dwarka, Delhi. The age of structure is between 15-20 years. The building demonstrates various failure symptoms which is basically due to age of structure, improper drainage and further extension of structure, without technical guidance.

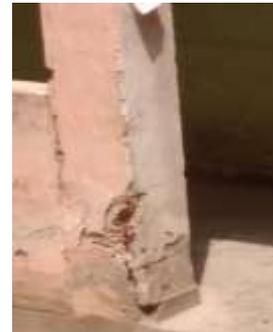
Fig -5: Cracks in Column

- Cracks in column: Thermal variation, excessive loading leads to cracks in column.

- Repair of Cracks in beam/ column

STEP 1: Remove the plaster/ finish over the surface and roughen the smooth surface.

STEP 2: Seal the cracked portion of structure by injecting or grouting polymer modified cement slurry.

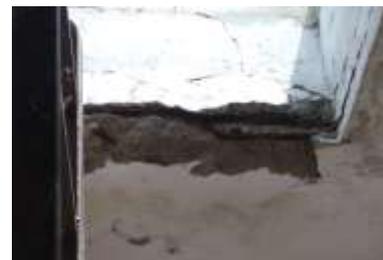
Fig -6: Spalling of concrete

- Spalling of concrete: Due to typical stresses, concrete break down into fragments, resulting in spalling of concrete.

- Repair of Spalling

STEP 1: Removal of loosen or spalled concrete.

STEP 2: Application of polymer modified cement mortar.

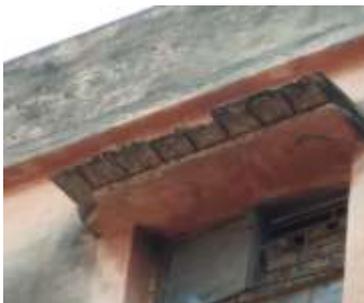
Fig -9: Failure of chajja

- Failure of chajja: Extensive spalling of concrete from chajja is observed, due to use of improper grade of concrete, water cement ratio and improper cover.

- Rehabilitation of failed chajja

STEP 1: Remove all the loose and flaked concrete.

STEP 2: Clean the corroded reinforcement with wire brush.

STEP 3: Recasting of chajja using M20 grade of concrete.

STEP 3: Apply finish coat of 1:3 cement mortar plasters.
