# Review on Restrengthening of Existing R.C Structure with Consideration of Structure Audit Report

Nidhi Jejurikar<sup>1</sup>, Prof. M.C Paliwal<sup>2</sup>, Er. Avinash Kumar Singh<sup>3</sup>

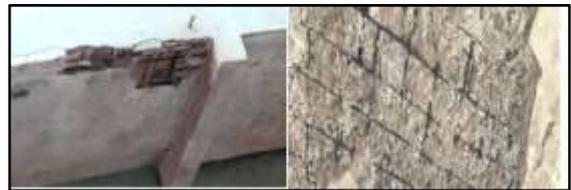
Fig.1 Spalling of concrete

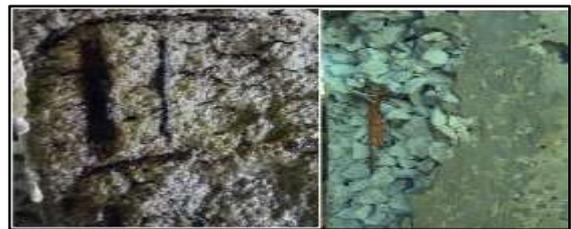
Fig.2 Corrosion action

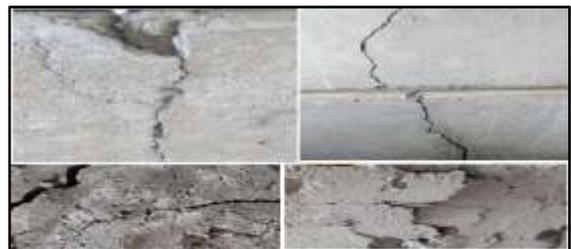
Fig.3 Structural cracks due to loading
