Repair and Rehabilitation of an Institutional Building: A Case Study

C. B. Shah School is considered as a contextual investigation for repair and rehabilitation. The site is situated in Ratansinghnagar, Sangli. The structure is developed in 1970's. This paper identifies with different parameters of structural audit and flexibility of the strategy rehabilitation of members subjected to corrosion, therefore giving clear and point by point data in regards to the repair method for the particular problem incurred in the structure.

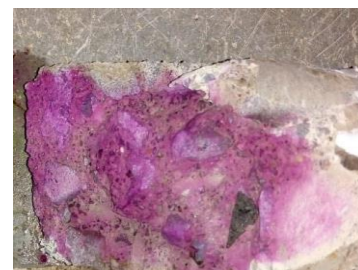
Fig -1: Carbonation test sample of Beam 02

In this test, phenolphthalein solution is used as indicator. Carbonation depth is accessed when solution is sprayed on core and concrete appears to be colorless indicating carbonation in concrete.

Sr. No	Description	Carbonation Depth (mm)
1.	Beam - 01	07
2.	Beam - 02	05
