Defects and Reasons of Poor Workmanship in Construction Industry

Abstract - The rate of construction project accomplishment is weak because of the rapid increasing rate of major defects in building as a result of poor workmanship. This paper aims to investigate the reasons which are effects on poor workmanship by survey. Based on the combination of Literature review and questionnaire survey examination of major problem of poor workmanship as a major cause of building defects. A quantitative research was conducted by sending questionnaires to the respondent who experienced in the construction. The result from questionnaire was used to analysis of three major factor of poor workmanship. And the second objective of this research is case study of building defects due to the poor workmanship. This paper helps to find out the factors which are contributing to the poor workmanship and analysis of defects in building. This help to the contractor to improve the quality performance on their construction project.

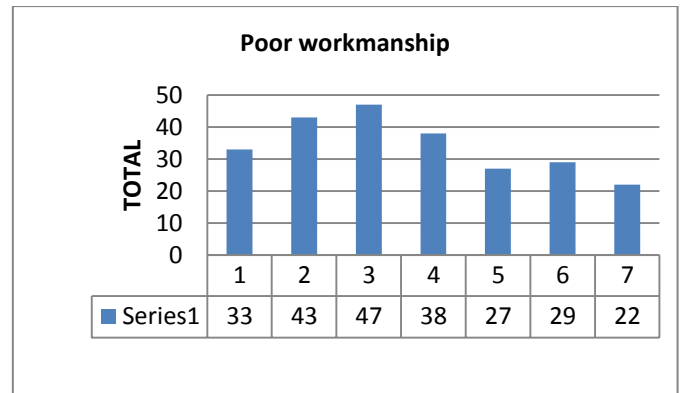
Chart - 1 graphical analysis on feedback of poor workmanship.

PARAMETERS	QUE 1	QUE 2	QUE 3	QUE 4	QUE 5	QUE 6	QUE 7
TOTAL	33	43	47	38	27	29	22
COUNT	10	10	10	10	10	10	10
MEAN	3.3	4.3	4.7	3.8	2.7	2.9	2.2
VARIANCE	0.45	0.23	0.23	0.17	0.45	0.5	0.62
SD	0.67	0.48	0.48	0.42	0.67	0.70	0.78

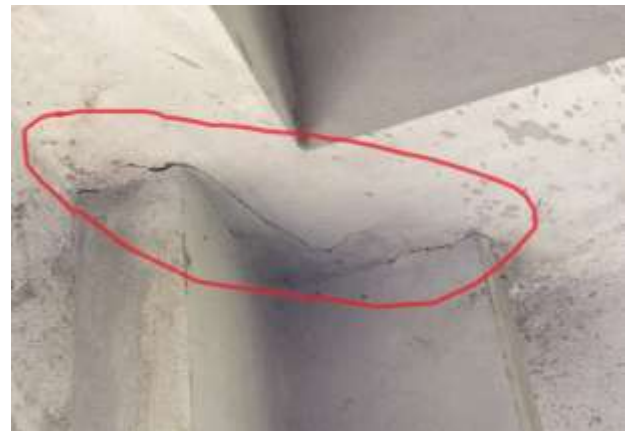
Fig - 1: Horizontal Crack at the beam-column junction.

Horizontal crack in fortified solid section is seen at the bar segment intersection, and on segment face where pliable pressure is to enormous. Segments with in satisfactory second obstruction limit, lacking fortifications, or manner of introduced support are inclined to flat breaking; due the impact of shear power and direct burden and uniaxial twisting. At long last, even breaks significantly lessen the shear quality of the section prompting an extraordinarily expanded danger of disappointment. Thus, it is required to be handled as quickly as time permits.

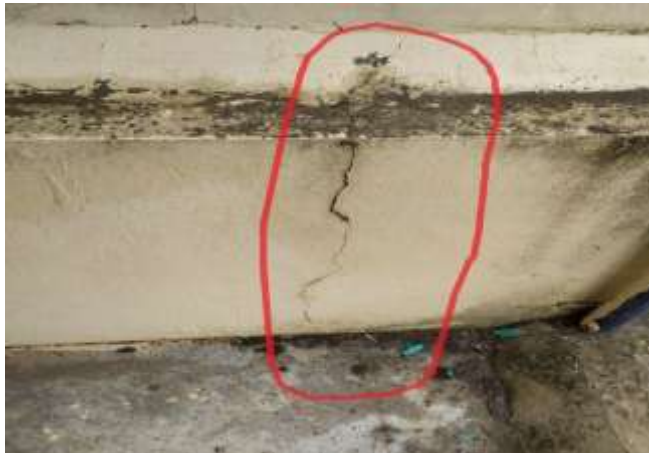
Fig - 2: Vertical cracks in concrete wall.

Vertical and slanting breaks in solid dividers regularly demonstrate establishment development. On the off chance that a vertical break augments at the top or base, the divider is either settling or step by step hurling, which may introduce major issues. Step breaks may likewise imply hurling.

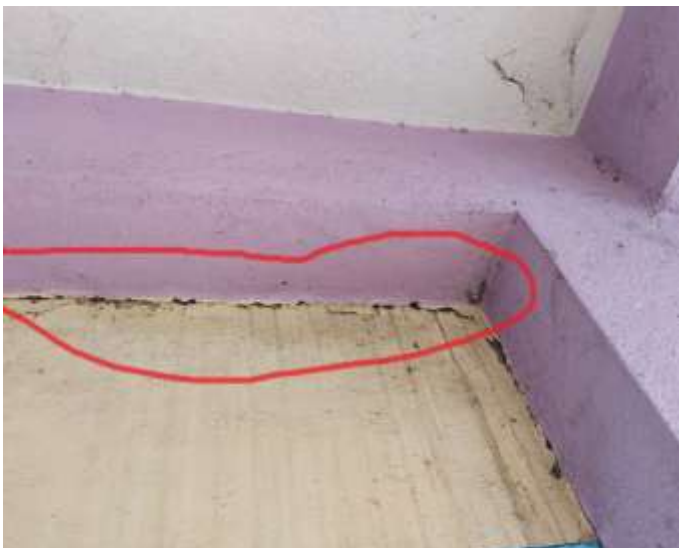
Fig - 3: Horizontal cracks in concrete wall.

Horizontal crack in solid dividers, in any case, demonstrate poor weight develop behind the divider or poor structure of divider. Dividers containing flat splits are not kidding issues because of the workmanship.

In the event that the solid encompassing the split feels moist or contains white fine stains, you may have a water penetration issue. Check whether water is spilling into the split. Spilling splits in concrete require prompt consideration.

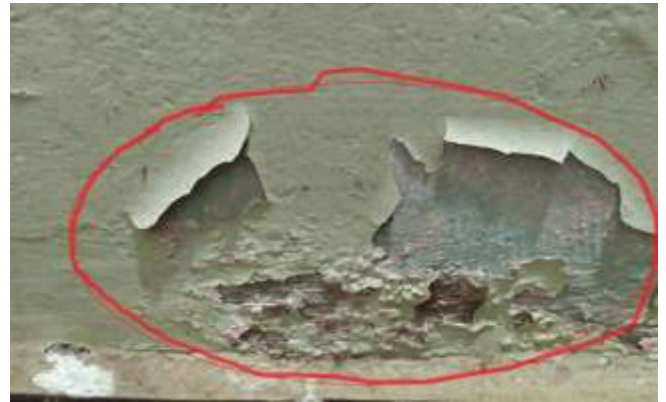
Fig - 4: Blistering Effect.

Blistering happens when air gets caught in the solid and can't break out of the seal that might be made during completing activities or brought about by a quickly setting surface. The air accumulates in spots under this water/air evidence surface seal and makes bothers. Why? One or a mix of these factors may be competent: turns blowing over strong surface and reducing surface moistness; a sub grade that is cooler than the strong; a tenacious mix with exorbitant fines that seal the surface quickly; lean mixes that must be worked nonsensically to convey needed consummations; strong that is done too early, by hand or machine; and unseemly usage of instruments. Keep some fundamental principles when finishing concrete. Air entrained diminishes depleting and grows the surface contact.

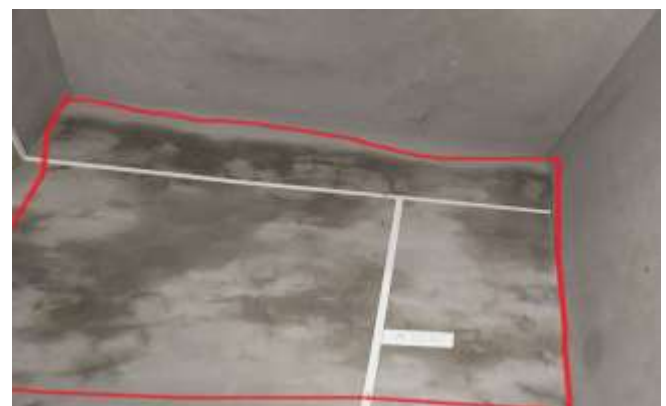
Fig - 5: Moisture defects on wall.

Dampness in building may happen because of terrible structure, flawed development and utilization of low quality of materials. Moistness influences the life of the structure as well as makes unhygienic states of the significant things of work in the development of a structure.

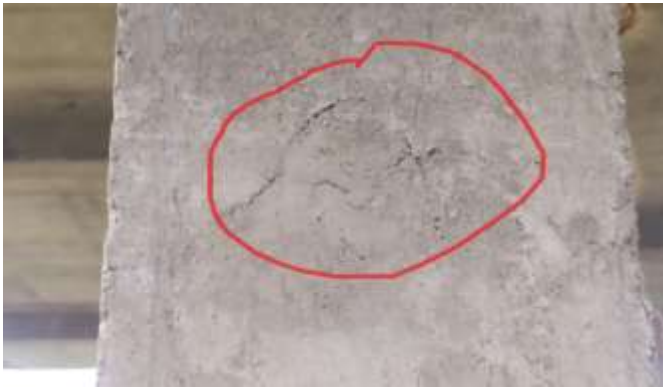
Fig – 6: Cracks in Concrete Columns

Askew cracks in fortified solid segments create and incorporate the whole essence of section anyplace along its stature. The primary driver of inclining splits in solid segments is lacking burden conveying limit of the segments; deficient cross-segment and insufficient support steel.

Horizontal crack in reinforced concrete column is observed largely at the beam-column junction and on column face where tensile stress is large. Columns with in adequate moment resistance capacity, insufficient reinforcements, or disposition of installed reinforcement are prone to horizontal cracking; due the effect of shear force and direct load and uniaxial bending. Finally, horizontal cracks reduce the shear strength of the column leading to a largely increased risk of failure. So, it is required to be tackled as soon as possible.

Splitting cracks in the reinforced concrete column are parallel vertical cracks with non-uniform width. Sections with Insufficient steel support, and low solid quality are powerless to experience such sorts of splits.

Erosion splits in solid sections are created along the line of fortifications. This sort of breaks is ordinarily uniform in width and enlarges as the segment is maturing.

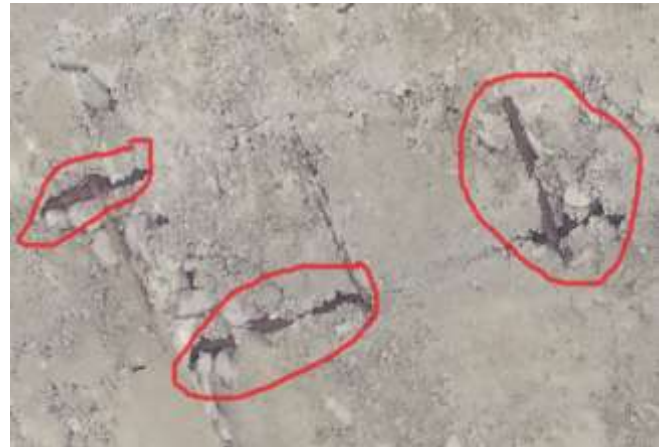
Fig-7: Improper reinforcement on slab.

Conceivable support erosion and insufficient bond among cement and steel bars are the reason for consumption fortification in solid segments.

On the off chance that such kind of breaks isn't handled the consumption of fortification would quicken extensively. A few issues can happen because of off base basic plan, enumerating, and details. Mistakes that may happen at this stage incorporate deficient thickness, inadequate support, off base geometry, inappropriate usage of materials, and erroneous itemizing. Issues experienced because of those blunders incorporate breaking because of inadequate fortification, over the top differential development because of ill-advised establishment configuration, expanded grouping of worries because of ineffectively structure re-participant and so on.
