# Case Study of Defect Due to Poor Workmanship in Construction Industry – Cracking

Savita Kadam<sup>1</sup>, Satyajeet Patil<sup>2</sup>.

<b>Project name</b>	Krushnmangal House.
<b>Address</b>	Vinayaknagar, Near VinayakMandir Islampur. Pin Code -415409
<b>Building type</b>	Residential building.
<b>No of floor</b>	G+1
<b>Name of contractor</b>	Mr. Nagesh R. Kumbhar.
<b>Construction started</b>	November 2018
<b>Date of completion</b>	December 2019

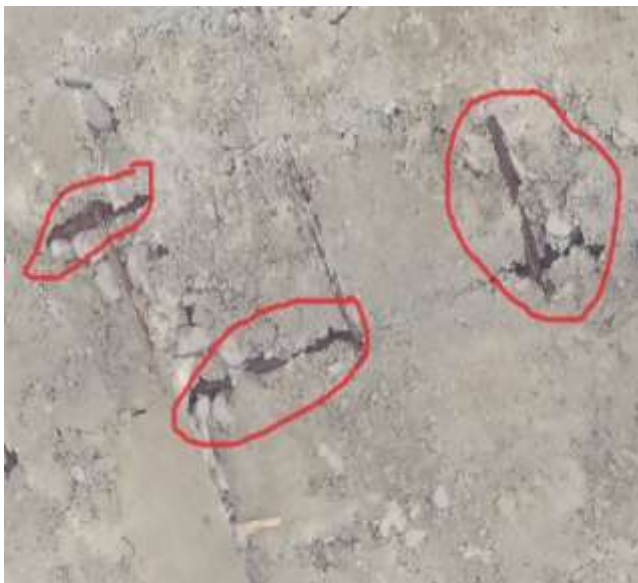
**Fig 1** – Spalling of concrete slab.

The word Spall in building portrays the chips or pieces of a material that is severed a greater article. The procedure of spalling otherwise called spallation is the surface disappointment that happens when a material, for example, solid, block, or limestone is exposed to overabundance dampness, consumption, enduring, and substantially more. Concrete Spalling ordinarily known as (solid malignant growth) is a blemish and can possibly be an outrageous risk Left untreated and presented to the components will cause broad basic harm and may make it split away from the façade, conceivably harming people in general and harming property. Spalling, at a low level, is

for the most part a restorative issue yet it can prompt auxiliary harm if not managed right away. Whenever left untreated, harm can happen to the fortifying bars inside the solid. Additionally, huge enough pieces could tumble off which could prompt genuine outcomes.

1. Consumption security is given by the measure of solid spread ensuring the steel.
2. Forestalling spallation is typically done at the start of blending the solid, by utilizing air-entrained solid, restoring great.
3. Making a point to apply a water-repellant sealer after the piece is restored. The water-repellant sealer is presumably the most basic fixing expected to forestall spallation.
4. After the solid is done however, one can utilize a Concrete Treat as a sealer on outside and indoor cement so as to keep dampness from entering.

1. Expel the solid at the spalled regions to uncover the consumed steel bars.
2. Scratch and clean the uncovered steel bars and utilizes a wire brush to evacuate the rust.
3. Apply two layers of hostile to rust paint to the steel bars.
4. Prior to fixing the region, apply a holding specialist to the influenced surface to guarantee appropriate bond.
5. Fix up the hacked region utilizing polymer altered concrete mortar.

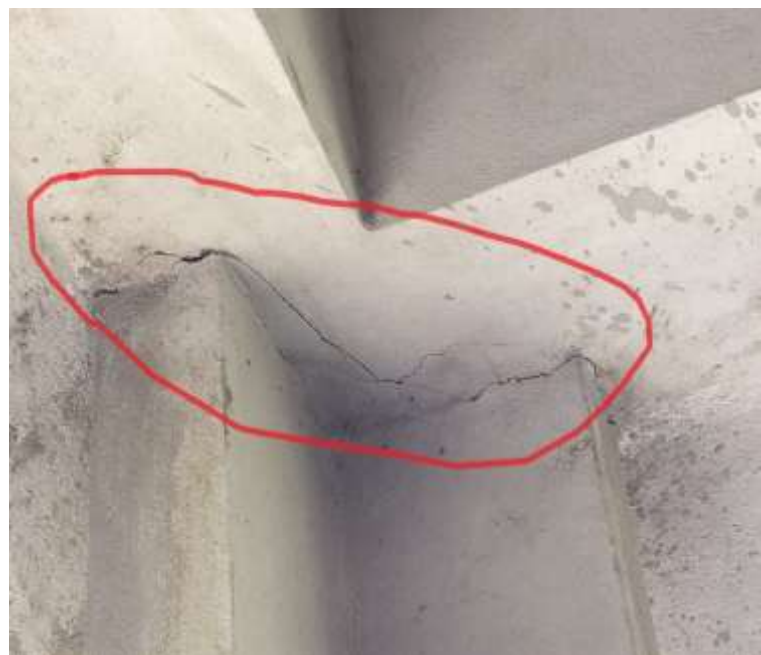
**Fig 3** - Crack on beam and column junction.

Even split in strengthened solid segment is seen to start for the most part at the bar section intersection and on segment face where pliable pressure is enormous. Segments with in satisfactory second obstruction limit, deficient fortifications, or mien of introduced support are inclined to flat splitting; due the impact of shear power and direct burden and uniaxial twisting. It happens when a material strains under pressure. At the point when two materials (having diverse flexible properties) assembled together under the impact of burden then extraordinary shear worries in these materials make breaks at the intersection. Dead and live loads are the fundamental driver of versatile twisting in any auxiliary segments of a structure.

**Preventive Measures:** Create slip joints under the help of solid section on dividers. Give flat development joints between the highest point of block board and fortified concrete solid pillar/section..

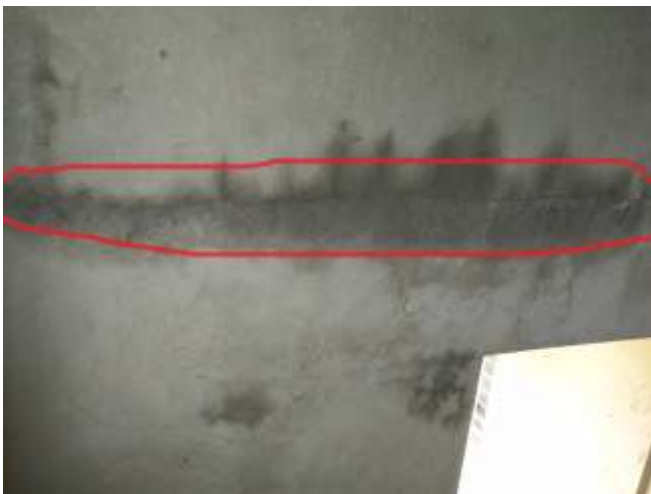
Fig 3- Horizontal crack on staircase.

The greater part of the structure materials with pores in their structure as between atomic space develop retaining dampness and therapist on drying. These developments are cyclic in nature and are brought about by increment or abatement in bury pore pressure with dampness changes. Shrinkage can be of plastic or dry. Components that cause concrete or mortar to encounter shrinkage incorporate over the top water, and concrete amount; rich concrete blends endure more prominent shrinkage..

- Provide development joints
- Use least conceivable amount of water for blending concrete cement or concrete mortar
- Compact concrete appropriately; vibrated solid endures lesser shrinkage contrast and physically compacted concrete

- Finally, maintain a strategic distance from the utilization of unreasonable concrete.

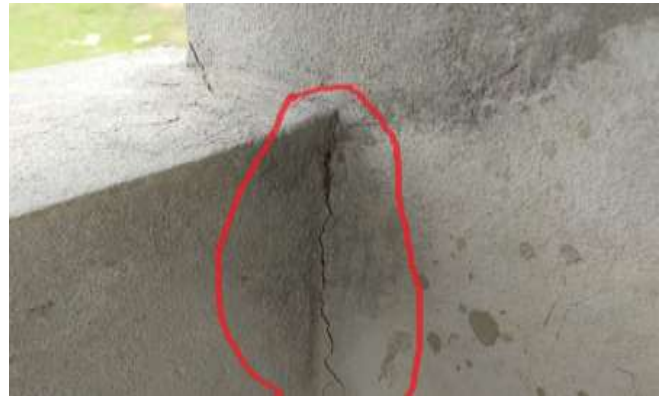
Fig -Crack at the corner

**Shrinkage** Most of the structure materials extend when they assimilate dampness from air and therapist when they are dry. Shrinkage can be of plastic or dry. The variables causing shrinkage in concrete cement and concrete mortar and their avoidances are as following.

1) **Excessive Water:** The amount of water utilized in the mortar blend can cause shrinkage. Vibrated concrete has less amount of water and lesser shrinkage than physically compacted concrete.

2) **Quantity of Cement:** when in doubt, the more extravagant the blend is, the more noteworthy the shrinkage/drying will be.

**Preventive Measures:** Use least amount of water required for blending concrete cement or concretes mortar as per water concrete proportion. Concrete cement is never permitted to work without mechanical blend and vibrator.

**Preventive Measures:** Do not utilize unreasonable concrete in the mortar blend.

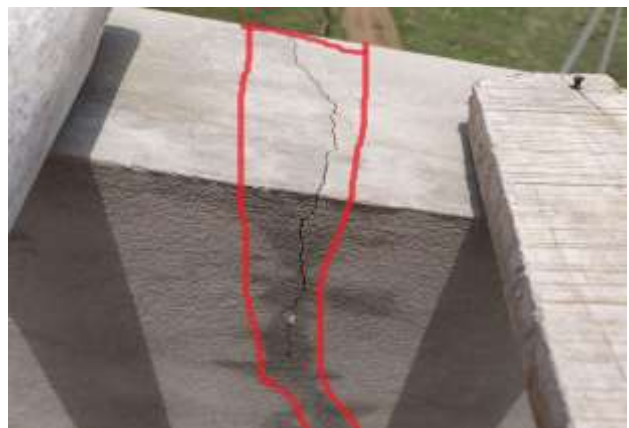
Fig 5- Crack on the Parapet wall

Thermal movement is one of the most intense reasons for breaking in structures. All materials pretty much develop warming and agreement on cooling. Surrounding

temperature changes and loss of warmth of hydration in part of structure at various rate lead to temperature varieties and resulting warm development. The warm development in a part relies upon various factors, for example, temperature varieties, measurements, coefficient of warm extension and some other physical properties of materials. Warm varieties in the inward dividers and middle floors are very little and subsequently don't cause breaking. It is primarily the outer dividers particularly slight dividers presented to coordinate sun based radiation and the rooftop which are dependent upon significant warm variety that are at risk to splitting.

Joints will be considered during the structure and developed appropriately. For instance, extension joints, development joints, control joints, and slip joints.

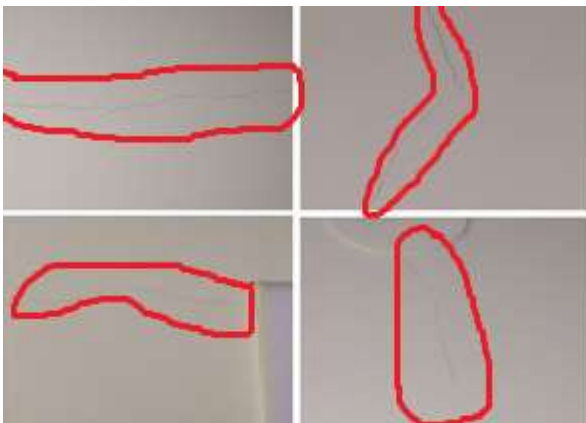
**Fig 6-Hairline Cracks on Wall.**

Divider breaks are genuinely regular in both new and more established homes and are frequently the consequence of typical house "settling" that can rapidly, cheaply be cured by re-taping the joints—the creases where the drywall boards meet. Every so often, in any case, splits in dividers connote a bigger issue that ought to be tended to before you endeavor to fix the break. Here's the manner by which to decide whether the break is hailing a major issue, and what steps to take to get your divider back fit as a fiddle.

Hairline splits over entryways and windows are likely because of settling. Places of all ages move and move unobtrusively after some time, and the most fragile region in a divider is the well on the way to break. A divider is built with vertical studs that reach out from floor to roof. The studs must be cut, be that as it may, so as to introduce an entryway or a window. While the manufacturer adds additional confining to the adjoining studs, these regions are as yet more fragile than the remainder of the divider, and when settling happens, these spots are the first to create splits. Hairline breaks across dividers and entryways don't demonstrate an auxiliary issue; they ought to just be re-taped and painted.

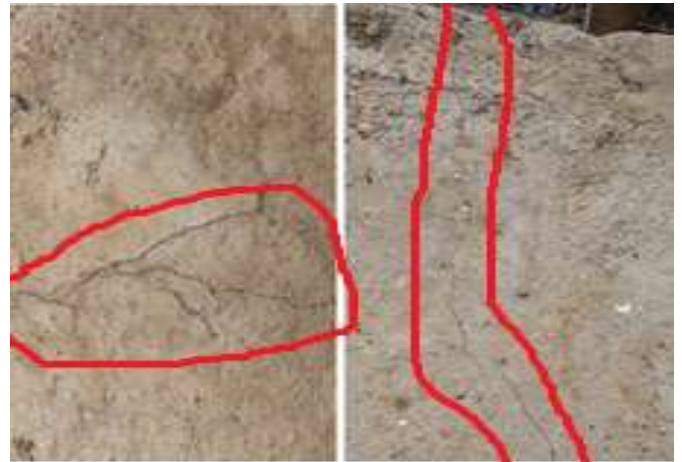
**Fig 7- Cracks on slab.**

Unforeseen splitting of cement is a continuous reason for grievances. Splitting can be the consequence of one or a mix of components, for example, drying shrinkage, warm compression, limitation (outer or interior) to shortening, subgrade settlement, and applied burdens. Breaking can be altogether diminished when the causes are considered and deterrent advances are used. For instance, joints gave in the structure and introduced during development power splits to happen in places where they are subtle. Splits that happen before solidifying for the most part are the consequence of settlement inside the solid mass, or shrinkage of the surface.

Breaking in cement can be diminished altogether or dispensed with by watching the accompanying practices:

1. Utilize appropriate subgrade planning, including uniform help furthermore, appropriate sub base material at satisfactory dampness content.
2. Limit the blend water content by augmenting the size and measure of coarse total and utilize low-shrinkage total.
3. Utilize the least measure of blend water required for usefulness; try not to allow excessively wet textures.
4. Dodge calcium chloride admixtures.
5. Give compression joints at sensible stretches, multiple times the chunk thickness
6. Give detachment joints to keep limitation from abutting components of a structure.
7. Forestall outrageous changes in temperature.
