ASSESSMENT OF LONG TERM DURABILITY CONSIDERATION OF CONCRETE ON COLUMNS AND BEAMS OF CONCRETE STRUCTURE (BUILDING) BY USING NON DESTRUCTIVE TEST METHOD

1.0 INTRODUCTION

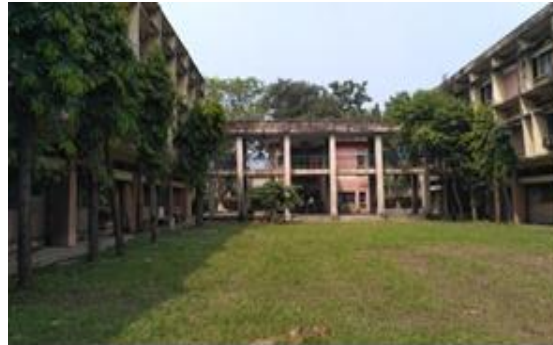
The concrete structure (building) having two blocks (Block A & Block B) was constructed 40 years ago. It was decided as a part of maintenance of building, the structural health assessment of building was required for checking the quality of concrete which was essential for developing methodology for repair and strengthen of building. In this regard, Non-destructive tests were conducted on columns & beams of building by Ultrasonic Pulse Velocity method for assessment of in-situ quality of concrete.

Fig: 1 View of Concrete Structure (Building)

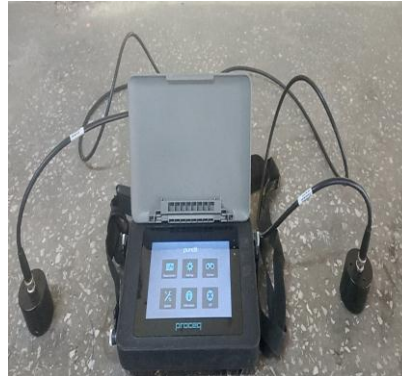
Pulses of longitudinal 'P' waves are produced by an electro-acoustical transducer which is held in contact with one surface of the concrete under test. After traversing a known path length L in the concrete, the pulse of vibrations is converted into an electrical signal by a second transducer and electronic circuits enable to determine the transit time T of the pulse to be measured.

Fig: 2 Ultrasonic Pulse Velocity Test Equipment (Proceq Model- PL 200)

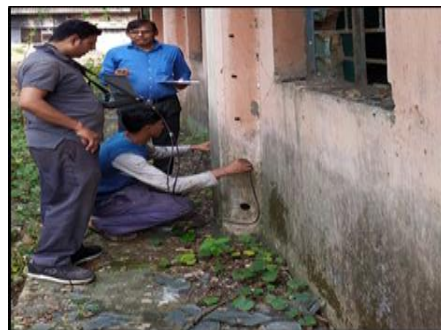
The Ultrasonic pulse velocity tests were conducted by direct method on column of size 50 cm x 50 cm at 30 test points with 50 cm path length. It was observed that out of 30 locations that were tested, 25 (83.33%) test locations indicate that concrete quality fell under good category, 4 (13.33%) test locations fell under medium category and the remaining 1 (3.33%) test location fell under doubtful category. Overall quality of concrete was good.

Fig: 3 UPV Test by Direct Method on Column

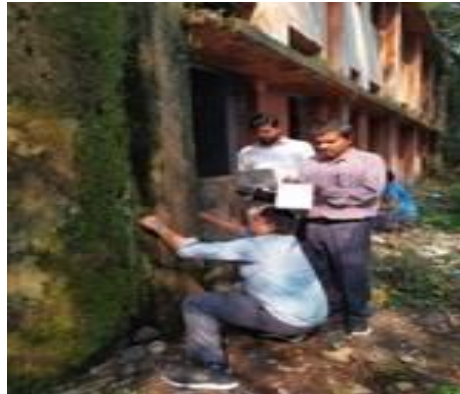
All columns (24 Nos. for block A & block B, 12 Nos. for each block) were in square section having cross section of 50cm x50cm. The non-destructive tests on the concrete columns were carried out using PUNDIT equipment. The UPV tests were conducted by direct method of pulse transmission as this is more reliable method. The test points were marked at 20 cm from ground level and thereafter 30 cm intervals vertically avoiding direct contact of stirrups on each column. Locations of stirrups were ascertained by using Micro Cover meter. Columns were selected for UPV tests on visual inspection and UPV tests were conducted on 16 columns (8 columns for Block A & 8 columns for Block B) by the same method.

Fig: 4 UPV Test by Direct Method on Column

16 columns (Block A & Block B of building) were investigated using UPV Direct method which was most reliable had been adopted in taking the pulse readings. In all 480 points were scanned for the entire 16 columns. Based on the results, 389 (81.04%) points had indicated that in-situ quality of concrete for the entire 16 columns had been found to be good category. The quality of remaining points 91 (18.95%) varied between medium and doubtful category. Since the UPV tests indicate exclusively the quality of in-situ concrete, it was suggested to extract cores from columns having quality good, medium and doubtful to assess the in-situ compressive strength and also the depth of carbonation.

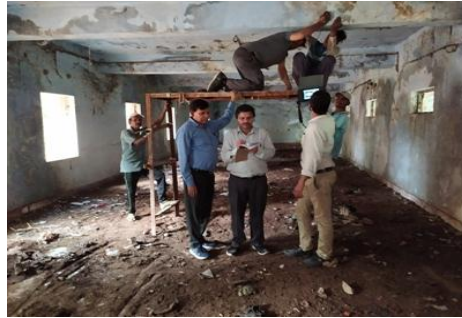
It was observed that out of 30 locations that were tested, 25 (83.33%) test locations indicate that concrete quality fell under good category and 5 (16.67%) test locations fell under medium category. Overall quality of concrete was good.

Fig: 5 UPV Test by Direct Method on RCC Beam

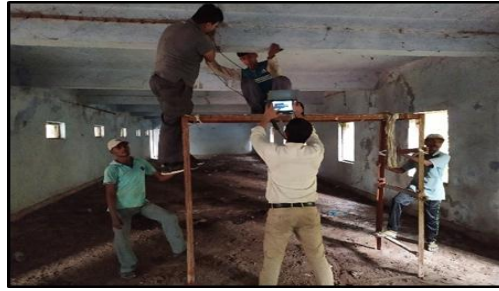
All beams (12 Nos. for block A & block B, 6 Nos. for each block) were in cross section of 40cm x 40cm with roof slab. The non-destructive tests on the concrete beams were carried out using PUNDIT equipment. The test points were marked at 20 cm from each column and then at 30 cm intervals horizontally along the length avoiding the stirrups on each beam. Locations of stirrups were ascertained by using Micro Cover meter. Beams were selected for UPV tests on visual inspection and UPV tests were conducted on 8 beams (4 beams for Block A & 4 beams for Block B) from outer and inner faces directly opposite to it in two rows by direct method.

Fig: 6 UPV Test by Direct Method on RCC Beam

8 beams (Block A & Block B of building) were investigated using UPV by Direct method which was most reliable one. In all 240 points were scanned for the entire 8 beams. Based on the test results, 199 (82.91%) points had indicated that in-situ quality of concrete for the entire 8 beams had been found to be good category. The quality of remaining points 41 (17.08%) varied between medium and doubtful category. Since the UPV tests indicate exclusively the quality of in-situ concrete, it was suggested to extract cores from beams having quality good, medium and doubtful to assess the in-situ compressive strength and also the depth of carbonation.
