Infill Walls in an Existing Reinforced Concrete Building During Seismic Motion

Abstract: Earthquake is a challenging occasion for the buildings located in seismic zone. There are many studies in order to examine the behavior of the building during earthquake and prevent the damages and losses caused by earthquake. Studies on infill walls are very popular even it is believed they are used as only the architectural elements. Even though it is known that they affect the structural behavior of the building, they are neglected considering that they have lost their load bearing capacity at the beginning of the earthquake. It is aimed in this paper to show that all of the infill walls are not in damage state even if seismic motion totally complete. According the results, while the inner infill walls has no damage, the outer ones up to Xth floor on X direction and Yth floor on Y direction lost their capacity.

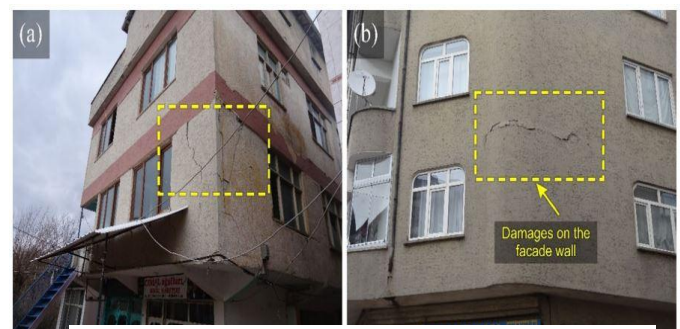
Fig. 1. Infill walls states after Sivrice earthquake in 2020

Besides previous analytical and experimental studies about the effects of infill walls, the field investigations after earthquake proves that not all of infill walls are damaged in buildings and continue to make important impact on the performance of buildings. The photos taken after the Wechuan Earthquake for determination the failure type of buildings by Zhao et al. shows that infill walls even in some damaged buildings are still standing on [9]. The same views of infill walls can be found after Van Earthquake which hugely influenced the people [10]. In an investigation after Gorkha Earthquake in Nepal is stated that the non-structural damages occurred mostly in low-rise buildings and also the failure of infill walls enabled people to stay in safe. It is also shown in this paper that there are most of building with undamaged infill walls [11]. It is clearly seen in the Fig.1 that even if some of infill walls cracked, most of the infill wall could resist the strong ground motion [12].

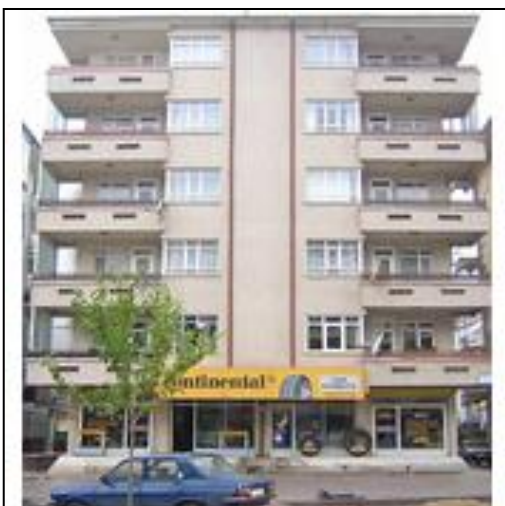
Fig. 2. Investigated Building

In this paper, an existing and still in use reinforced concrete (RC) building from Turkey is used by implementing nonlinear dynamic analysis for testing of the objective. The illustration of the building is given in Fig. 2. X direction of the building is accepted as the short side of the plan and the Y direction is along the long side of the plan. The building has 7seven story and 3-meter height between each floor. It is known that the building built in 1989 by the rules of TEC in 1975 [13]. Therefore, it is considerably appropriate to represent current RC building stock both in Turkey and also other earthquake-endangered regions.

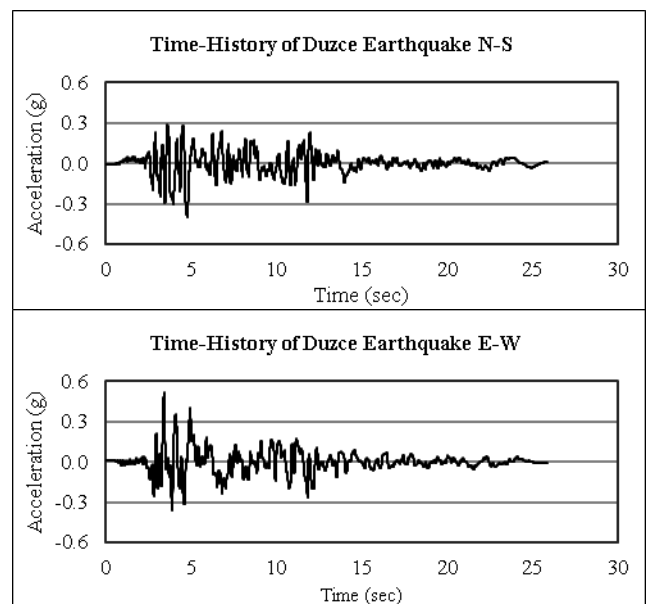
Fig. 3. Time histories of Duzce Earthquake in 1999.

The state of infill walls is observed by using of nonlinear dynamic analysis which is the best way to obtain more correct consequences. The SAP 2000 v.20.1.1 package program is preferred to model and analyze [14]. The ground motion used in analysis is selected as Duzce Earthquake from Turkey with 7.1 magnitude. The time histories are demonstrated in Fig. 3.

These time histories need to be scaled to account impact of the soil type. Scaling was done via SeismoMATCH package program considering as the soil class ZC defined in TEC-2007 [15-16]. The response spectrum graph of the ZC soil class and the scaling are shown in the Fig 4 and Fig. 5.

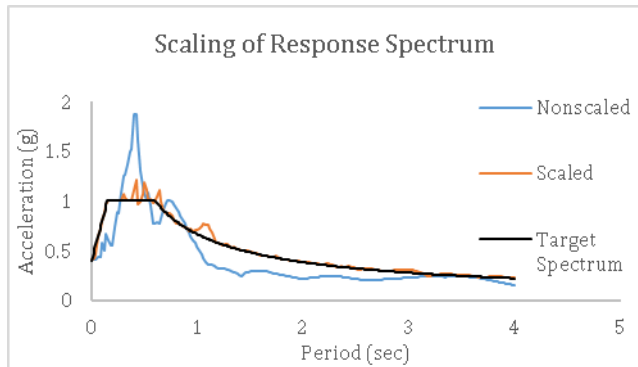
Fig. 5. Scaling of acceleration

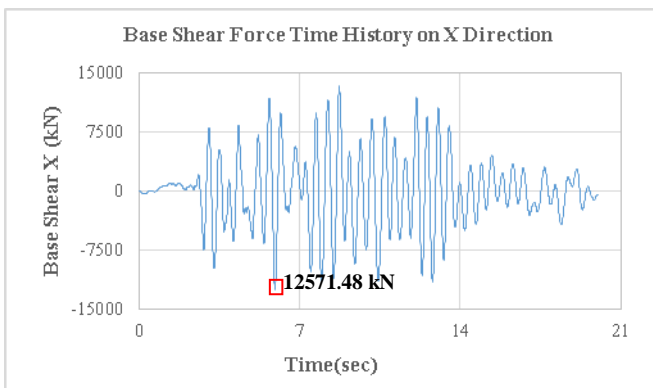
Fig. 8. Base shear forces along X direction during Duzce earthquake

Moreover, it can be seen in Fig. 7 the deformed shaped and the hinges states of the building. Also, the basic outputs of dynamic analysis are given with from Fig. 8 to Fig.12 by being shown on the maximum value for each. Fig. 6 shows the change in base shear force with time along X direction. Fig. 7 displays change in the base shear force with time along Y direction. The top displacement outputs are demonstrated by Fig. 8 and 9 for X and Y direction respectively. According to these results, while the maximum base shear force was 12571 kN for X direction, 13759 kN for Y direction. Top floor of the building could displace utmost almost 7 cm along X direction and approximately 5 cm along Y direction. Additionally, when Fig 3. And dynamic outputs are compared mutually, it can be said that while the earthquake was more effective within first 7 seconds on Y direction, on X direction the effectiveness of seismic motion lasted longer.

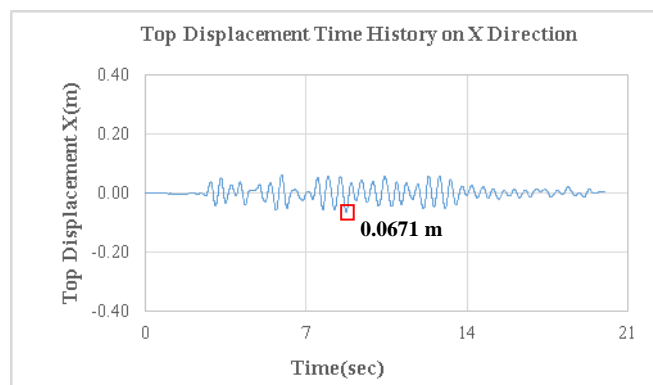
Fig. 10. Top displacements along X direction during Duzce earthquake

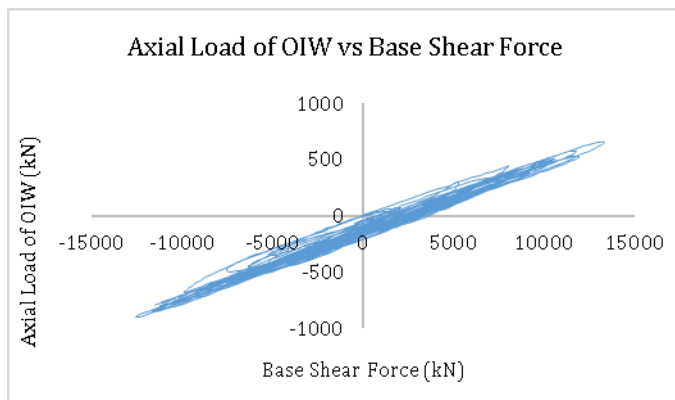
Fig. 12. Axial load of an outer infill wall (OIW) which has the maximum demand and base shear force relationship

- 3-) From the relationships graphs, it is seen that the damage in infill wall perfectly correlated by the base shear force and top displacement.
- 3-) After the time maximum displacement occurred for both sides, it is not observed remarkable infill wall failure.

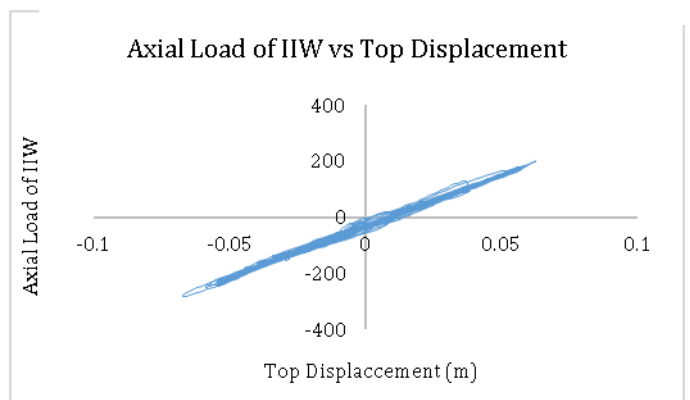
Fig. 15. Axial load of an inner infill wall (IIW) which has the maximum demand top displacement relationship

- 4-) It is clear seen that inner infill walls have less danger in terms of damage occurrence. In this building, only %8 of inner walls was able to exceed half of axial load capacity.

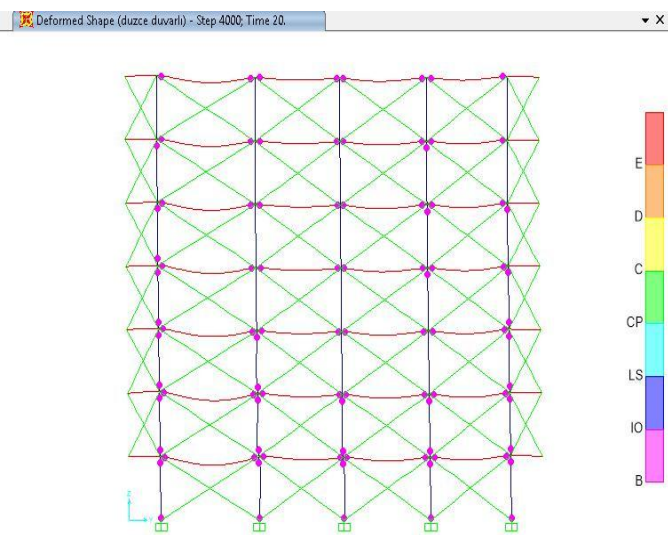
Fig. 18. Inner infill walls damage states along Y direction at the end of ground motion

In Fig. A and Fig. B display the sides of the building that received the highest number of damaged outer infill wall at the end of the earthquake along both directions. It is obviously clear that there were not failed infill wall in the top three floor along X direction. Along Y direction, the number of floor having undamaged outer infill walls was two. In addition, to exemplify of the inner infill walls state, the failure shape of a frame with inner infill wall at the time earthquake finished is given by Fig. C.
