Seismic behavior of retrofitted RC frame with prefabricated RC wall panel under cyclic loading

ABSTRACT

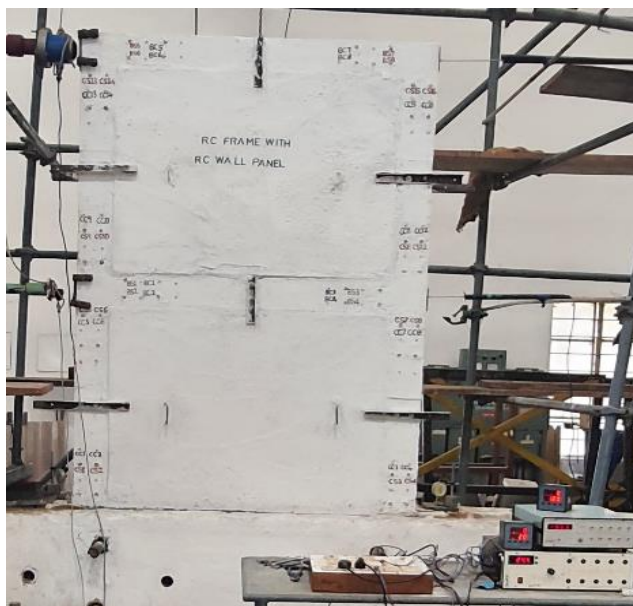
Fig -4: Test set up

Load cell of 1000KN and 50KN are fixed at the top and bottom storey respectively. Instrument for measuring the deflection (LVDT) is also fixed opposite to the load cell arrangement. Rigid body rotation of foundation block is measured using dial gauges placed on both sides of foundation. Strain measurements are taken using Demec strain gauge. Display units such as LVDT and Load cell units are placed. Hydraulic pumps are used for the application of load.

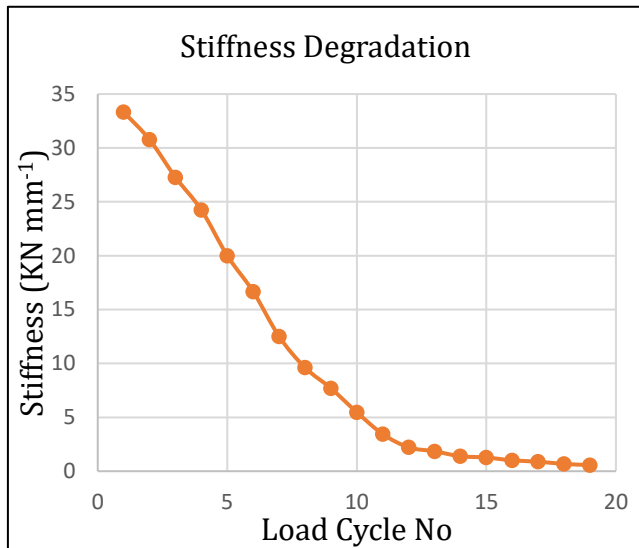
Chart -3: Stiffness Degradation

The stiffness tends to decrease due to the column crushing, bond failure and energy dissipation. Stiffness degradation occurs from 33.33 to 0.57 KN/mm for about 19 cycles.

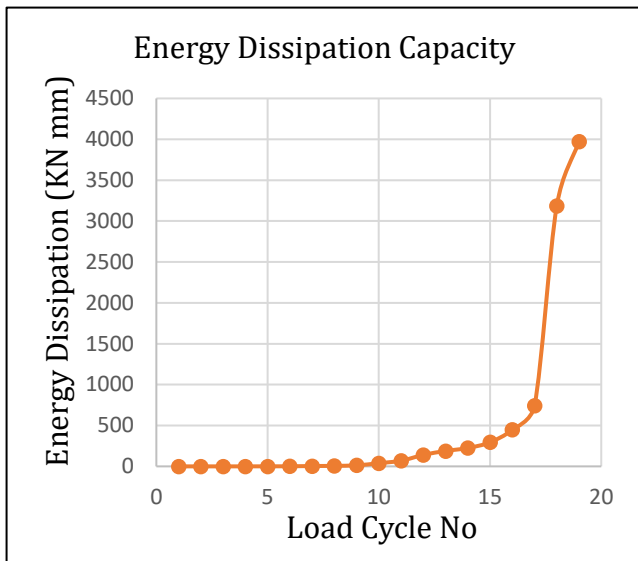
Chart -6: Energy Dissipation Capacity

The energy dissipation capacity of the frame during various load cycles was calculated as the sum of the area under the hysteresis loops from the load versus the top storey deflection diagram obtained. The energy dissipation capacity during the first cycle of loading was 0 KN mm and that during the 19th cycle was 3973 KN mm. The energy dissipation capacity values are calculated for all cycles and the variation of energy dissipated by the frame during each cycle is shown in chart -6.

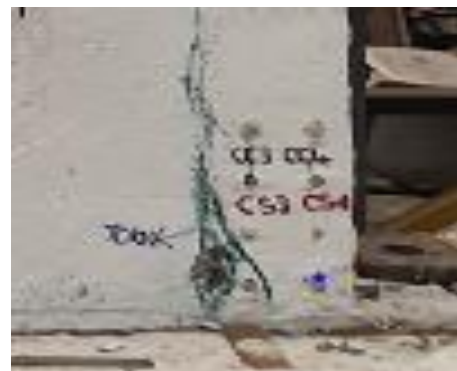
- At 70 KN, several minute cracks appeared at the windward column at 600mm from the foundation. Due to diagonal compression strut action, the bottom storey panel to frame crushing has initiated. Similarly, the top storey panel exerts compression behavior on the beam-column joint of the first storey.

Fig -11: Corner crushing

The failure pattern confirms that the stiffness of the wall panel is more compared to the stiffness of the RC frame. This had led to the early failure of the structure before reaching its ultimate capacity. The stiffness of the prefabricated wall panel can be reduced by decreasing the thickness of the panel to have a better interaction between the frame and the panel. As the in-plane loading on the panel continues, there is a separation initiated at the interface of the wall panel and the frame members (beam and column) at the off-diagonal corners. Once a gap is formed, the stresses at the tensile corners are relieved while those near the compressive corners are increased. As the load continues to increase, further separation occurs between the wall panel and the frame, resulting in contact only at the frame sections near the loaded corners. Due to this behavior of the RC wall frame, it resembles a braced frame with one diagonal member (compression). This compression strut action increases the shear demand more on the beam-column joints causing the early failure of the structure without reaching its maximum potential. The main reason for the debonding of the panel from the frame on the off-diagonal corners was due to the greater strength and stiffness of the wall panel compared to the frame. Thus, the intended purpose of providing the wall panel to resist the seismic forces is not met out. Another main failure pattern observed is the top storey cover crushing due to increased compressive load on the corners of the frame. Due to this effect, further load transfer becomes difficult and thereafter the concrete core starts taking the load. Once the frame reaches its peak load, the load carrying capacity reduces gradually but the frame starts yielding at a higher rate. The test is stopped when the bottom storey beam-column cover got separated from the concrete core.

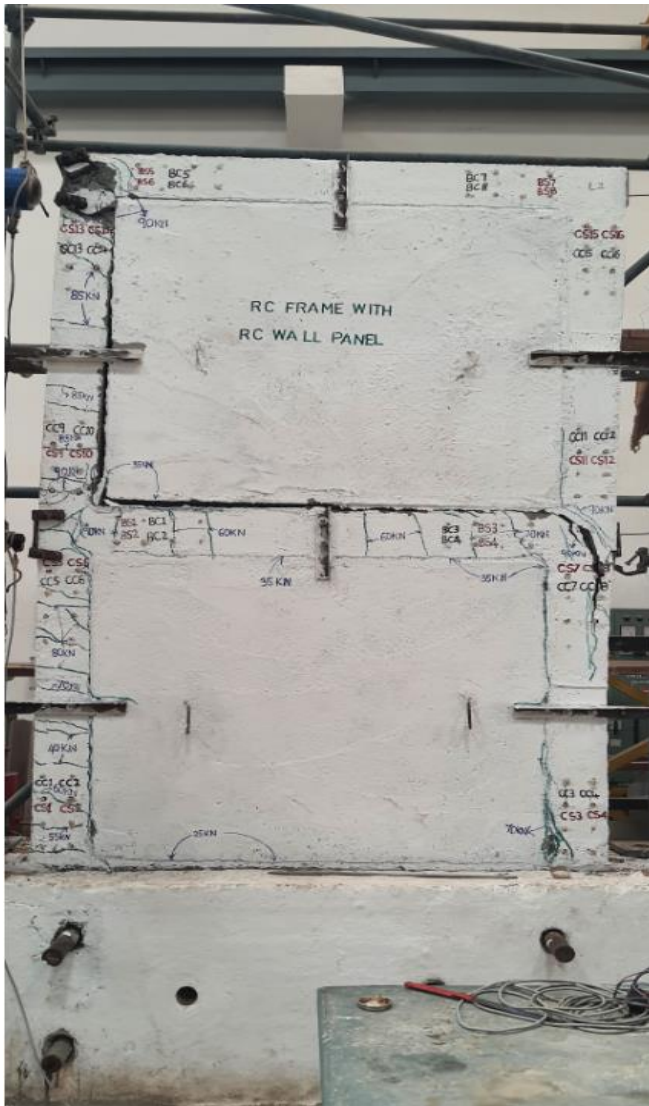
- At 90 KN, the top story concrete crushing occurred which further increased diagonal cracking at the first storey beam-column joint. This is the peak load of the frame which caused a deflection of 156.9 mm.

Fig - 12: Maximum deflection of RC frame with RC wall panel

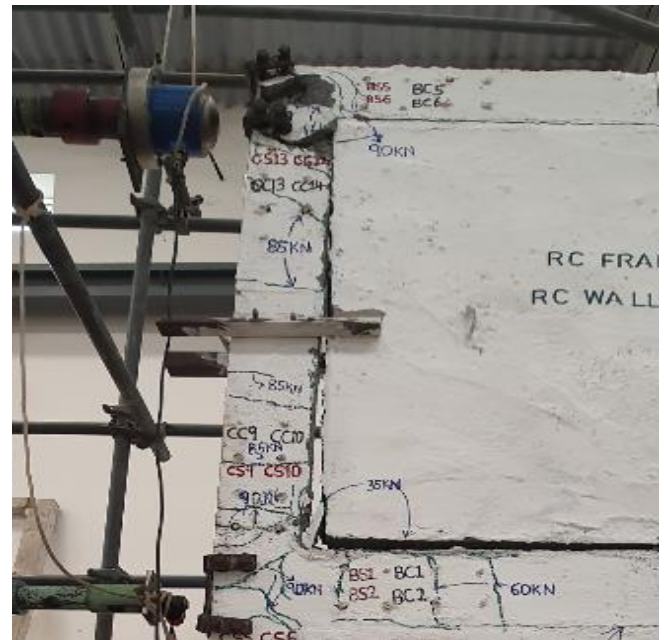
- At 80 KN, several cracks are found at the windward column and appear throughout the column width.
- At 85 KN, the top story cover crushing has initiated, and minute cracks were found at the windward top story column.

Fig -14: Top storey cover crushing

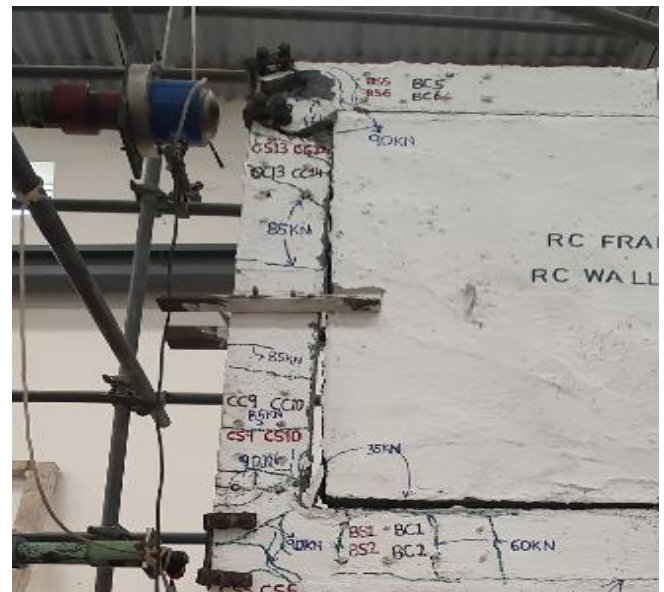
Fig -15: Debonding of wall panel

As per the analytical modelling, the maximum strains are concentrated at the beam-column joints and minimum on the wall panels. This effect is analogous to that of the experiment as the major cracks are formed on the joints. Also added to that there is a debonding of the wall panel from the frame as the load cycle increases. The load carrying capacity and the deformation obtained in the analytical procedure are lesser compared to the experimental values. This may be due to minor variations while performing the test.

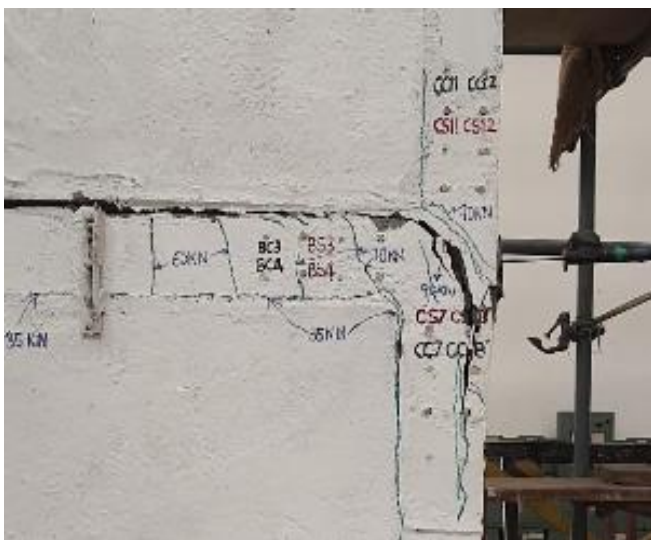
- At 80 KN, the frame yields to a maximum deformation of 166.8 mm. At this load the beam-column joint of the first story cover has separated from the core frame. After the cover separation, the testing is stopped, and the final deformations are noted.

Fig -13: Joint failure

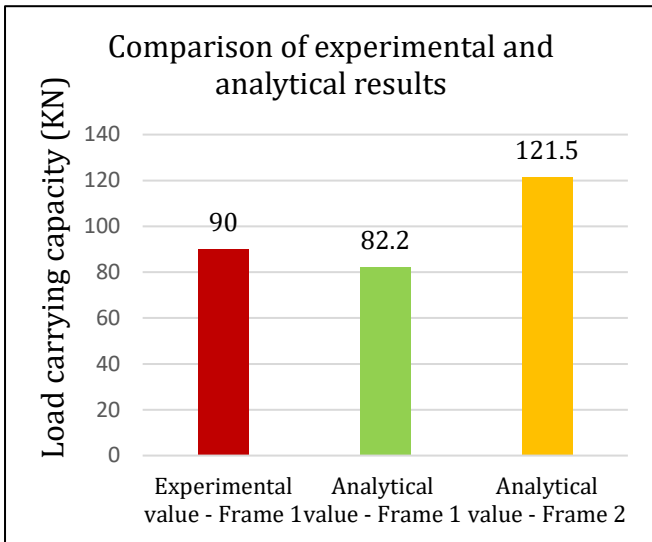
Chart -9: Strength comparisons of frames

special mortar is laid over the fibre. The overall thickness of the layers is 8.6mm. The thickness is limited to 10mm to avoid delamination of the layers. The retrofitted frame has a higher load carrying capacity of 121.5kN with a lateral deformation of 142.88mm. Also, the frame members have lesser strain concentration in the beam-column joints compared to the normal frame. This proves that the retrofitting process yields higher strength and lesser damage to the structure.
