SEISMIC STRENGTHENING OF NON-ENGINEERED SCHOOL BUILDING IN STONE MASONRY IN THE STATE OF GUJARAT

Chandrark Bhavsar¹, Ms.Megha Bhatt²

¹PG Student, M.E.(Civil) Infrastructure Engineering, L.D.R.P. Institute of Technology & Research, Gandhinagar

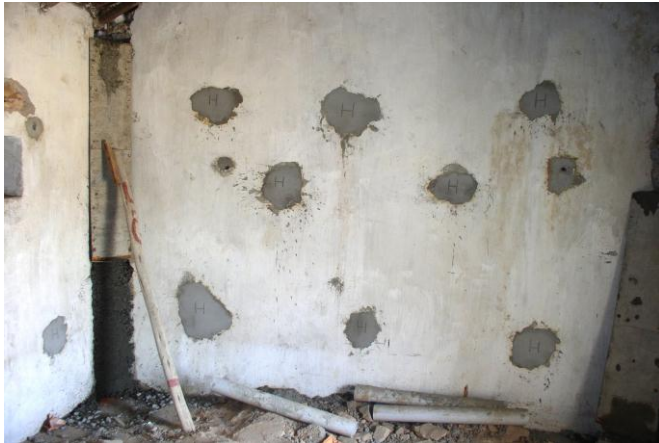
(1) Header stone :URM or in stone masonry walls ,stone Stitching the outer and inner wythes (stone layers) of the stone walls by the installation of reinforced concrete *headers*

or 'bond' elements to serve as 'through' stones, so as to prevent de lamination.

Fig-1: Wall with Header stone

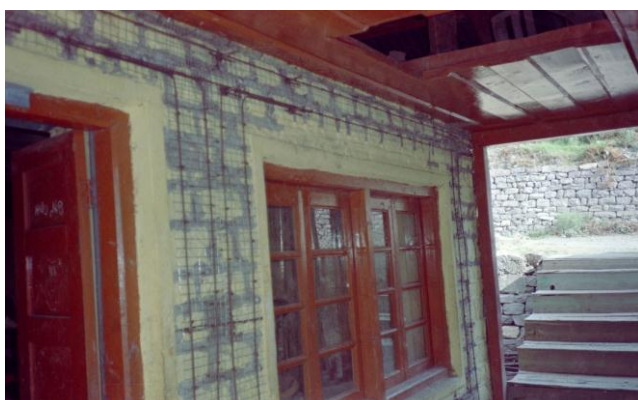
It is provided to ensure the action of the walls together to resist the lateral seismic forces effect on the entire building preventing the separation of the walls at the corners of the building, and installing cross ties across rooms connecting the seismic belts on the opposite walls. These ties acting in conjunction with the belt will hold the opposite walls together to improve the integrating action of the bands further. Similarly Vertical belts also provided connecting and stretching up to all all levels of horizontal belts to the foundation of the wall footing.

Welded wire mesh belts is provided for the same along with 6 mm steel wires fixed to the wall with masons nails and washers. This will allow the belts in their proper horizontal and vertical position.

Fig-2: Horizontal and Vertical Seismic Belts

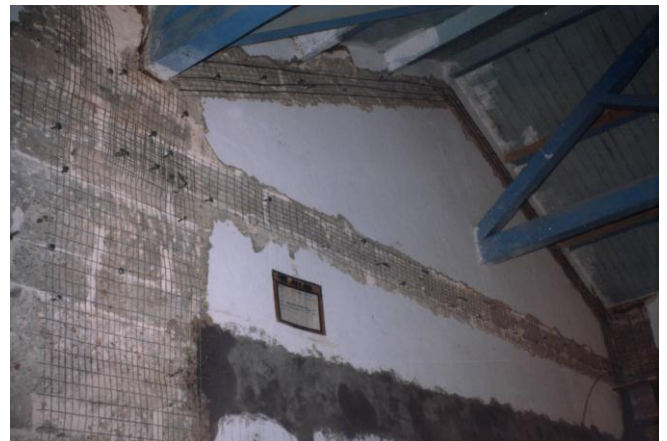
For wall height above lintel levels , where double pitched heavy joist and purlin truss is rested on the lintels and walls and gable ends being heavy stone masonry construction, Gable shaped welded wire mesh belt is also provided in the same manner as that of the horizontal and vertical seismic belts and also they are to be fixed with each other. This arrangement provide maximum integrity to the high walls constructed in stone and with heavy roofing system.

Fig-3: Gable Bends

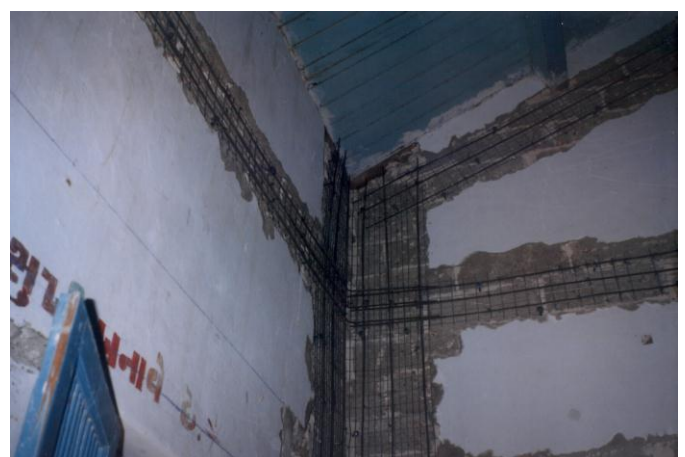
To prevent separation of two adjoining wall , corner belt along with vertical reinforcement of 6mm diameter is to be fixed with masons nail and washer

Fig-4: Corner belt with vertical reinforcement

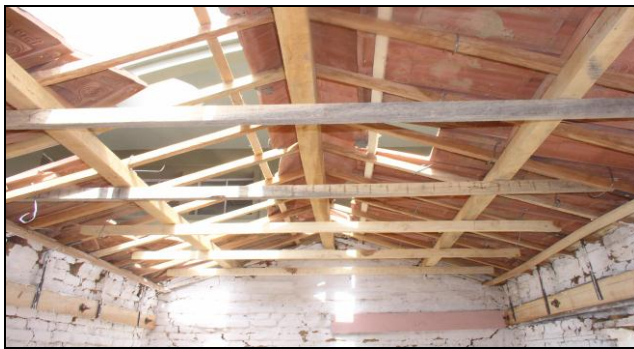
For Pitched roof with wooden joist , purlin and rafter type of roof with clay tiles or Manglore pattern tiles , cross wooden

bracing is to be provided to fix all the members from the bottom and ties with galvanized wire.

Fig-5: Wooden in-plane Bracing
