Highway Failure and Their Maintenance: A Study of Amravati City, Maharashtra.

Abstract

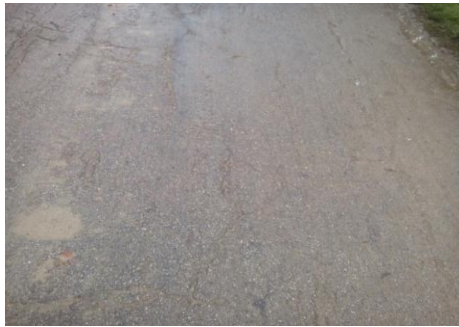
Longitudinal breaking is situated close to Yashoda Square. It permits dampness invasion, underlying disappointment. It is caused because of temperamental base, unfortunate development. Surface dressing is utilized to fix this break (Figure 7).

Figure 7 Longitudinal cracking at Yashoda Square

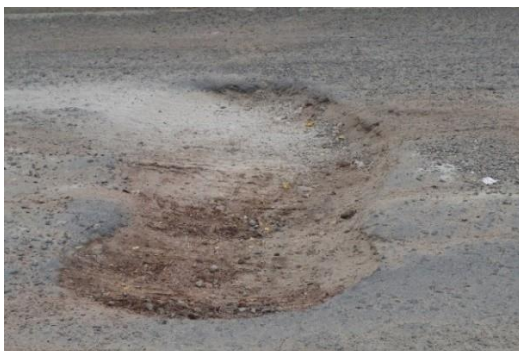
Pothole is the most well-known disappointment that happens in many spots as Juni Vasti, Laali Lawn and so on. It makes underlying disappointment and harshness. It is brought about by the development of weighty stacked vehicle and gathering of downpour water. At the point when the profundity of the pothole is extensive then cutting, filling, moving activity is considered for low profundity pot opening and number of potholes are all the more just filling of the premix materials are done (Figure 8).

Figure 8 Potholes at Juni Vasti

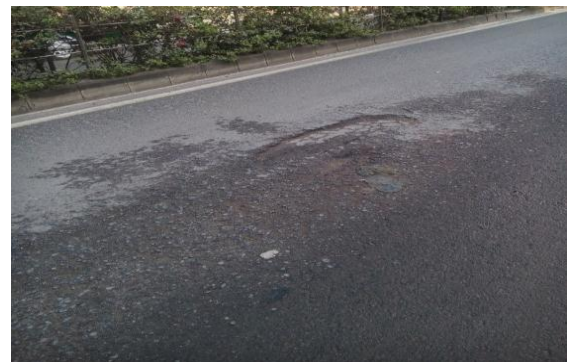
Water draining is found at Rayba Hotel, Chaparashi Pura. It lessens slip obstruction and underlying scaffolding. It is brought about by unfortunate blend plan in with more and unsatisfactory fastener. Sanding is applied to fix by spreading coarse sand over the surface. Sanding and surface dressing are done to fix this water dying (Figure 10).

Figure 10 Water bleeding at Rayba Hotel

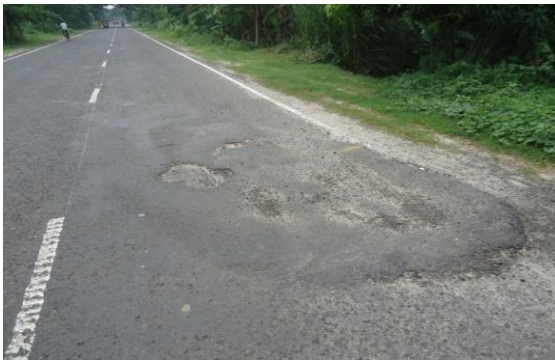
Groove and pushing are found at Juni Vasti, Dastur Nagar. They make unpleasantness and raised segment. It happens because of unfortunate blend configuration, weighty traffic, unacceptable folio, and so forth. Subsequent to cutting the disappointment segment, the methods including premix filling, rolling, and fixing are completed separately to fix them (Figure 11).

Figure 11 Corrugation and shoving at Dastur Nagar

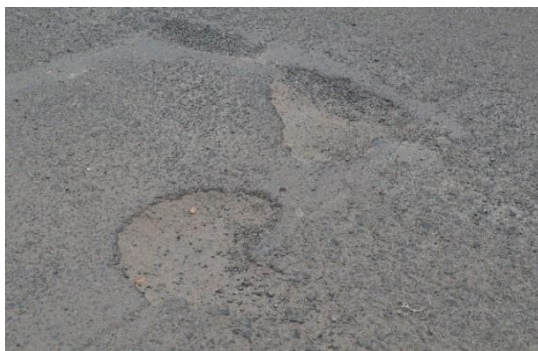
Discouragement is found in Yashoda Square. It makes sadness on streets. It is brought about by weighty precipitation and ill-advised waste framework. Despondency is fixed by eliminating the impacted part and supplanting it by premix filling (Figure 12).

Figure 12 Depression at Yashoda Square

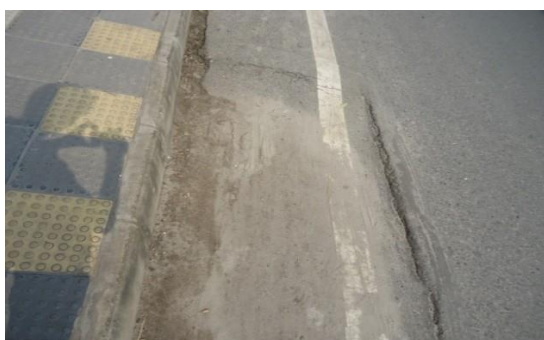
Rutting happens close to Nowdapara. Trenches that are loaded up with water can cause vehicle hydroplaning. It is brought about by weighty truck burdens and unfortunate development methodology. The rutting piece ought to be processed off and supplanted with premix. At long last, fixing is applied on premix for fix (Figure 13).

Figure 13 Rutting at Nowdapara
