# EVALUATION OF PAVEMENT SURFACE DISTRESS USING SMARTPHONE SENSOR DATA AND IMAGE-BASED ANALYSIS TECHNIQUES

Jadeja Krushanrajsinh Ramsinh<sup>1</sup>, Dr.Prachi Pandya<sup>2</sup>, Durgesh Kumar Singh<sup>3</sup>, Dr.C.G.Patel<sup>4</sup>

<sup>1</sup> Final Year Student, Department of Civil Engineering (IoT) Ganpat University, Gujarat, India

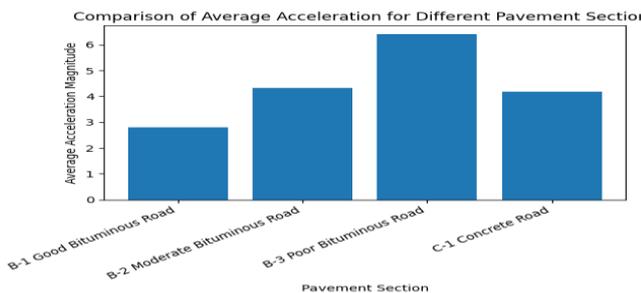
**Fig. 6:** Comparison of average acceleration magnitude for different pavement sections

A comparative evaluation of all selected pavement sections was carried out using average acceleration magnitude as a representative indicator of pavement-induced vibration response. The comparison reveals a clear relationship between pavement surface condition and acceleration response. The good-condition bituminous pavement (B-1) recorded the lowest average acceleration value (2.81), reflecting superior surface condition and ride quality. In contrast, the poor-condition bituminous pavement (B-3) recorded the highest average acceleration value (6.42), confirming severe surface distress.

The moderate-condition bituminous pavement (B-2) and the cement concrete pavement (C-1) exhibited comparable average acceleration values of 4.33 and 4.17, respectively. However, their vibration patterns differed in nature: the bituminous pavement showed irregular peaks due to localized surface defects, while the concrete pavement showed periodic sharp spikes due to pavement joints. This comparison demonstrates that smartphone accelerometer data can capture both pavement condition severity and pavement type characteristics.
