Failure investigation of Indigenized Boat under Carriage and Improvement in Frame Design

Anil Kumar¹, Shivkumarappa²

¹ Asst. Manager, R&D Defence, Bangalore Complex, BEML Ltd, Bangalore, India

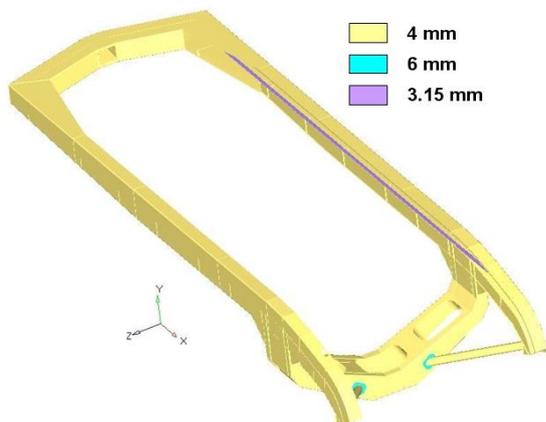
Fig -2: IGES Model of Tilting Frame

Tilting frame assembly comprises of Fe510 IS 5986 material plate construction and DIN 2391 tubing as shown in Fig - 2.

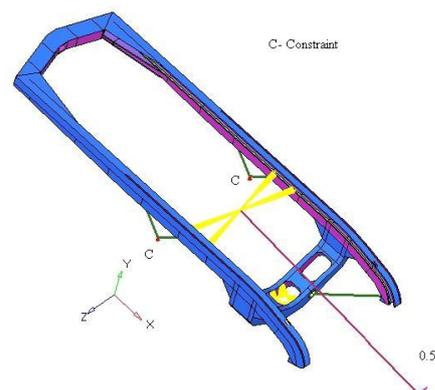
Fig -4: FE model of Boat under carriage Tilting Frame

FE modeling (See Fig -4) and Solution of Tilting-frame structure carried out by Hypermesh and Nastran respectively under afore mention conditions.

The max stress on Tilting frame is well within the limit of respective material. The twist reported under river current force is around 2 mm which is more enough to cause derailment of Travel truck from indigenized Boat under carriage (refer RCA). Based on FE analysis and Root cause analysis, Existing Tilting frame structure has modified as shown in Fig - 6.

Now, the maximum twist reported under river current force is around 1 mm which is self sufficient to operate Boat under carriage without failure (refer RCA).
