A case study: Failure analysis of crude oil pipeline rupture

Abstract: A cross-country crude oil pipeline section of 18" diameter API 5 LX 65, LSAW of 996 km was ruptured during its operation. This pipeline is used for carrying the crude oil from an offshore tank farm to a land-locked refinery. The failure occurred along the longitudinal seam. The affected pipeline section length was 206 km. The pipeline section was in operation since a 2002 and failure reported in 2017 i.e. more than 15 years of operation. This pipeline is laid as two parallel strings of 18" diameter pipelines. Prior to failure about two years back the pipeline was inspected using Axial MFL technology based intelligent pigging survey. However, no significant corrosion or other defect was identified in ILI findings in the section which would have eventually failed. Pipeline failed from its longitudinal seam, failure initiated from HAZ when the pipeline was in operation. The failure occurred much below the MAOP of the Pipeline. The MAOP is 91.4 kg/cm² where the pipeline was operational at 77 Kg/cm². Failure appeared to be fish mouth type of failure. Pipeline failure was examined from an operational as well as metal

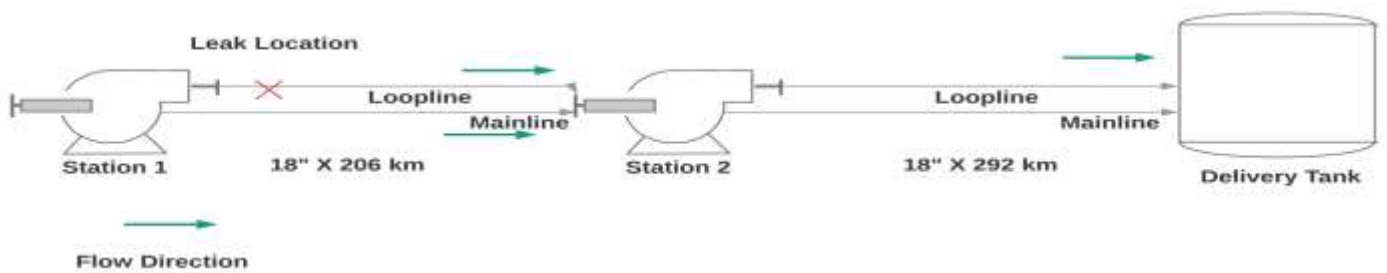
Figure 1: Operational Configuration of the pipeline during failure

The pipeline operating was being operated as the configuration is as shown in figure 1. The Pipeline in section-1 was being operated through both of the parallel pipelines. However, due to some maintenance activity, the pipeline was operated through a single pipeline in section 2. Every station is equipped with 2 motor-driven centrifugal pumps. After a continued uninterrupted operation, centrifugal pumps at station-1 tripped in the low suction. The flow rate increased in loopline in section-1 even after the pumps have tripped. This is a typical indication of a pipeline rupture. Pipeline section failed around 12 km downstream from station 1.
