# Impact Assessment of Hydro Geo-Technical Variation in Parts of Sector-8, HUDA Division, Ambala and Analysis of Foundation Design W.R.T. Water Logging Area.

**Abstract** - Houses in some parts of the City of Ambala are facing problems related to water seeping in and flooding of the ground floor area. This also leads to damping of walls and settling of foundation. As a result of settlement, structural members like beams and columns attain cracks. Thus this study has been undertaken to investigate the reason for the rise of water table and also its effect on the structural stability of the buildings. As Ambala is expected to see development in the next 10 years which includes multi stories this study thus become important to be carried out. This paper, after days of site study, list out the reasons and their remedies mainly in Sector 8, HUDA Division of Ambala.

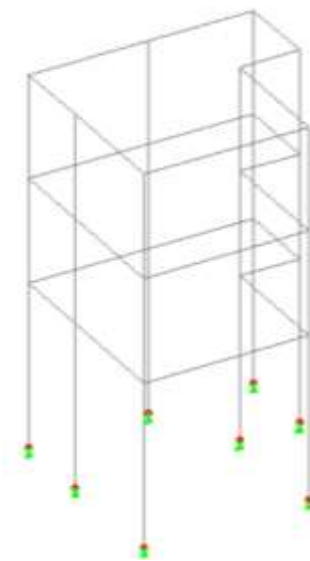
Figure 6 Building analysed in a standard structural analysis software

The building was designed as G+3 with basic loads like dead load and live load taken from IS 875 (Part1).
