Review About Incidents in Dams and Dike Behaviors Induced by Internal Erosion

Aldulaimi Ali A. Ahmed ¹, AlSaadi Anmar J.²

Key Words: Embankment dam, Failures, Incidents, Internal erosion, Sinkholes.

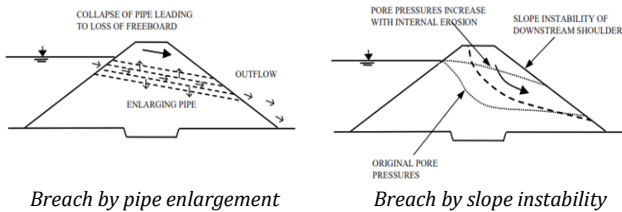
- a. Gross enlargement of the pipe.
- b. It was overtopping (e.g., due to the settlement of the crest from suffusion or due to the formation of a sinkhole from a pipe in the embankment).
- c. Slope instability of the downstream slope.
- d. Unraveling of the downstream face.
- e. Static liquefaction is a slope instability that may include increased pore pressure and collapse in the eroded zone.

Fig -2: Potential breach (failure) phenomena-pipe enlargement and slope instability, [4].

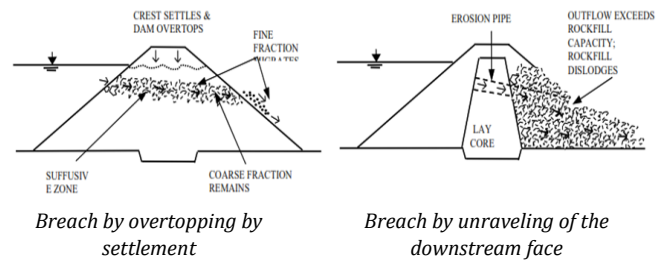
Fig -3: Potential breach (failure) phenomena-overtopping by settlement and unraveling of the downstream face, [4].
